# Holden Beach Oceanfront Pier Due Diligence Inspection Holden Beach, North Carolina

October 15, 2021

Applied Technology & Management of NC

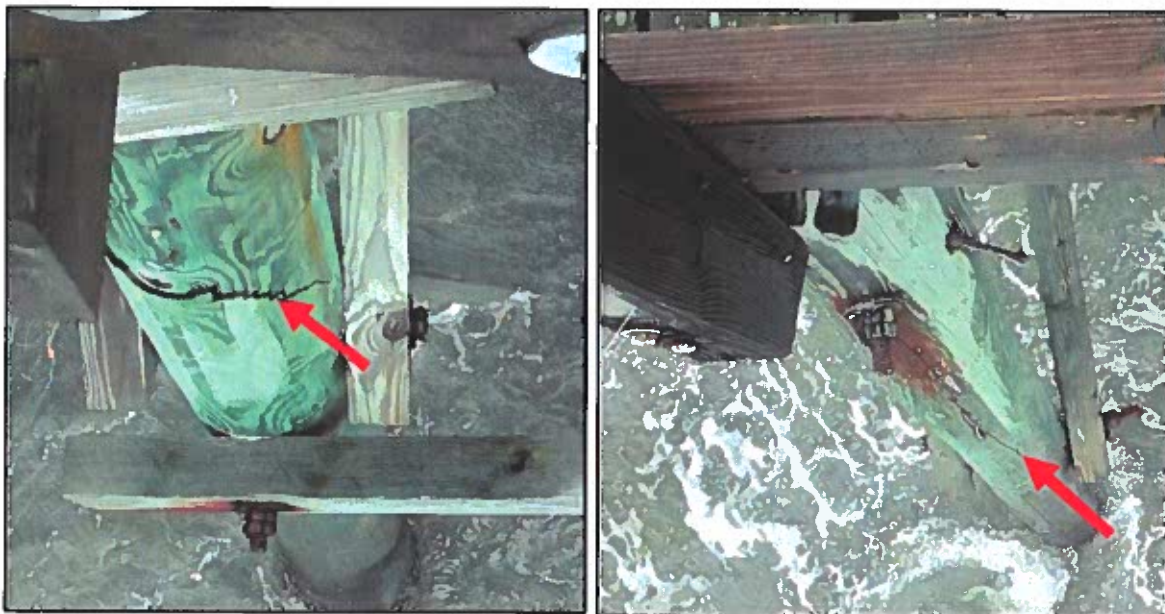
There are no observed defects due to fungal, borer, or biological attack above the mean low water level. Due to weather conditions at the time of inspection, underwater visual and tactile inspections were limited, however it was found that subsurface pile conditions were similar to intertidal and above water pile conditions. Five piles were cracked, broken, and/or overstressed and are in critical condition as shown in Figure 6. The rest of the piles appear to be in satisfactory condition. The underwater inspection also generally found the piles to be in satisfactory condition.

**Figure 6. Cracked piles in critical condition**

- Without critical design information related to the timber piles and site conditions, it is difficult to perform a critical assessment of existing and remaining capacity. The three piles that are cracked or broken should be replaced immediately. The two piles that have reduced load bearing should be repaired immediately.

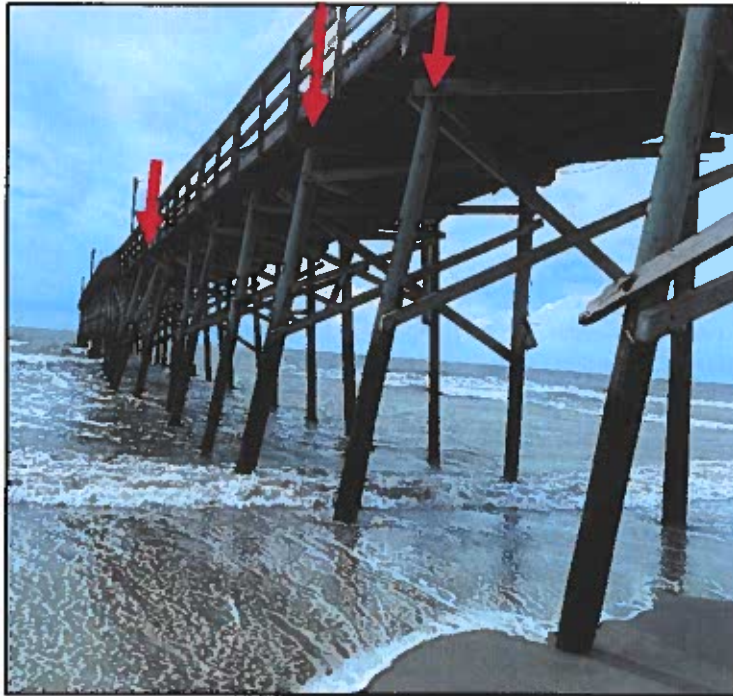
There are several locations where piles were non-plumb and are leaning or tilted. Misalignment may be the result of storm damage, subsidence, or lack of structural support from crossbeams. There are also two critical areas where the piles have a reduced load bearing capacity. See Figures 7-9.

**Figure 7. Photo of significant leaning of piles in two locations**

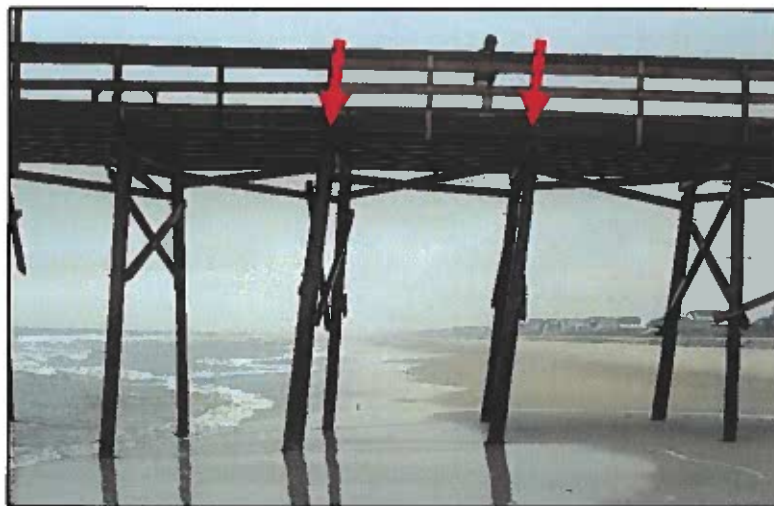
**Figure 8. Photo of leaning piles nearshore**

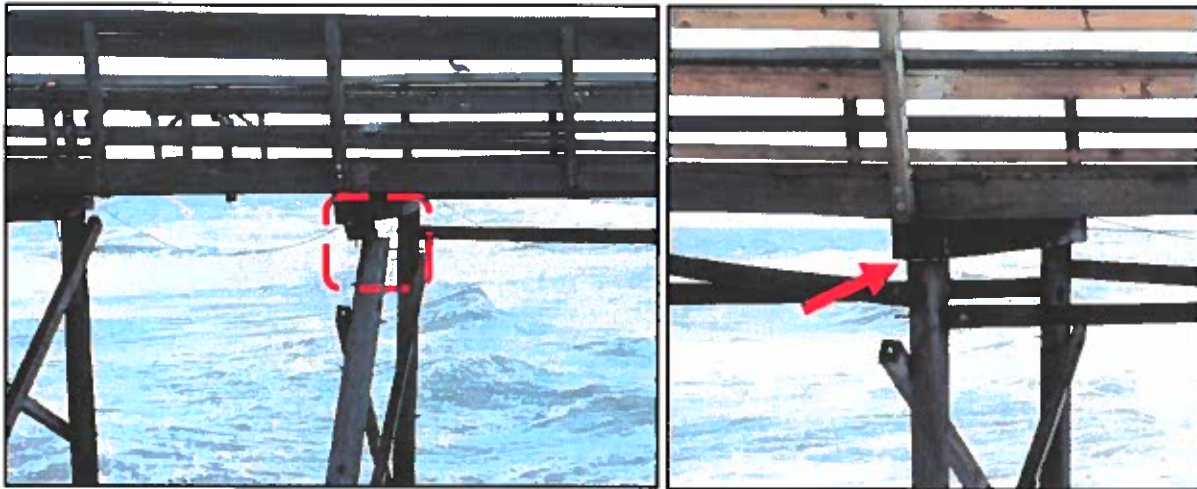
Figure 9. Photo of 50% bearing capacity pile (left), Photo of 100% non-bearing capacity pile (right) (air gap exists between pile and pile bent with only metal straps providing support)

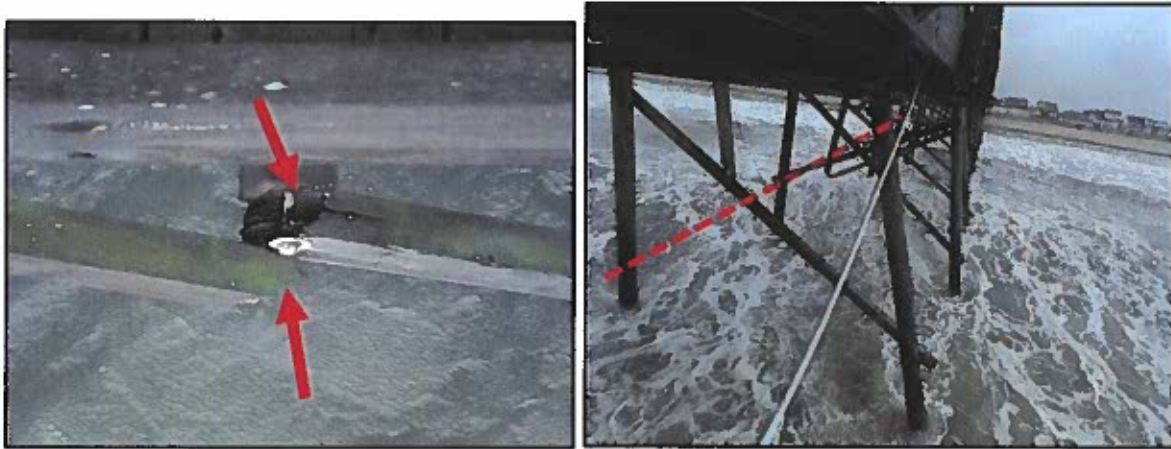
A majority of the horizontal and vertical cross-braces are either missing, detached, or broken which is a *critical condition for the structure* (see Figure 11). The hardware throughout the entire structure is heavily corroded and has greater than 50% section loss. There is an inconsistent use of cross-bracing along the pier. Below are examples of broken or missing cross-bracing. Figure 12 is an example of the significantly corroded hardware connecting the cross-bracing to the piles.

Figure 11. Example of broken cross-brace (left) and missing vertical cross-brace (right)

Missing, detached, or broken cross-braces are critical elements and require replacement. Most of the pile bents and stringers are in fair condition and do not require immediate replacement. Nearly all visible connections are in critical condition and will require replacement. ATM recommends the use of marine-grade stainless steel to deter corrosion of metal fasteners where exposed to sea water.

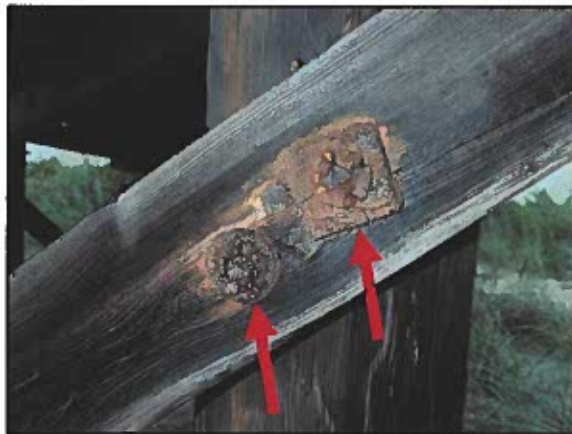
Figure 12. Example of hardware in critical condition (over 50% section loss)

One of the key concerns observed during the inspection was the heavily corroded and missing/damaged connection hardware throughout the pier structure. Most connections appear to have more than 50% sectional loss (thereby reducing their strength by 50%).

- Ongoing wear to the decking from weathering will require ongoing maintenance and replacement of deck boards as necessary.
- Corrosion of fasteners and bolt connections of the structural elements of the pier will reduce strength and performance. ATM recommends replacing the connections with marine-grade stainless steel to deter corrosion in metal fasteners where exposed to sea water.

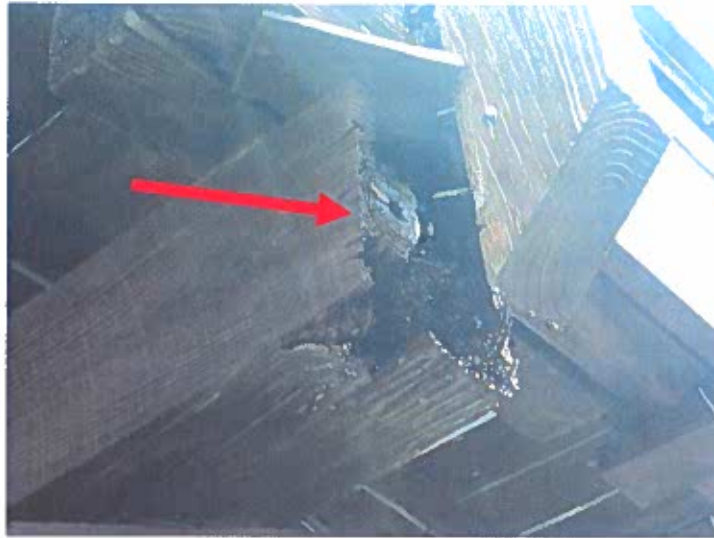
The pile bents vary in size, and several have been recently replaced. Overall, most of the pile bents are in good condition. Some of the pile bents are exhibiting wood rot at the ends and are in poor condition. The piles appear to be attached to the pile bents by a dowel of unknown dimension and condition and/or straps. An example of a pile bent in poor condition is shown in Figure 13.

**Figure 13. Example of a pile bent in poor condition, exhibiting deterioration at the end.**

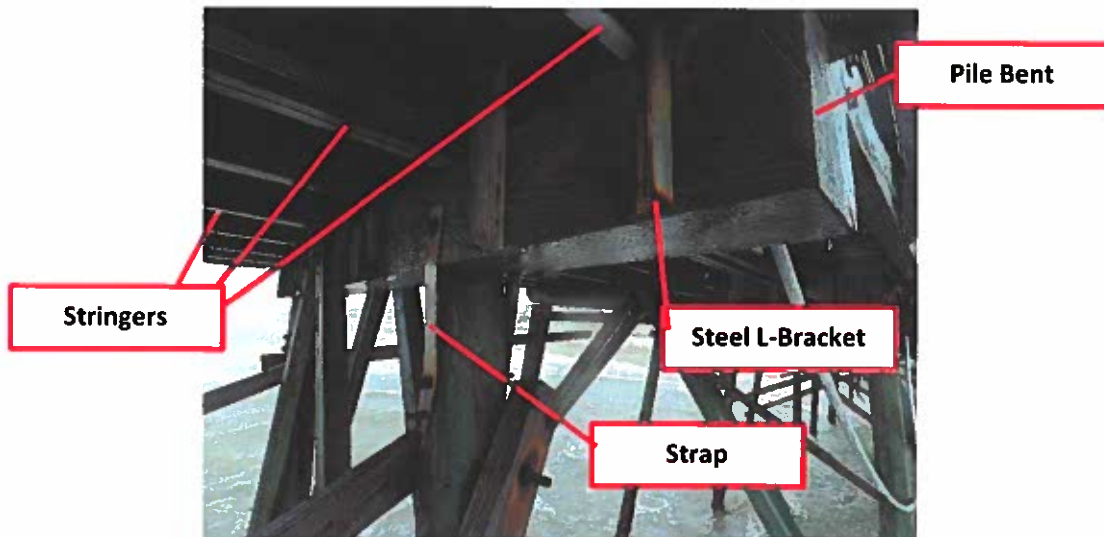
The stringers appear to be in fair condition. Upon inspection, there were various methods of connection including nails, steel L-brackets and steel straps as shown in the Figure 14 - 16. In several locations there was no apparent connection between the stringers and the pile bents. Therefore, their condition is unknown. The connection hardware was inconsistent overall, and in many cases, they exhibited moderate to extreme corrosion.

**Figure 14. Example of stringers attached to pile bents by steel L-brackets with moderate corrosion (fair condition). Pile is attached to pile bents by straps.**

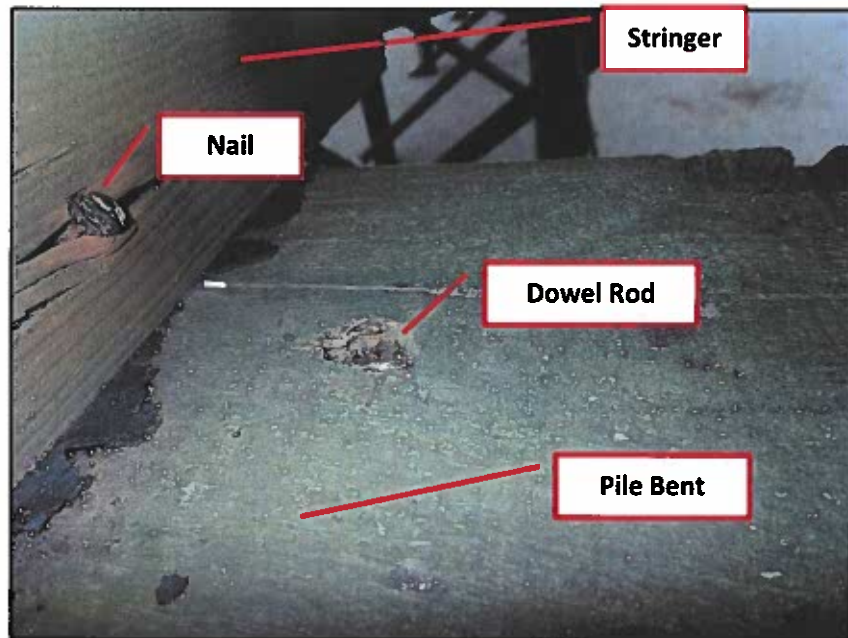
Figure 15. Example of what appears to be a dowel rod through the top of the pile bent to connect to the timber pile below. Also shown is a nail attaching the stringer to the pile bent.

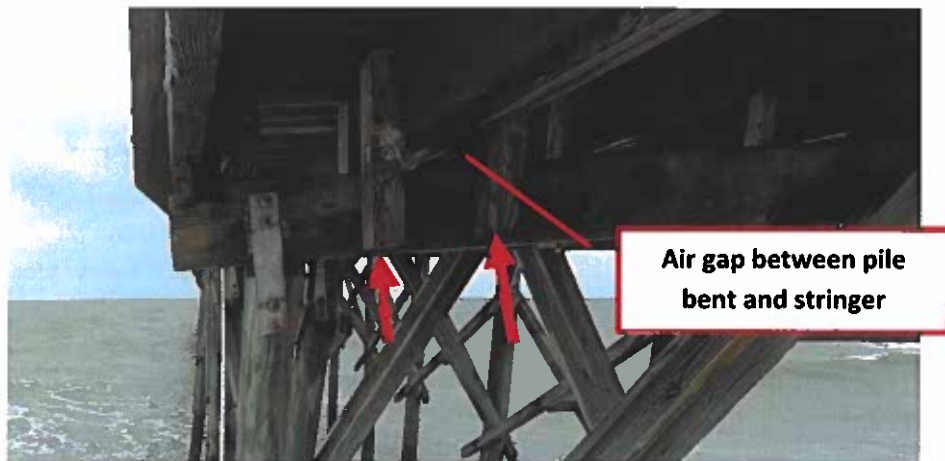
Figure 16. Example of timber bracing (red arrows) used to connect stringers to pile bents. Pile attached to pile bent by metal strap. Note that one of the stringers is not sitting on the pile bent in this photo.

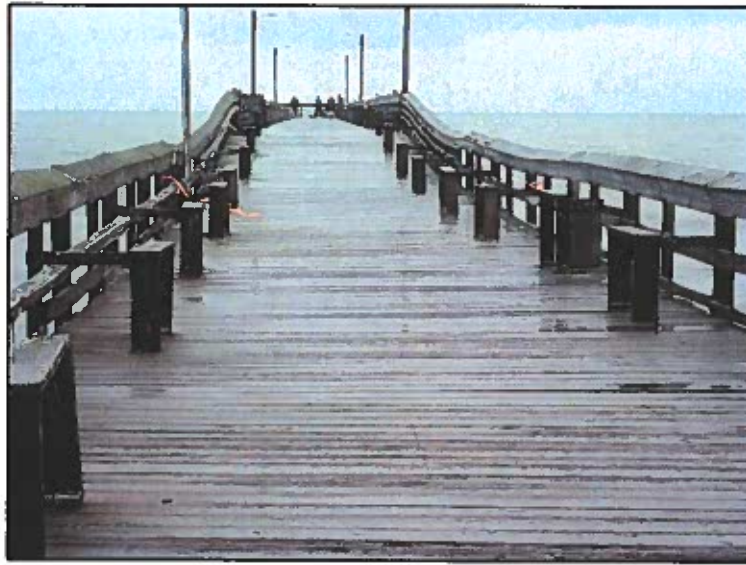
The timber decking appears to be in fair condition. There are several locations where boards have been recently replaced. The age of the decking is unknown but shows signs of degradation consistent with age and exposure including rusting hardware and wood splitting. The decking appears to be maintained and no tripping hazards were observed.

**Figure 17. Example of timber decking**

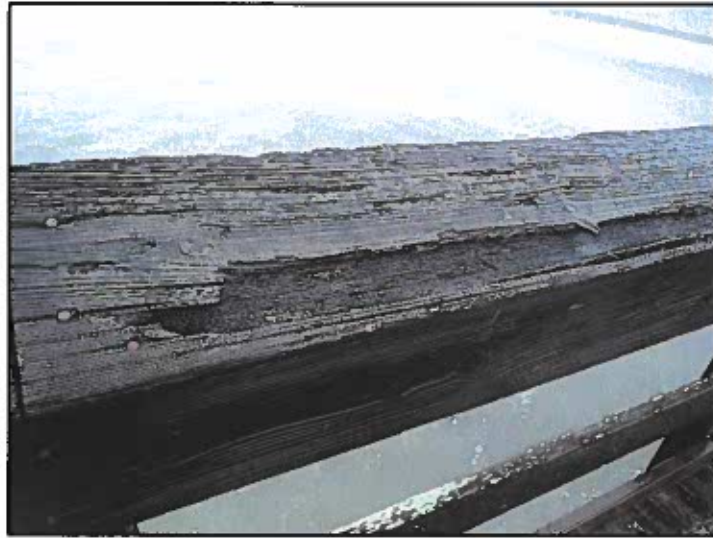
Overall, the timber handrails appear to be in poor condition. There is one critical section of handrail on the east side nearshore that exhibited excessive movement when pushed upon. There were several areas where new handrails were installed. There were a few locations where the handrail had degraded timber and exhibited >25% cross sectional loss. *Handrails in poor condition are a severe safety risk.*

Figure 19. Example of railing in poor condition

- In many areas, the handrails are loose and/or structurally deficient. This is considered a life-safety issue and should be corrected immediately.

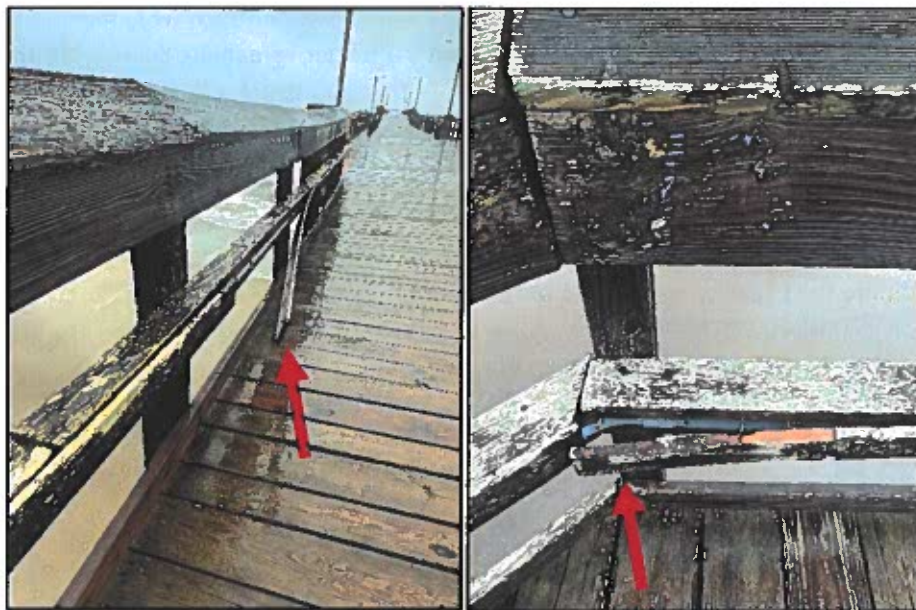
The conduit for the electrical wiring for light posts is enclosed in timber along the railing. There are several locations where the connections were compromised and are a recognized safety hazard.

Figure 20. Photo of detached conduit enclosure attached to handrail

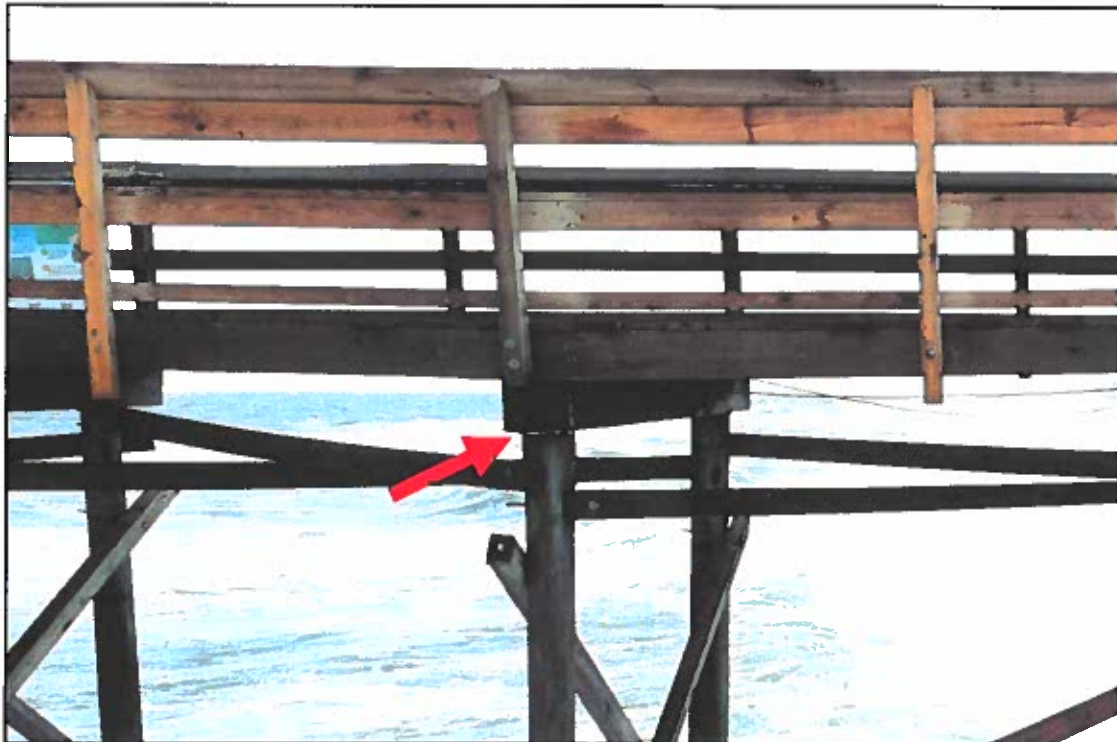
**Photograph 2: Pile 17A - 100% Non-Bearing pile, timber cap supported by steel fish plates**

ELEMENT	RECOMMENDATION	ESTIMATED COST
Timber Piles	Install timber pile shim (17A).	\$ 3,000
	Replace inkind timber pile shims (24A).	\$ 3,000
	Post pile repair to the top 2 feet of the three overstressed piles (25B, 40A & 52A).	\$ 15,000
Timber Pile Cap	Replace inkind timber pile cap (Bent 27).	\$ 9,000
Timber Stringer	Replace inkind timber stringer (Bent 27 to 26).	\$ 7,000
<b>Priority Recommendation Subtotal:</b>		<b>\$ 37,000</b>

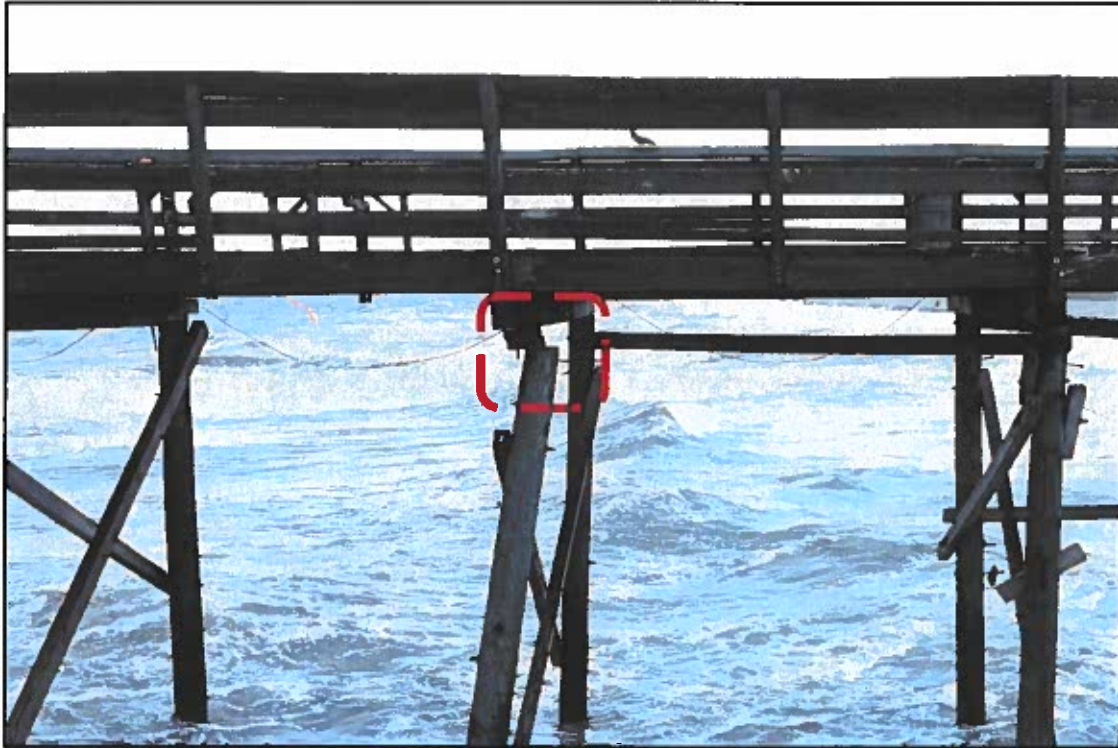
**Photograph 3: Pile 24A - 50% Bearing due to displaced pile shims**

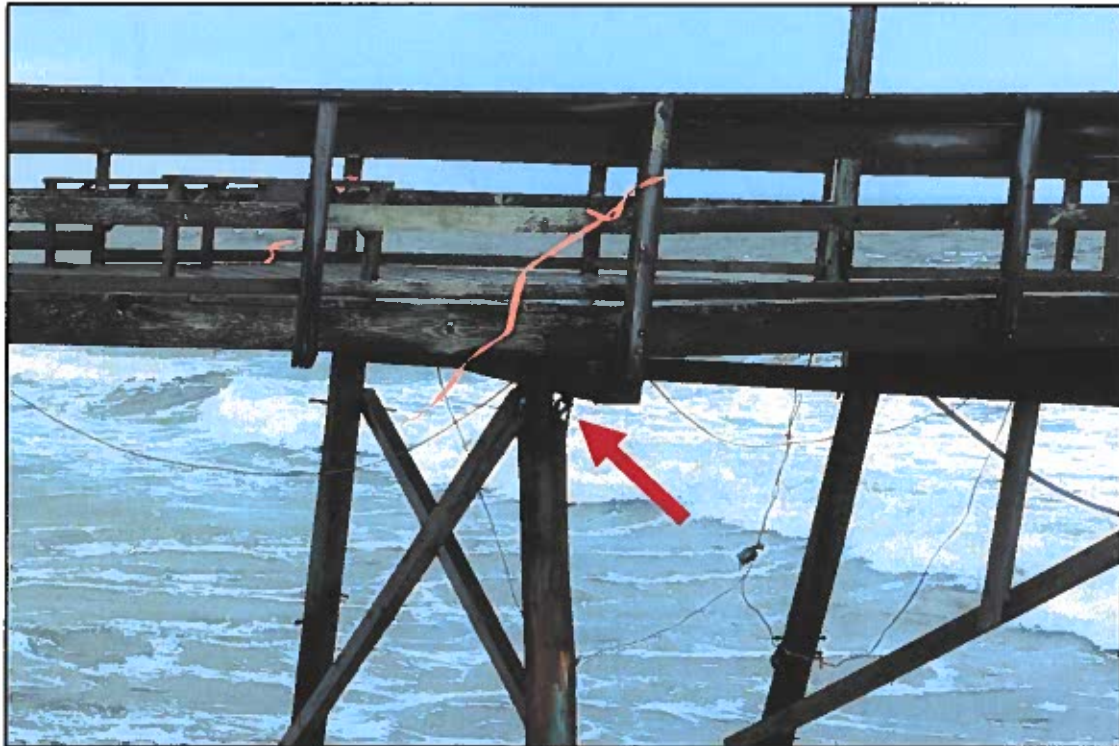
**Photograph 4: Pile 25B - Top 18-inch pile is broke/overstressed**

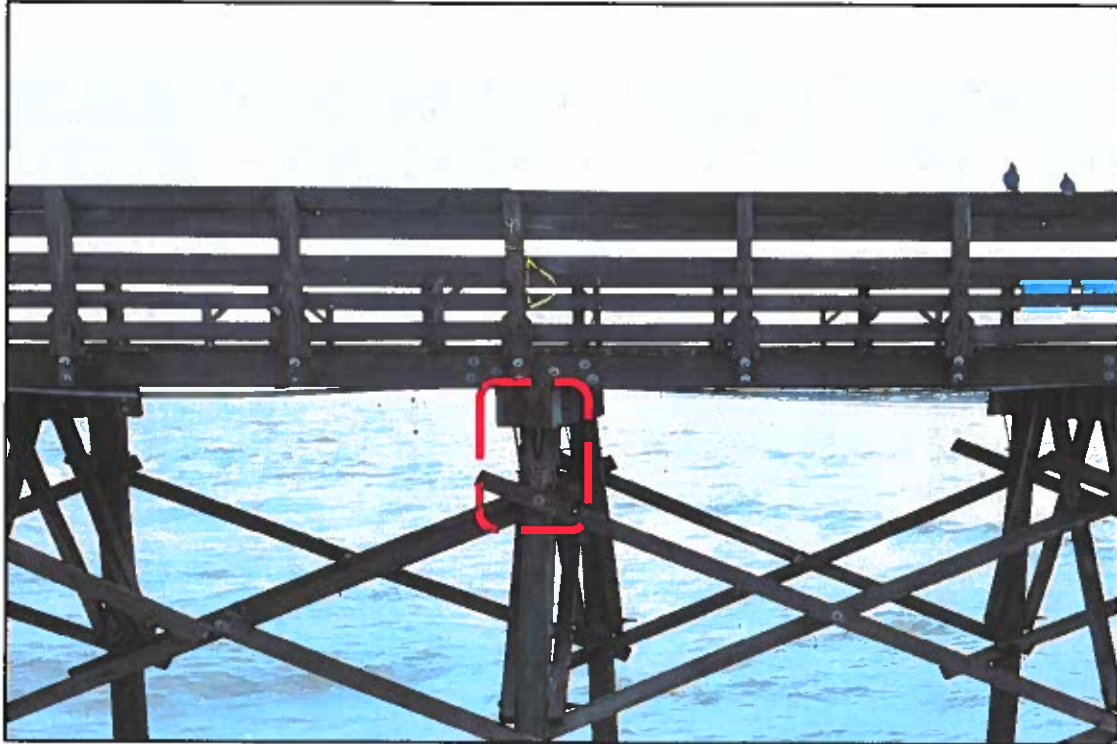
**Photograph 5: Pile 40A - Top 18-inch pile is broke/overstressed**

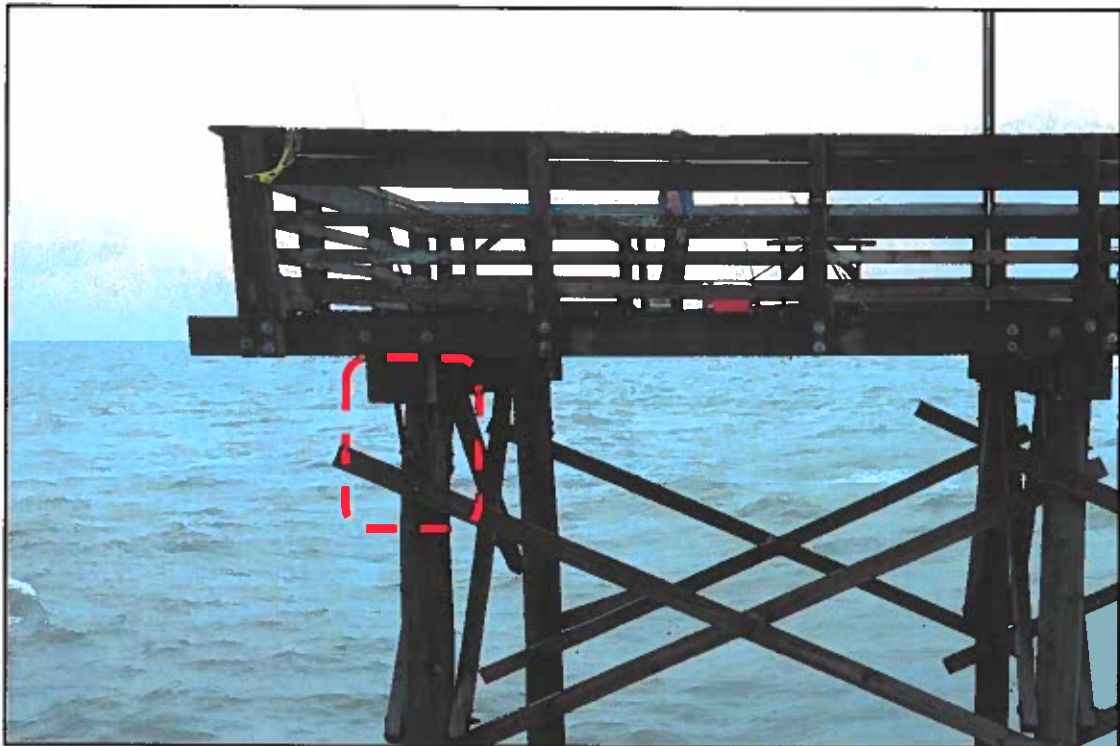
**Photograph 6: Pile 52A - Top 18-inch pile is broke/overstressed**

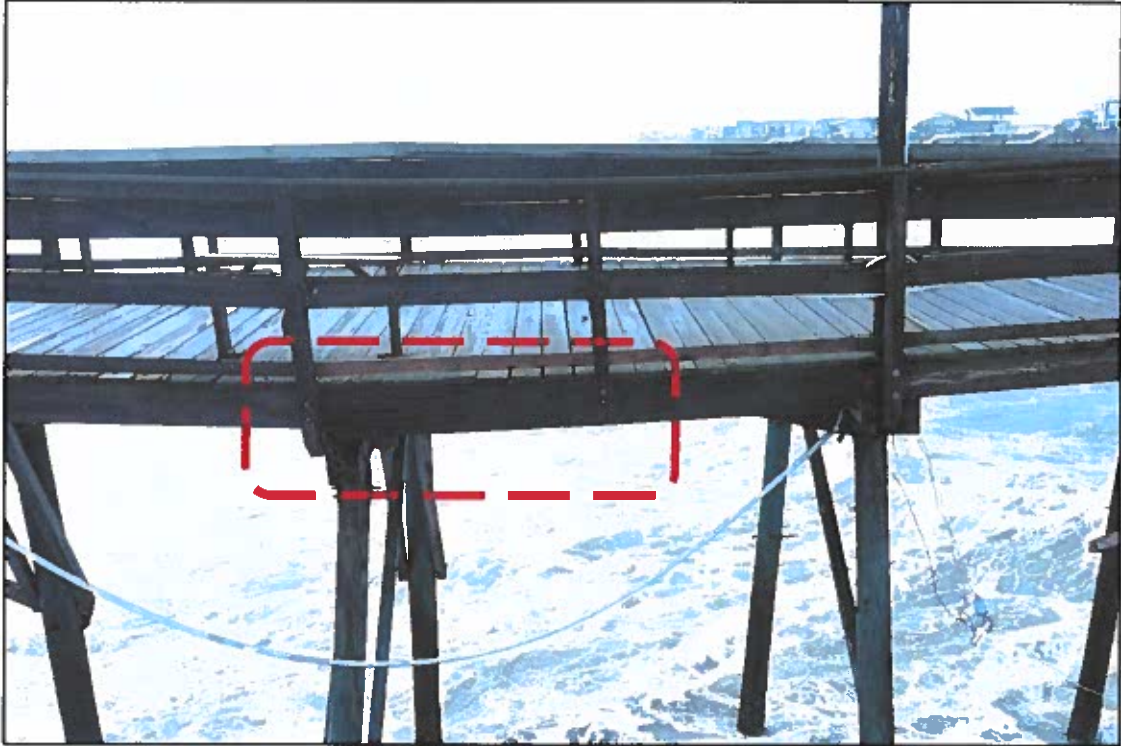
Additionally, between Bents 26 to 28 deflection and rotation was noted in the walking surface. The cause of this deflection appears to be overstressing in the pile cap of Bent 27 and the timber stringer from Bent 27 to 26 (Photograph 7). However, during the time of the inspection, the pier appears stable at the time of inspection.

**Photograph 7: Bent 27 - Overstressed pile cap & stringer**
