# RIGHT ANGLE

February 24, 2023

Re: Evaluation of Holden Beach Pavillion  
Structural Condition

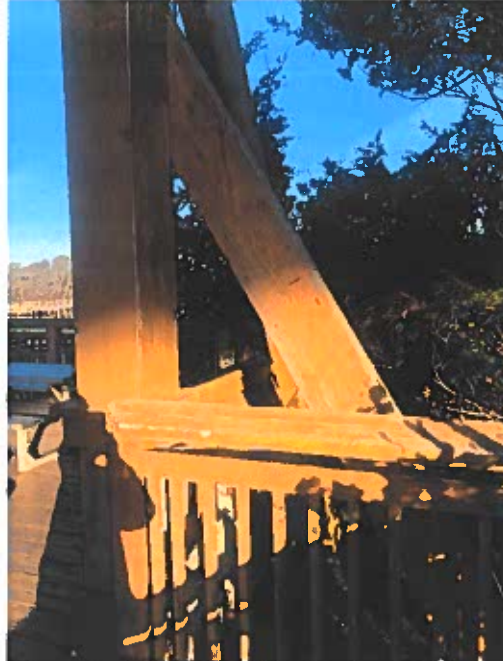
Visual observations were taken compared to the design drawings previously mentioned. It does appear that the "Temporary Bracing System" was installed per the design drawings for the structure visible above grade. No significant deficiencies were noted in these areas.

Photo 1 – Rear right side temporary bracing

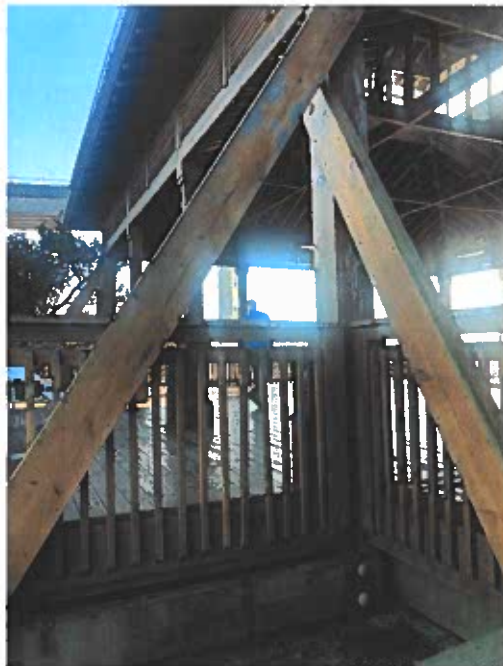
Photo 2 – Rear left side temporary bracing

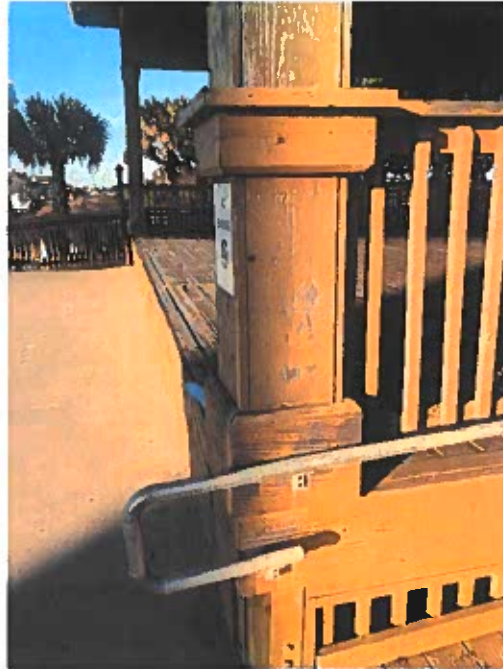
Investigation of the pile foundation revealed that no work had been completed as designed in the “Column Repair Plan” which had called for two sister piles to be installed at 10 locations of existing pile locations. These were located around the perimeter with connection details to the existing piles and band framing.

Photo 3 – Corner pile with no pile repairs

the column repairs, which were designed by an engineer were never implemented. Although this may contribute to the sagging of the roof framing members, there are additional factors such as over-spanned beams, poor connections, design flaws, corrosion, etc that are negatively impacting the structural integrity of the pavilion.

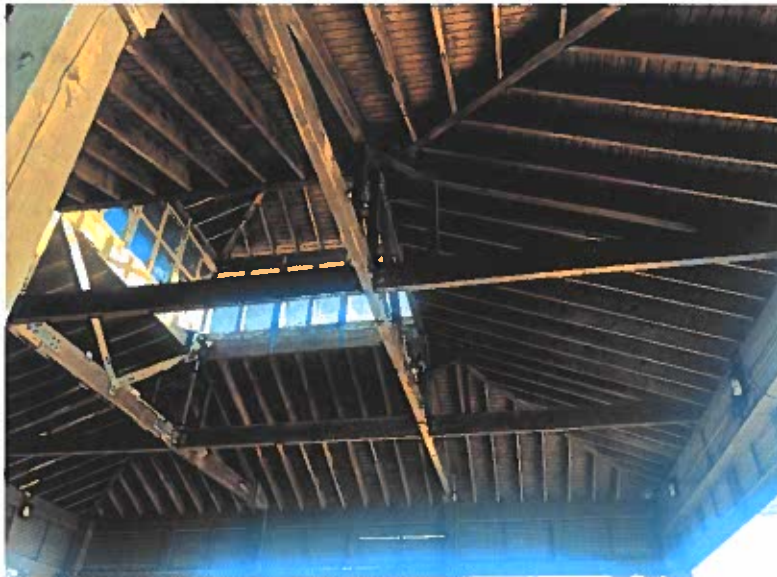
The roof truss system appears to have been field constructed. Observation of the framing indicates sagging over the approximately 36 foot span. The butt spliced connections with plates have significant gaps. There were also noted vertical framing elements out of plumb.

Photo 4 – Roof framing

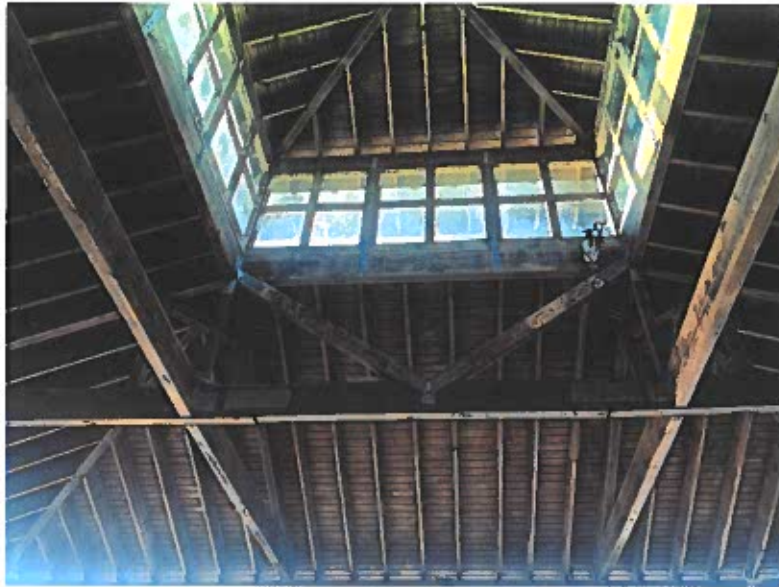
Photo 5 – Roof Framing

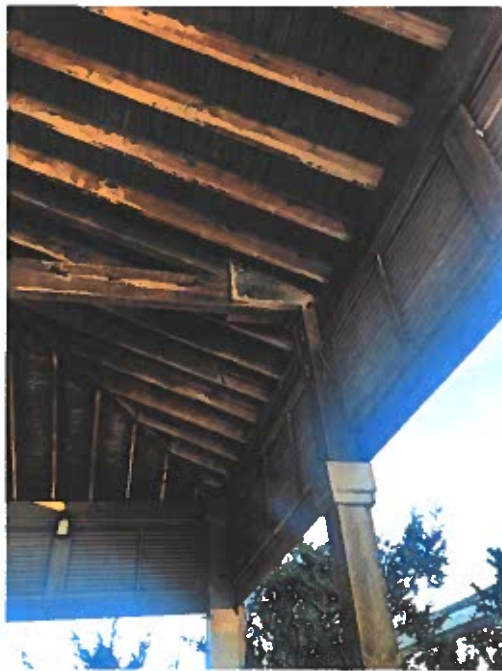
Also noted during inspection are plates and hardware showing signs of corrosion from the exposure to the marine environment.

Photo 6 – Truss plate
