Inlet Hazard Area Boundary, 2019 Update:

Science Panel Recommendations to the
North Carolina Coastal Resources Commission

February 12, 2019

NC Coastal Resources Commission's Science Panel on Coastal Hazards
& NC Division of Coastal Management

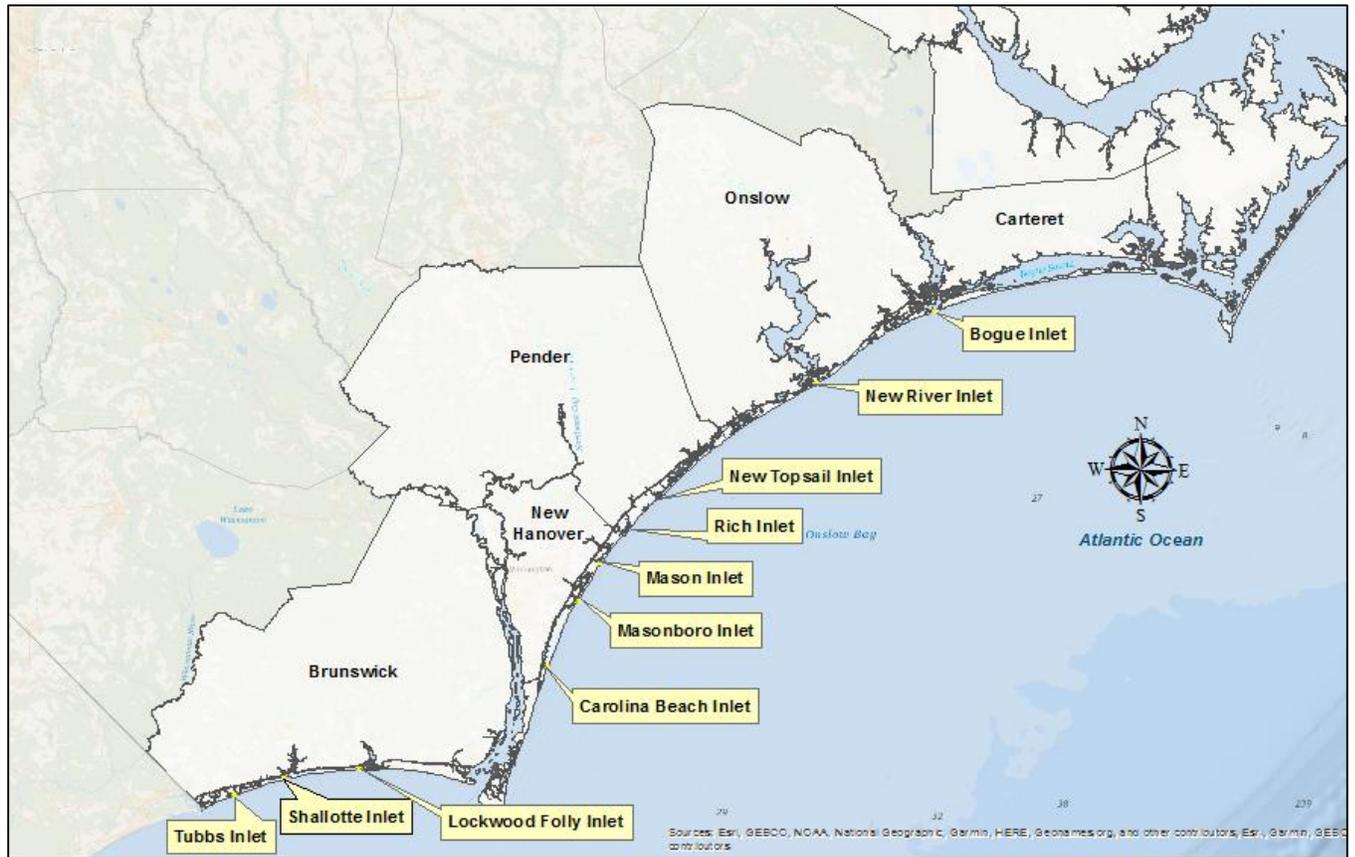
Figure 1. Study area includes Tubbs, Shallotte, Lockwood Folly, Carolina Beach, Masonboro, Mason, Rich, New Topsail, New River and Bogue Inlets. At least one side of each inlet is developed.

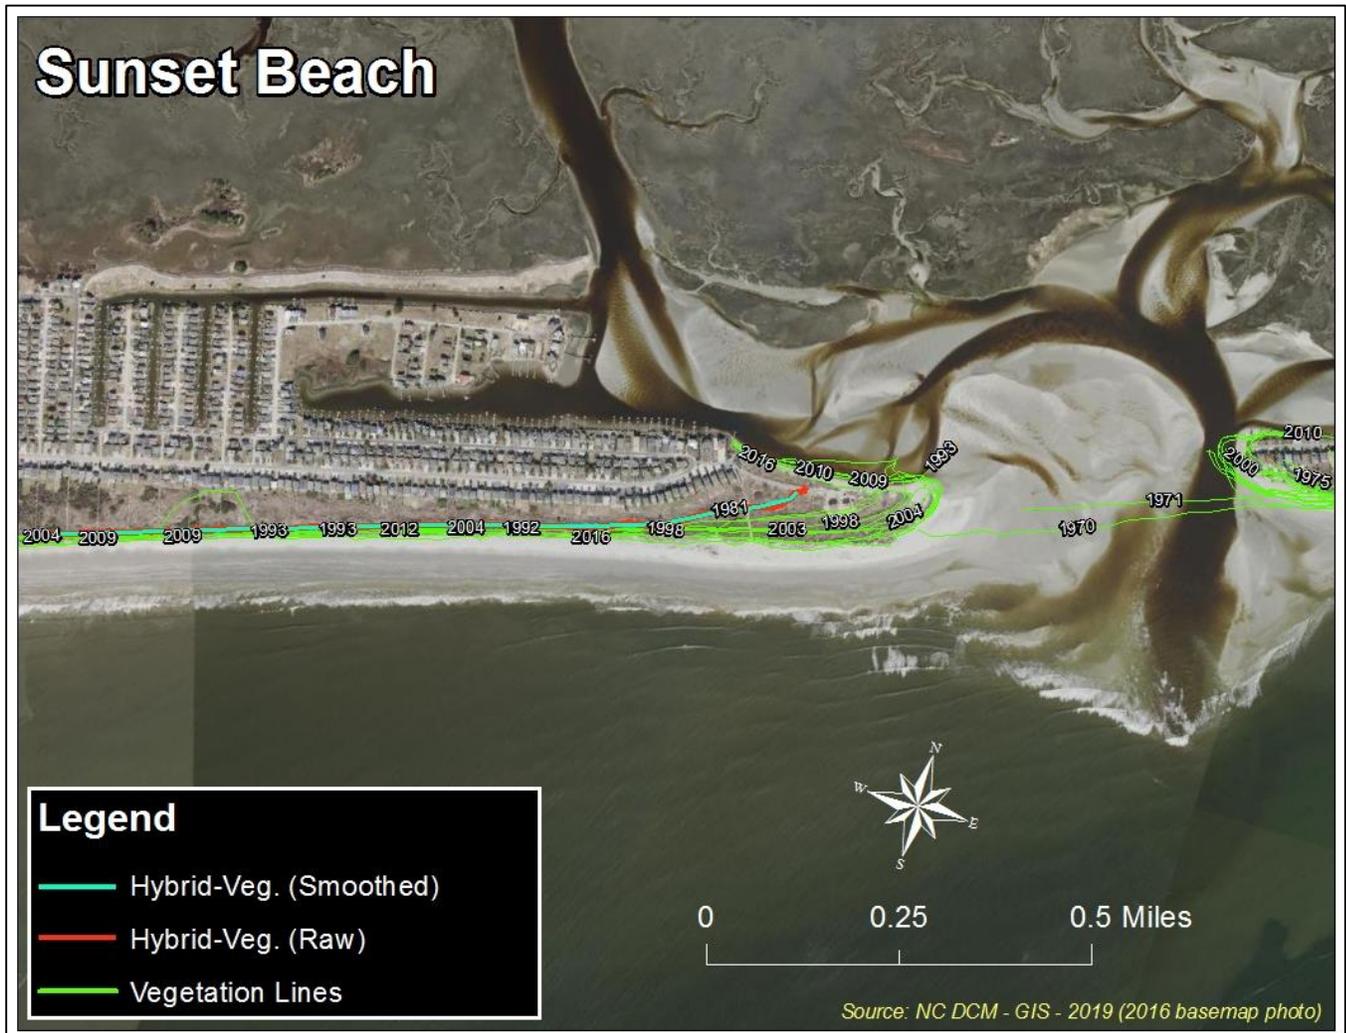
Figure 7. Tubbs Inlet at Sunset Beach. Vegetation Lines mapped: 1981, 1992, 1993, 1998, 2003, 2004, 2009, 2010, 2012, 2016. Vegetation line segments making up the Hybrid-Vegetation Line: 1981, 1993, 1998, 2003, 2004.

applying the IHAM (Figures 7, 8). The oceanfront shoreline boundary of inlet influence is inlet transect-210 (Figure 9). The 90-Year Risk Line is the recommended landward boundary (Figure 10).

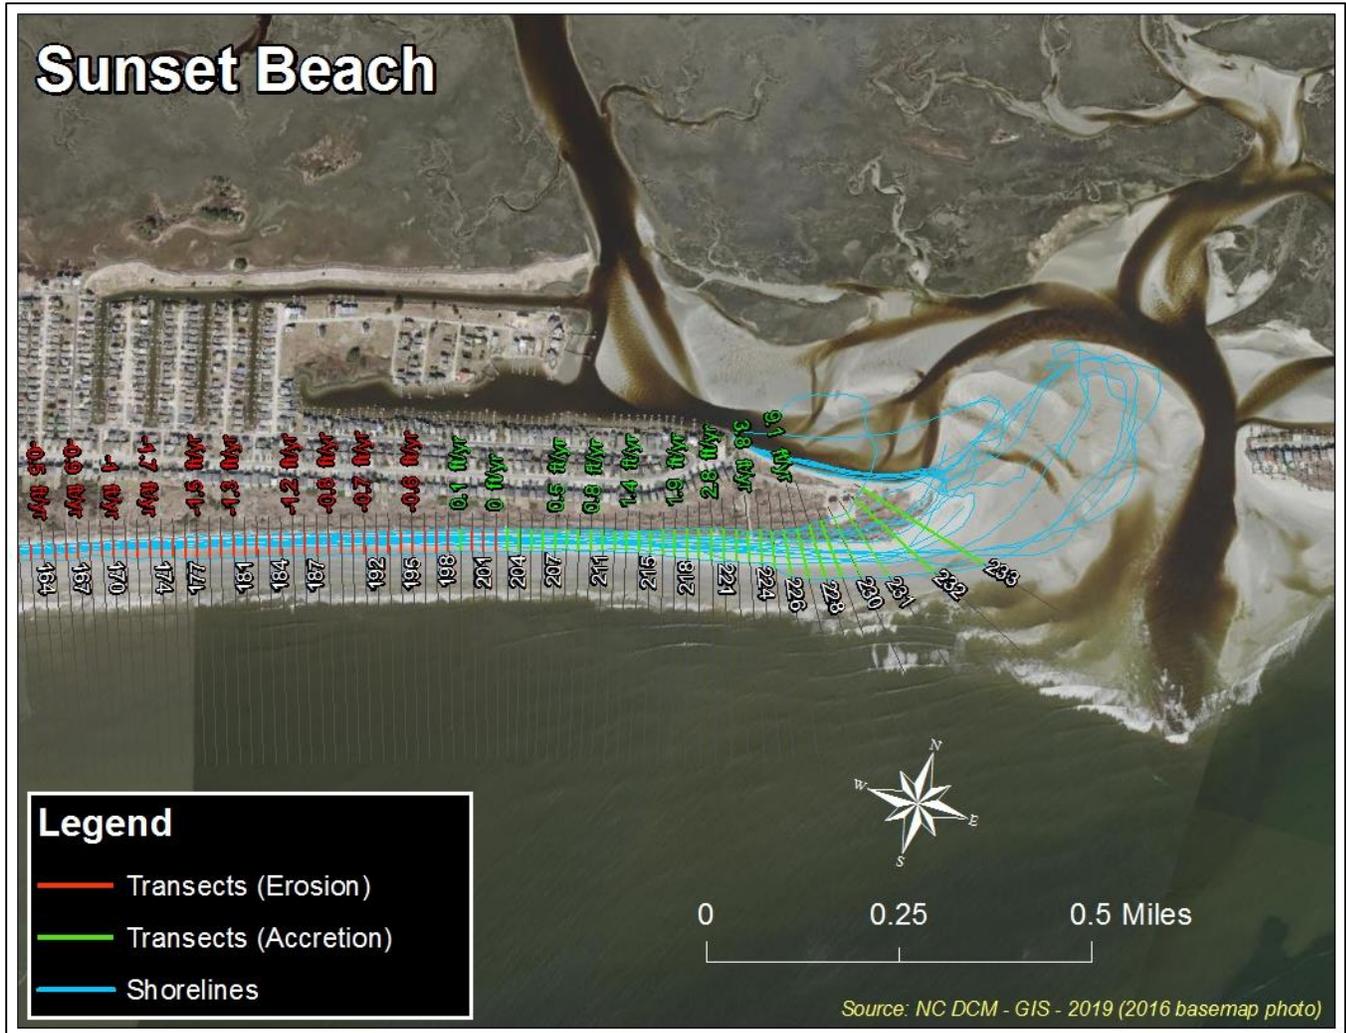
Figure 8. Tubbs Inlet at Sunset Beach. Shorelines included in the analysis: 1981, 1992, 1993, 1997, 1998, 2003, 2004, 2006, 2008, 2009, 2010, 2012, 2016.

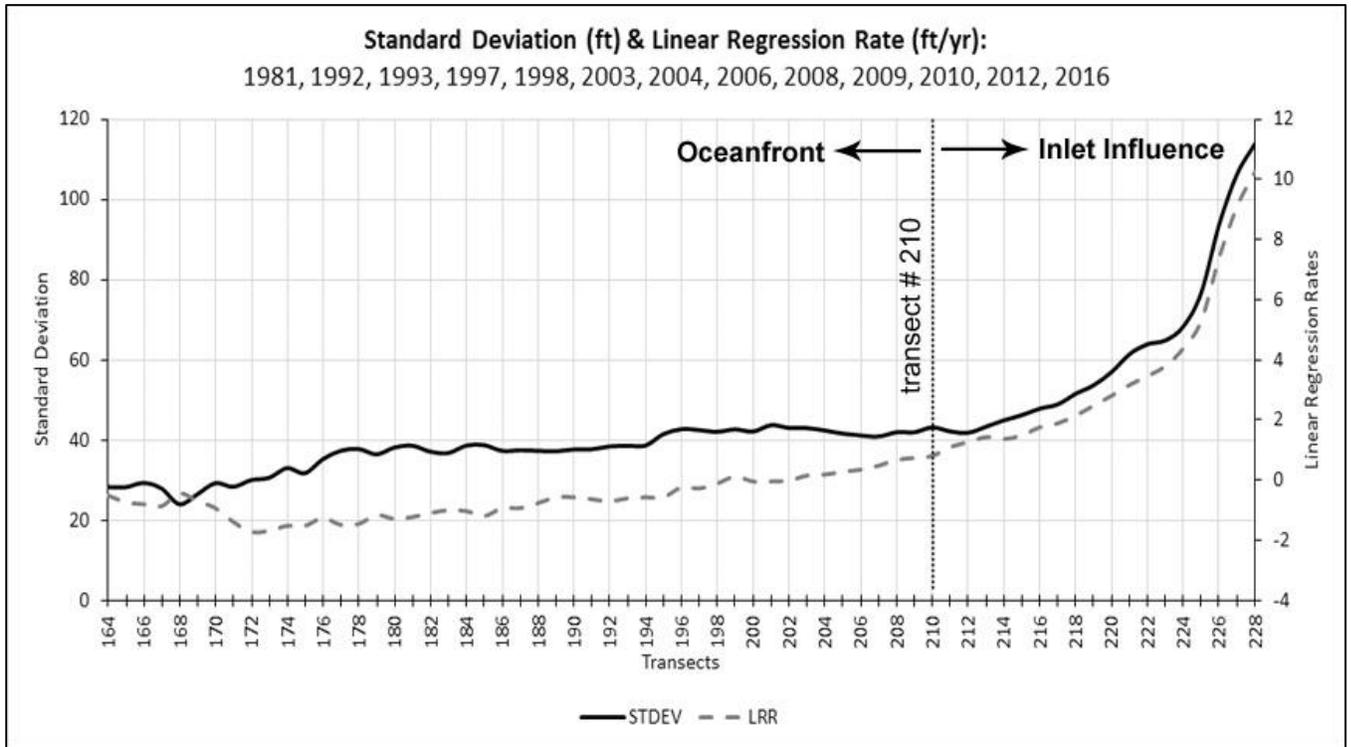
Figure 9. Based on standard deviation of shoreline position at Tubbs Inlet-Sunset Beach, transect-210 is recommended as the inlet-ocean transition boundary. Negative Linear Regression Rates indicate erosion, while positive values represent accretion (right axis).

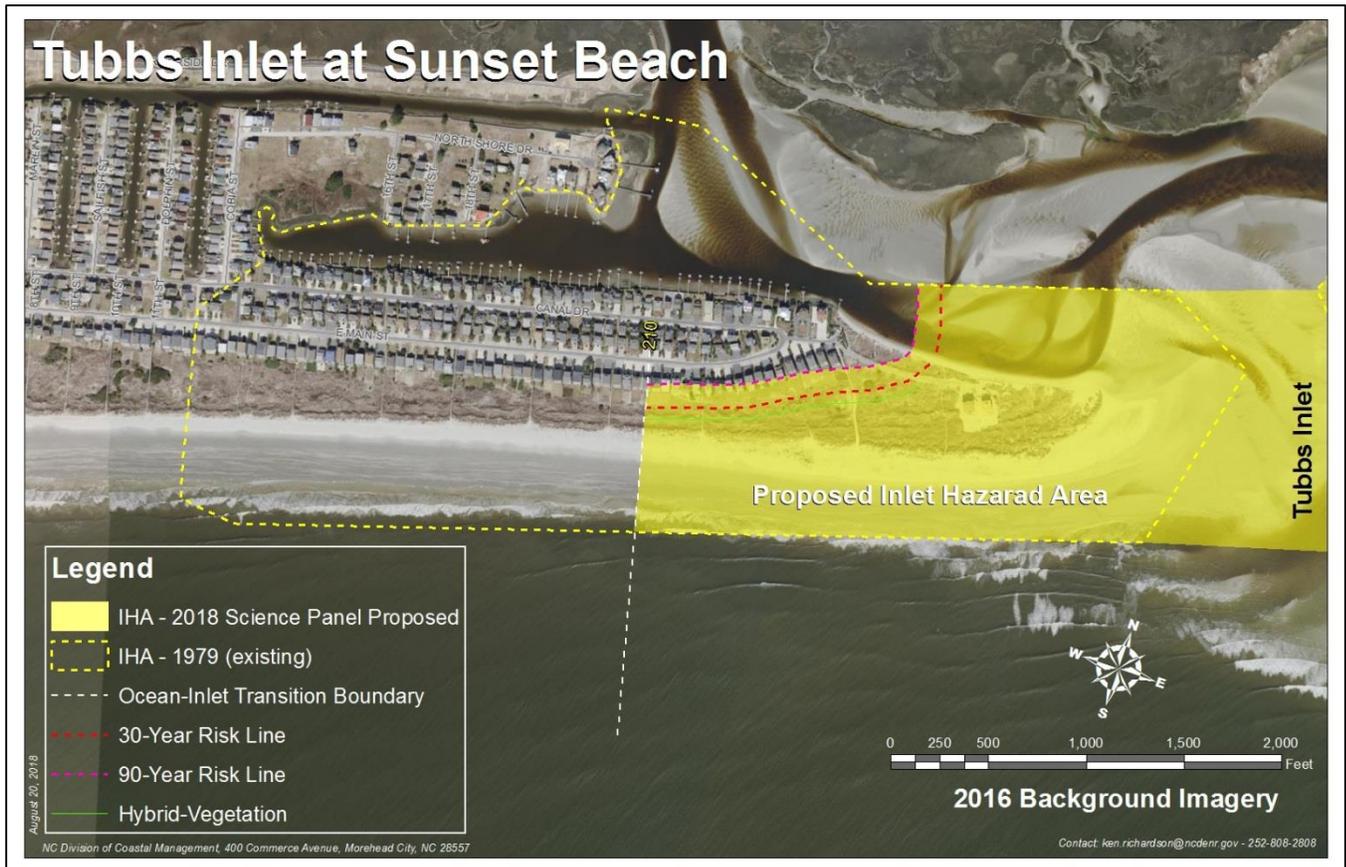
Figure 10. Tubbs Inlet at Sunset Beach Hybrid-Vegetation Line and the recommended IHA boundary with the 30- and 90-Year Risk Lines.

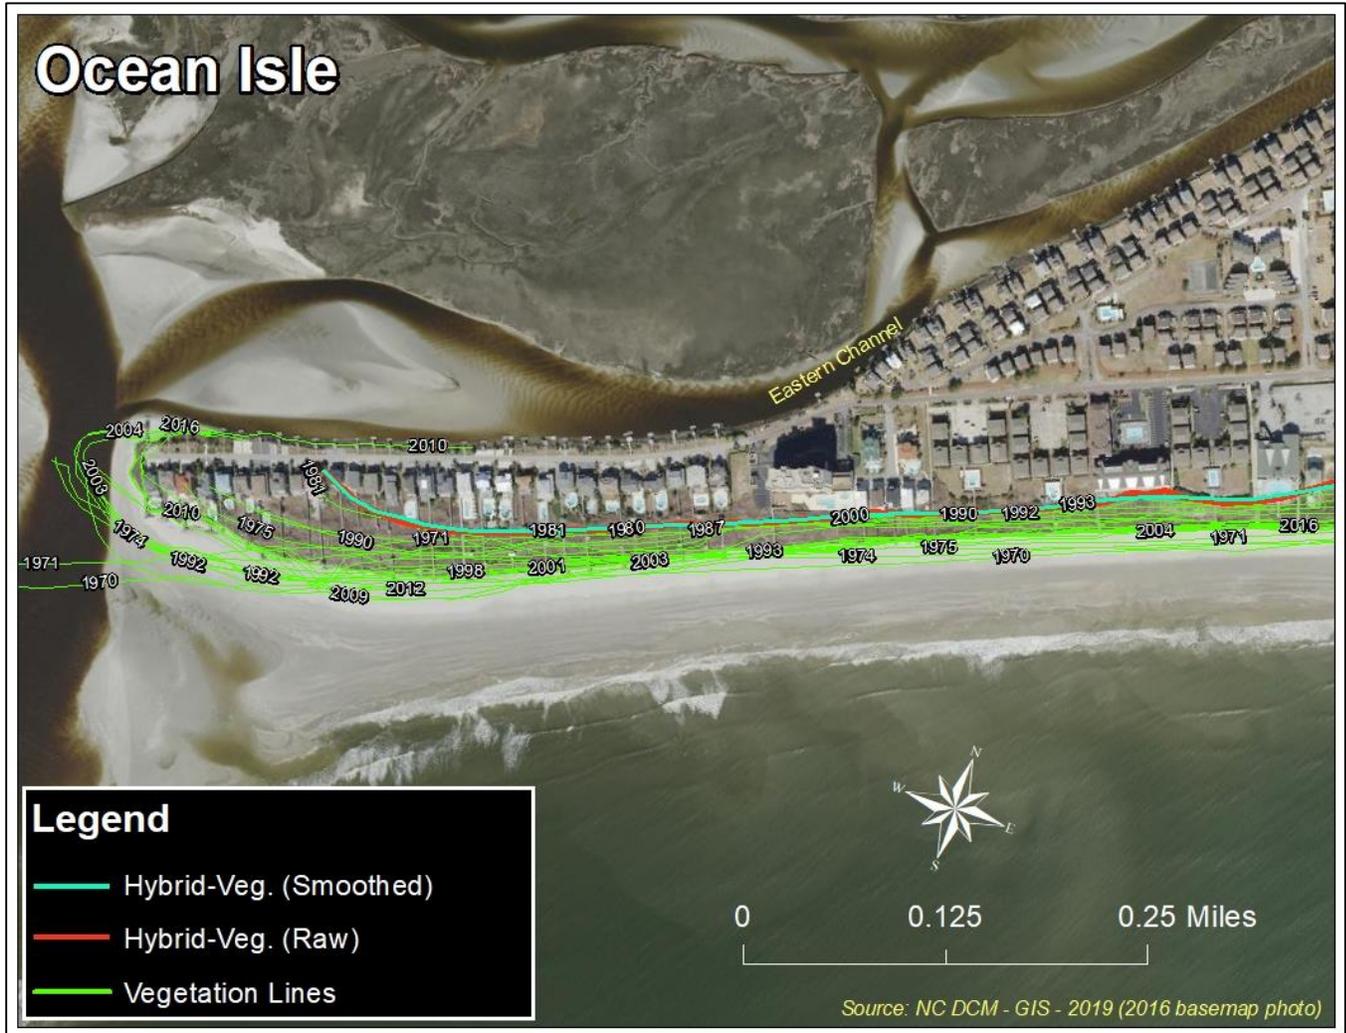
Figure 11. Tubbs Inlet at Ocean Isle. Vegetation Lines mapped: 1974, 1975, 1980, 1981, 1987, 1990, 1992, 1993, 1998, 2000, 2001, 2003, 2004, 2009, 2010, 2012, 2016. Vegetation line segments making up the hybrid-vegetation Line: 1980, 1981, 1990, 1993, 2000.

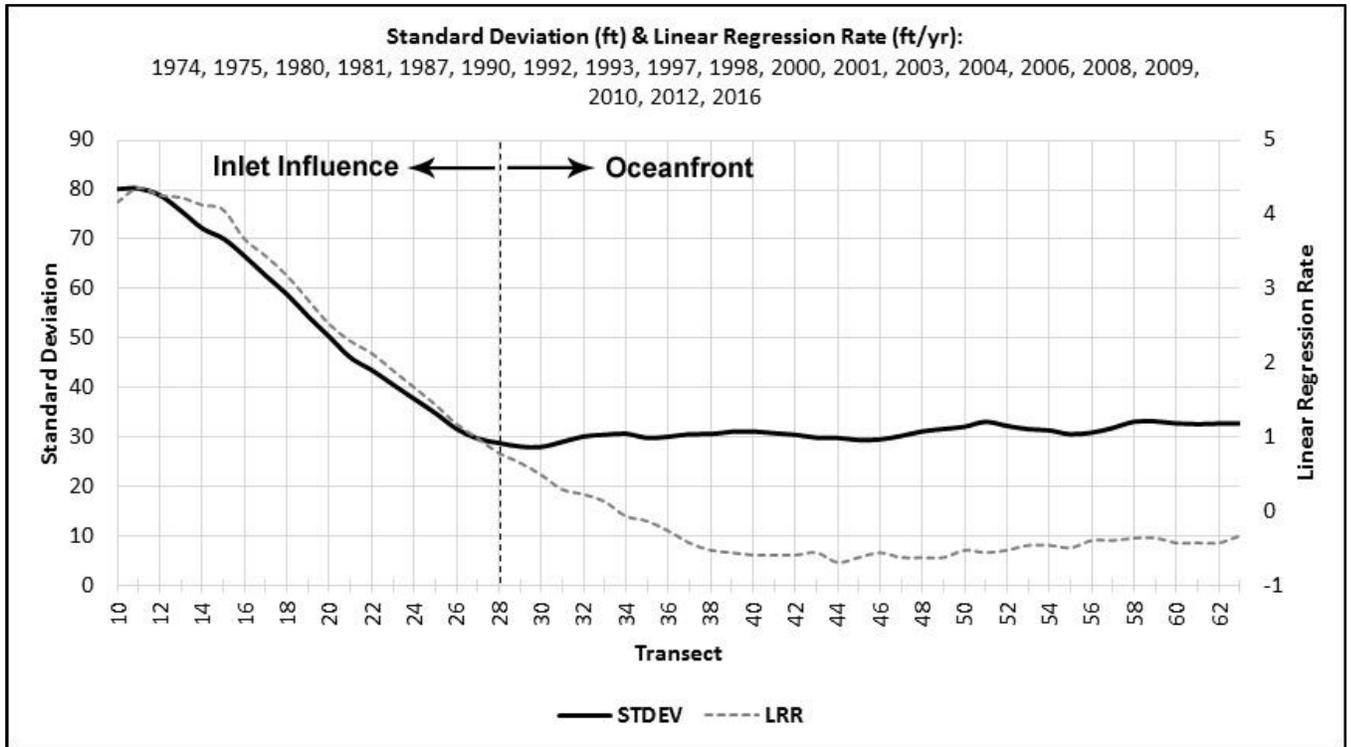
Figure 13. Based on standard deviation of shoreline position at Tubbs Inlet-Ocean Isle Beach, transect-28 is recommended as the inlet-ocean transition boundary along the shoreline. Negative Linear Regression rates indicate erosion, while positive values represent accretion (right axis).

Using the IHAM, transect-28 is the boundary of inlet influence (Figure 13); the recommended landward boundary is the 90-Year Risk Line (Figure 14).

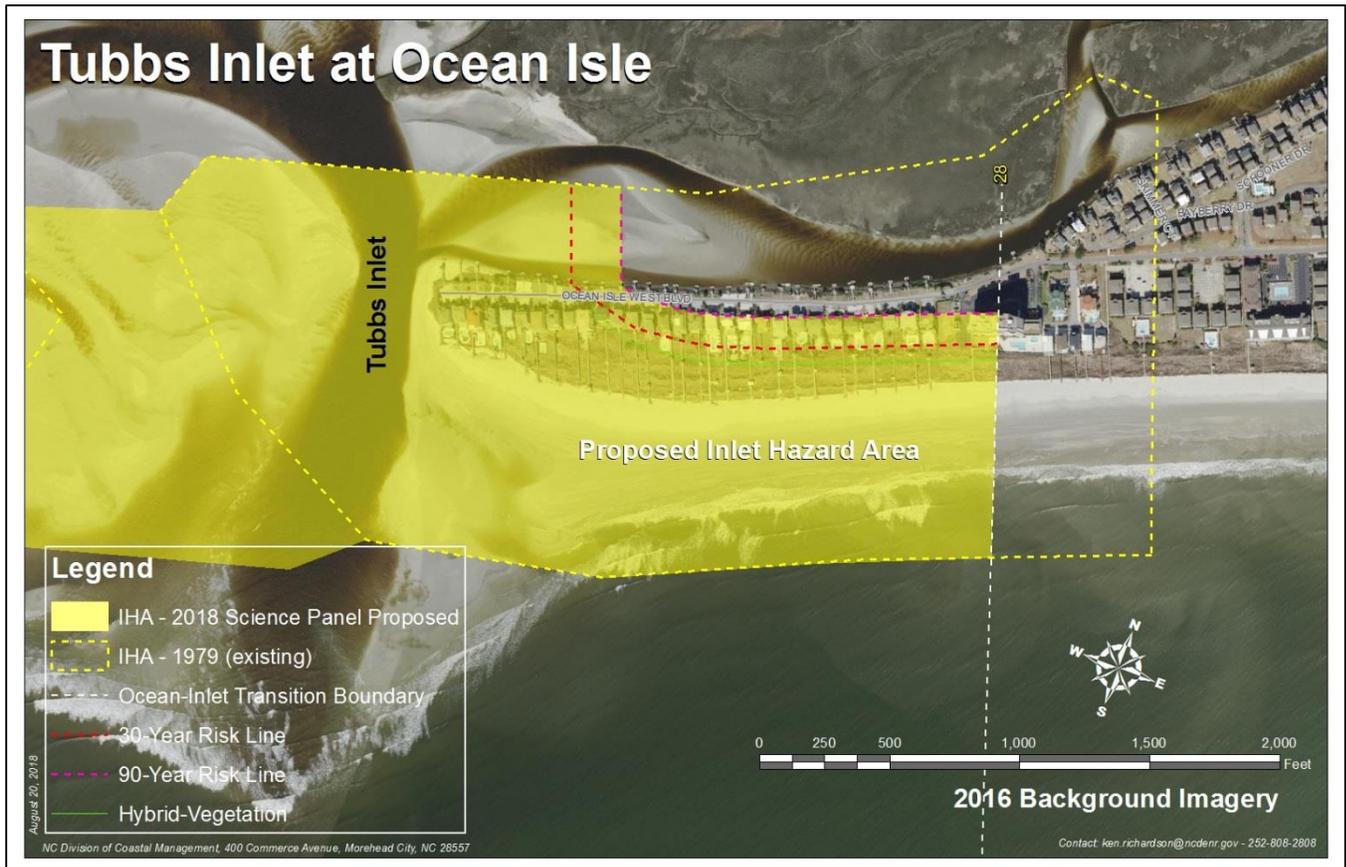
Figure 14. Map of Tubbs Inlet at Ocean Isle Beach Hybrid-Vegetation Line and the recommended IHA boundary with the 30- and 90-Year Risk Lines.

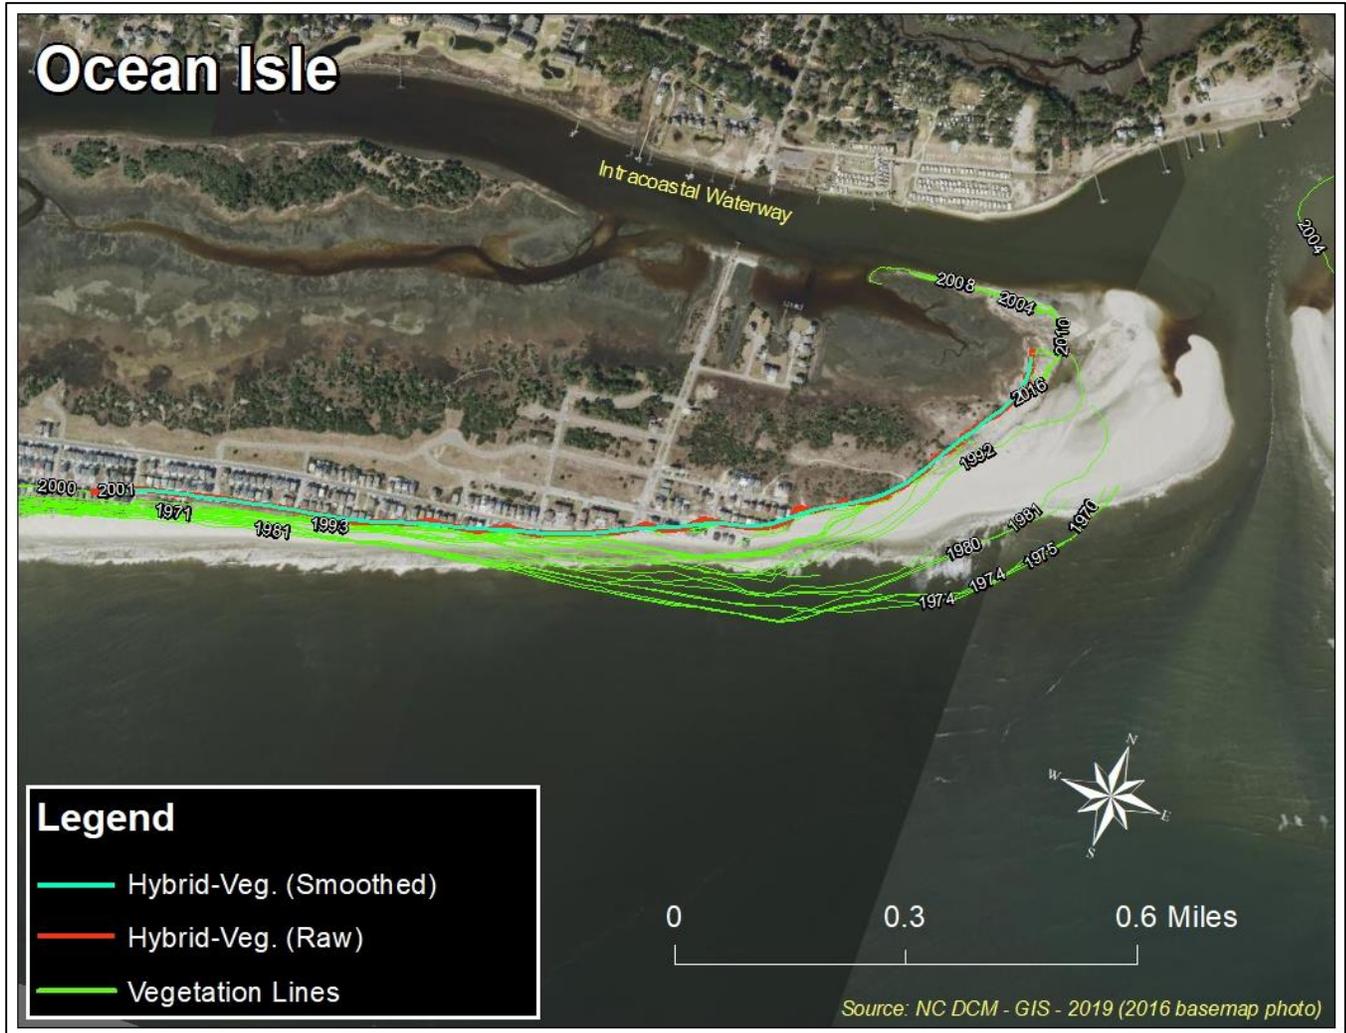
Figure 15. Shallotte Inlet at Ocean Isle. Vegetation Lines mapped: 1970, 1974, 1975, 1980, 1981, 1987, 1990, 1992, 1993, 1998, 2000, 2001, 2003, 2004, 2008, 2009, 2010, 2012, 2016. Vegetation line segments making up the Hybrid-Vegetation Line: 1998, 2000, 2001, 2003, 2004, 2008, 2009, 2010, 2012, 2016.

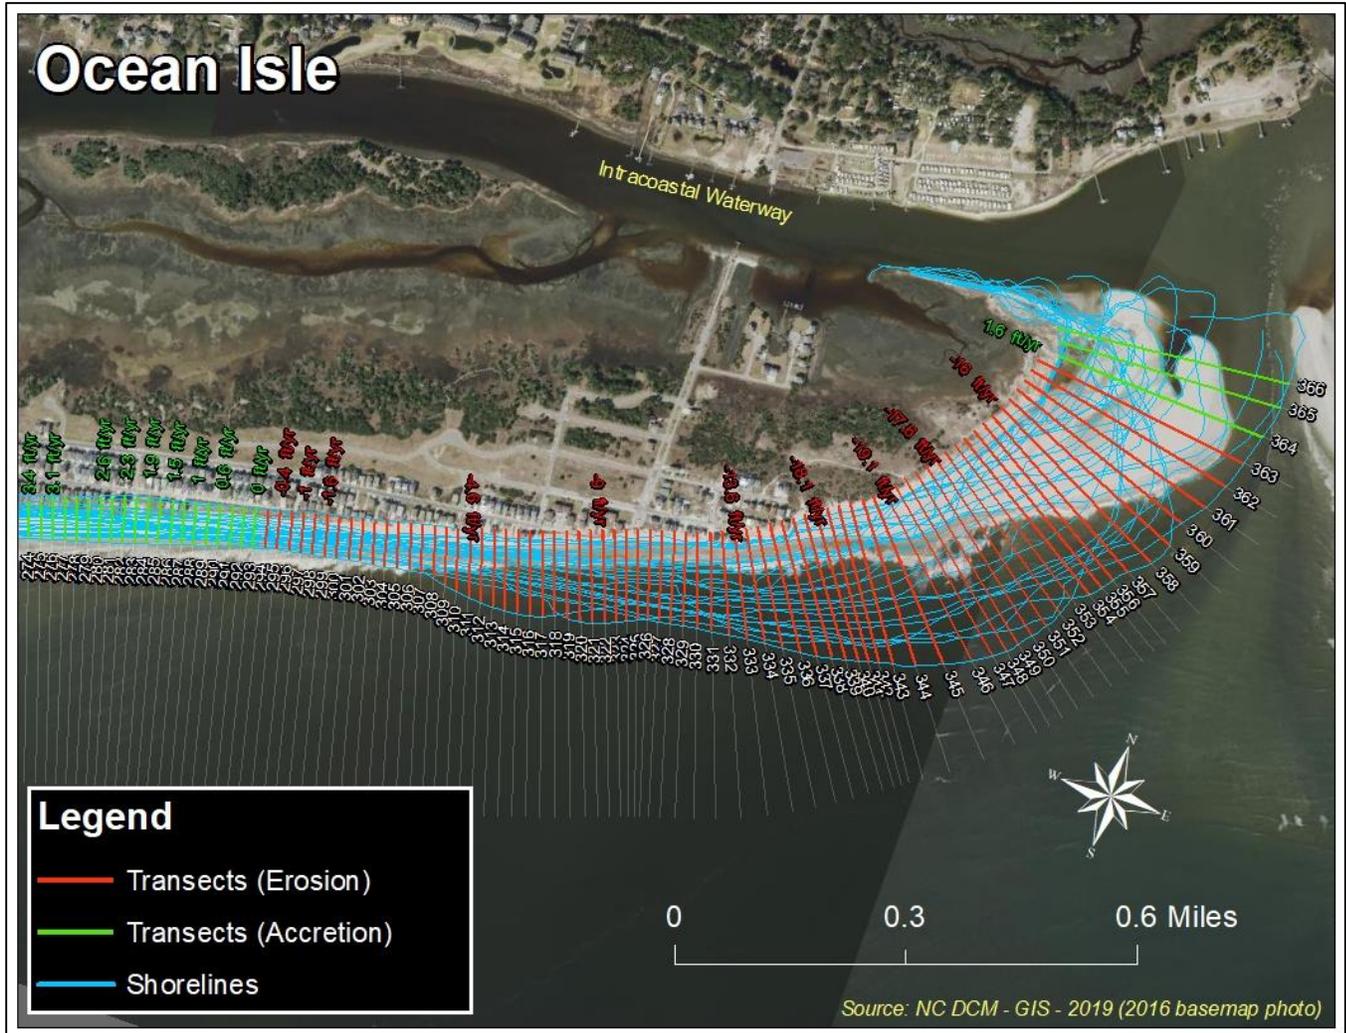
Figure 16. Shallotte Inlet at Ocean Isle. Shorelines included in the analysis: 1933, 1938, 1944, 1970, 1974, 1975, 1980, 1981, 1987, 1990, 1992, 1993, 1997, 1998, 2000, 2001, 2003, 2004, 2006, 2008, 2009, 2010, 2012, 2016.

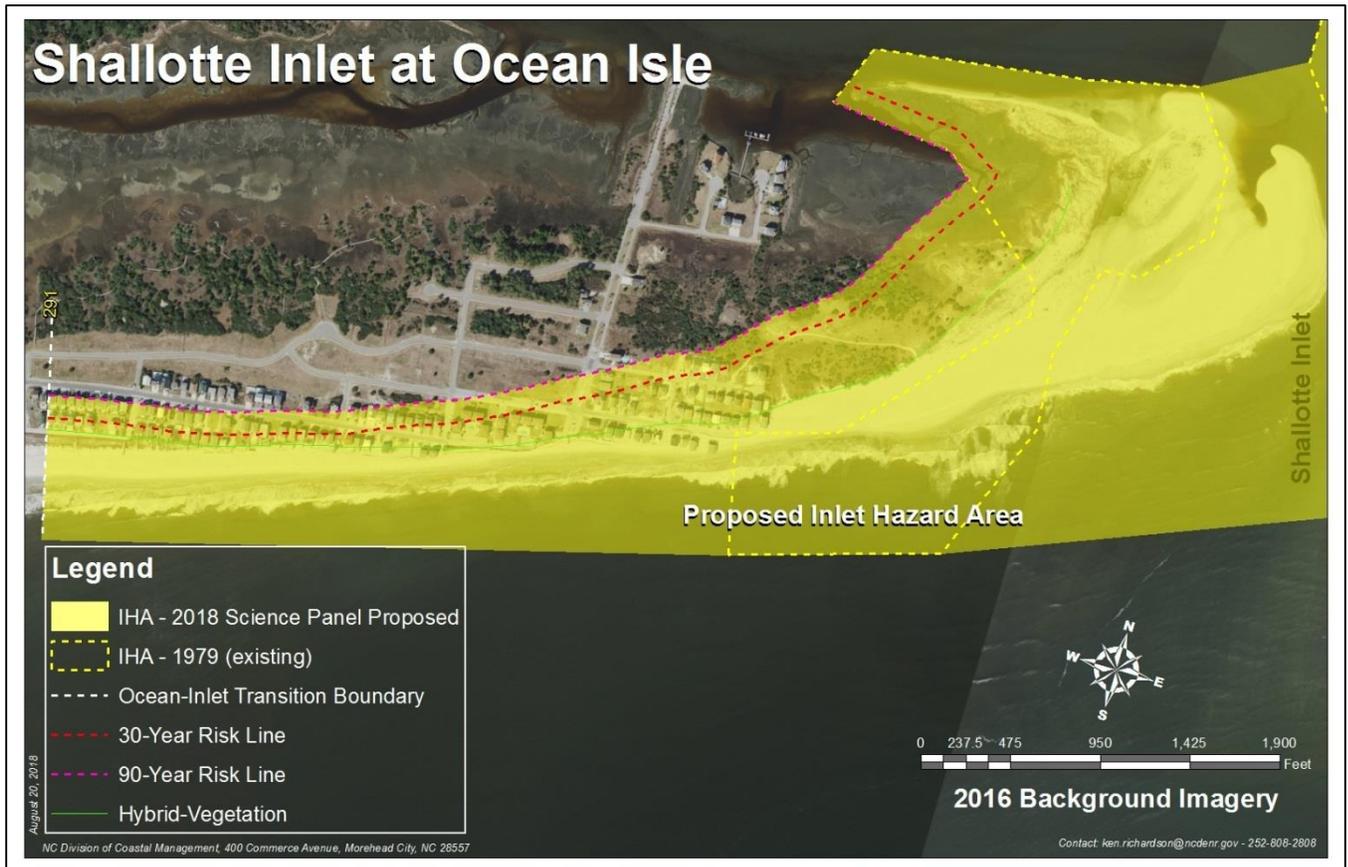
Figure 18. Shallotte Inlet at Ocean Isle Beach Hybrid-Vegetation Line and the recommended IHA boundary with the 30-Year Risk Line and modified 90-Year Risk Lines.

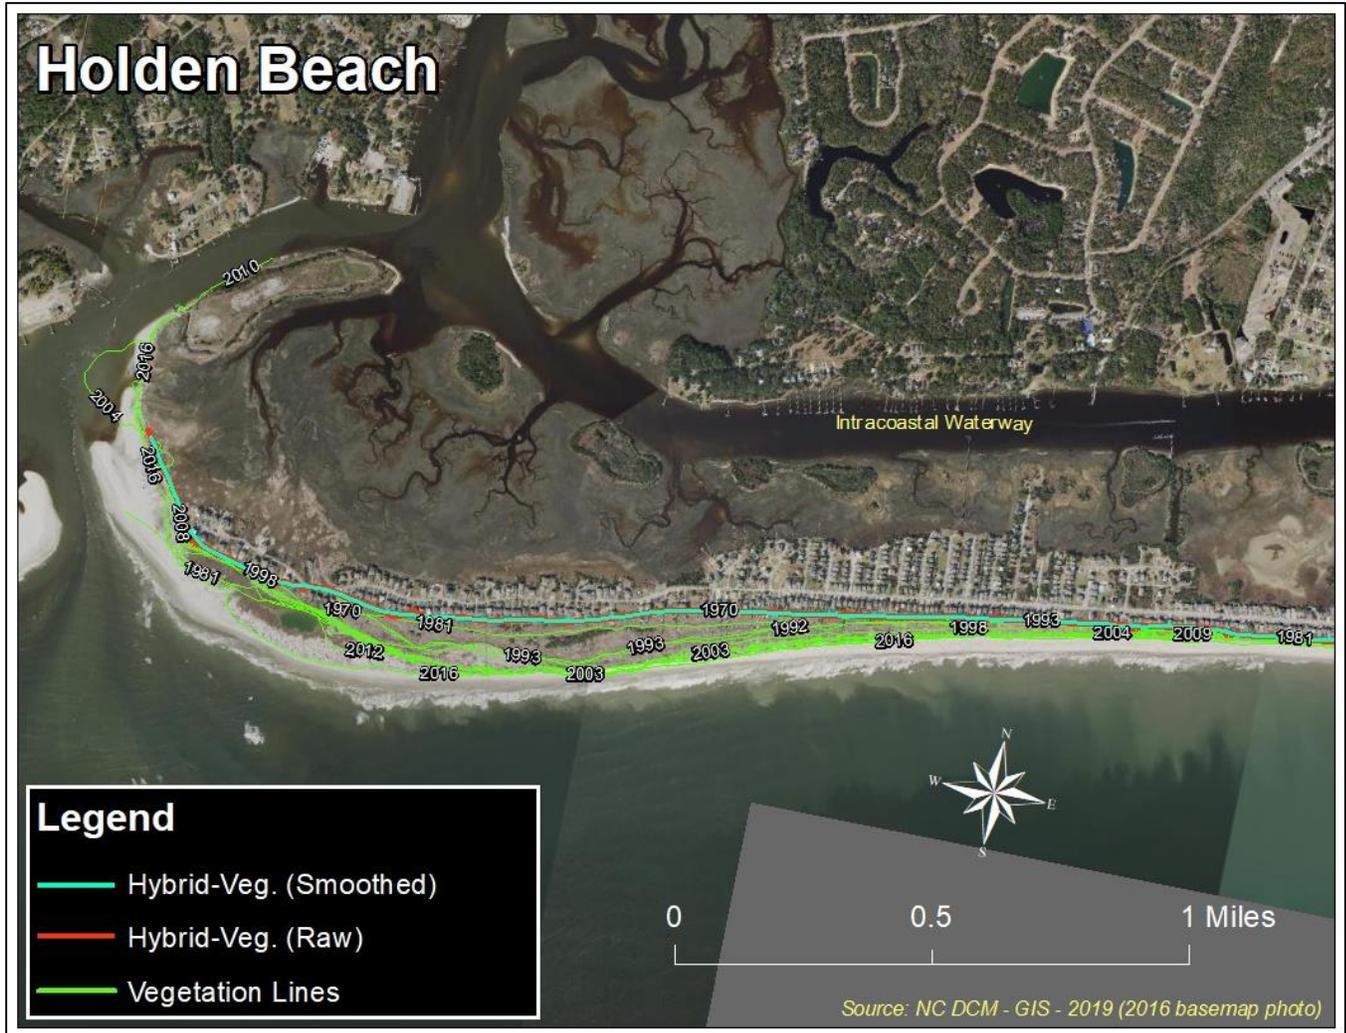
Figure 19. Shallotte Inlet at Holden Beach. Vegetation Lines mapped: 1970, 1981, 1992, 1993, 1998, 2003, 2004, 2008, 2009, 2010, 2012, 2016. Vegetation line segments making up the Hybrid-Vegetation Line: 1970, 1981, 1992, 1993, 1998, 2003, 2004, 2008, 2009, 2010.

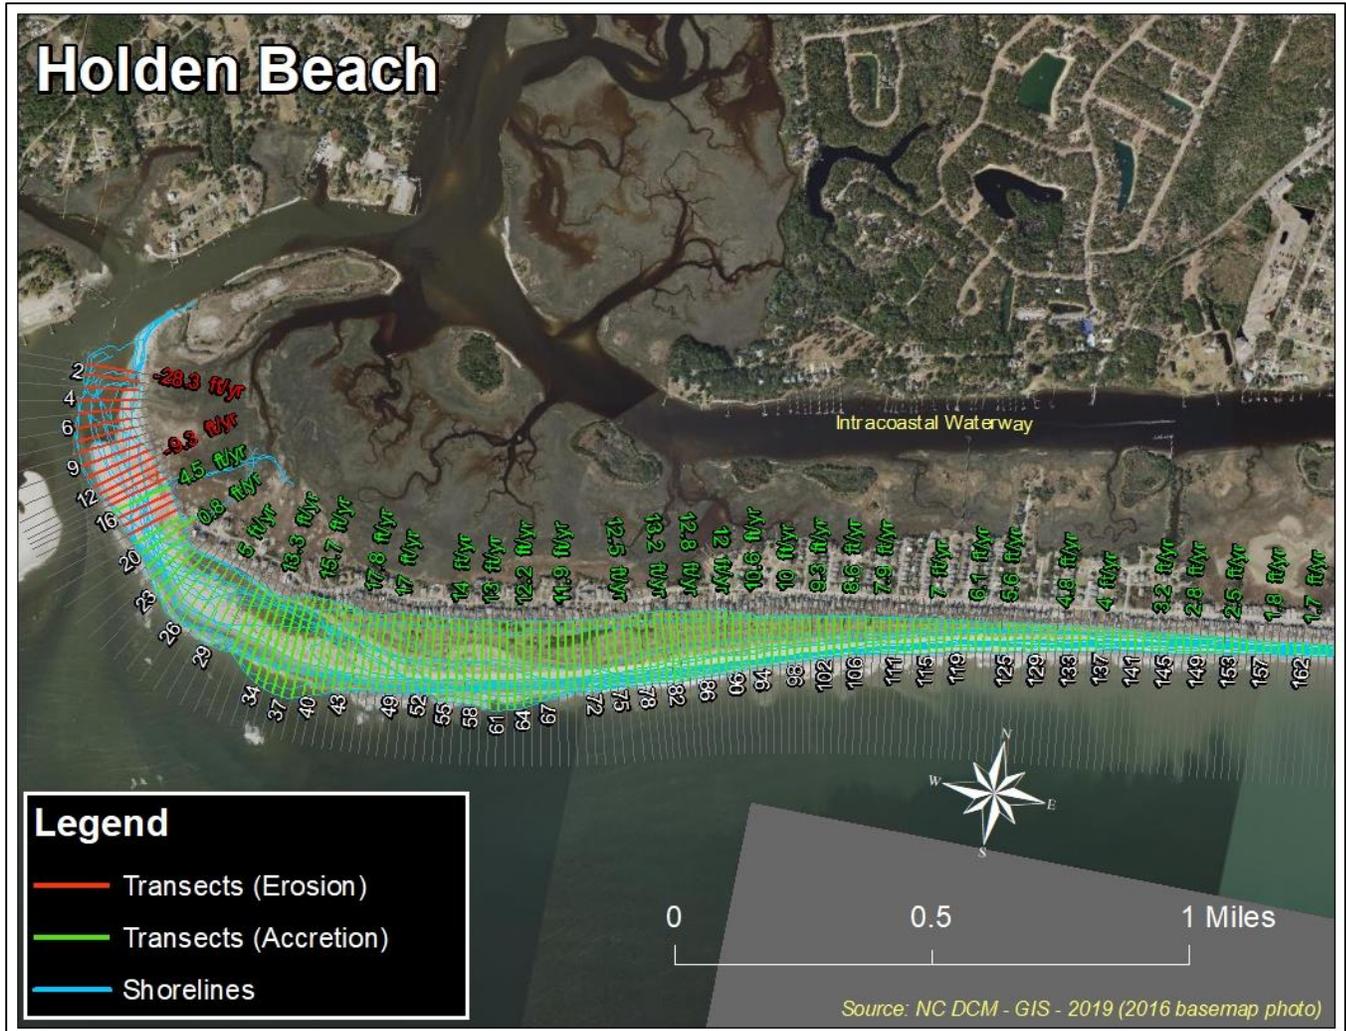
Figure 20. Shallotte Inlet at Holden Beach. Shorelines included in the analysis: 1970, 1981, 1992, 1993, 1997, 1998, 2003, 2004, 2006, 2008, 2009, 2010, 2012, 2016.

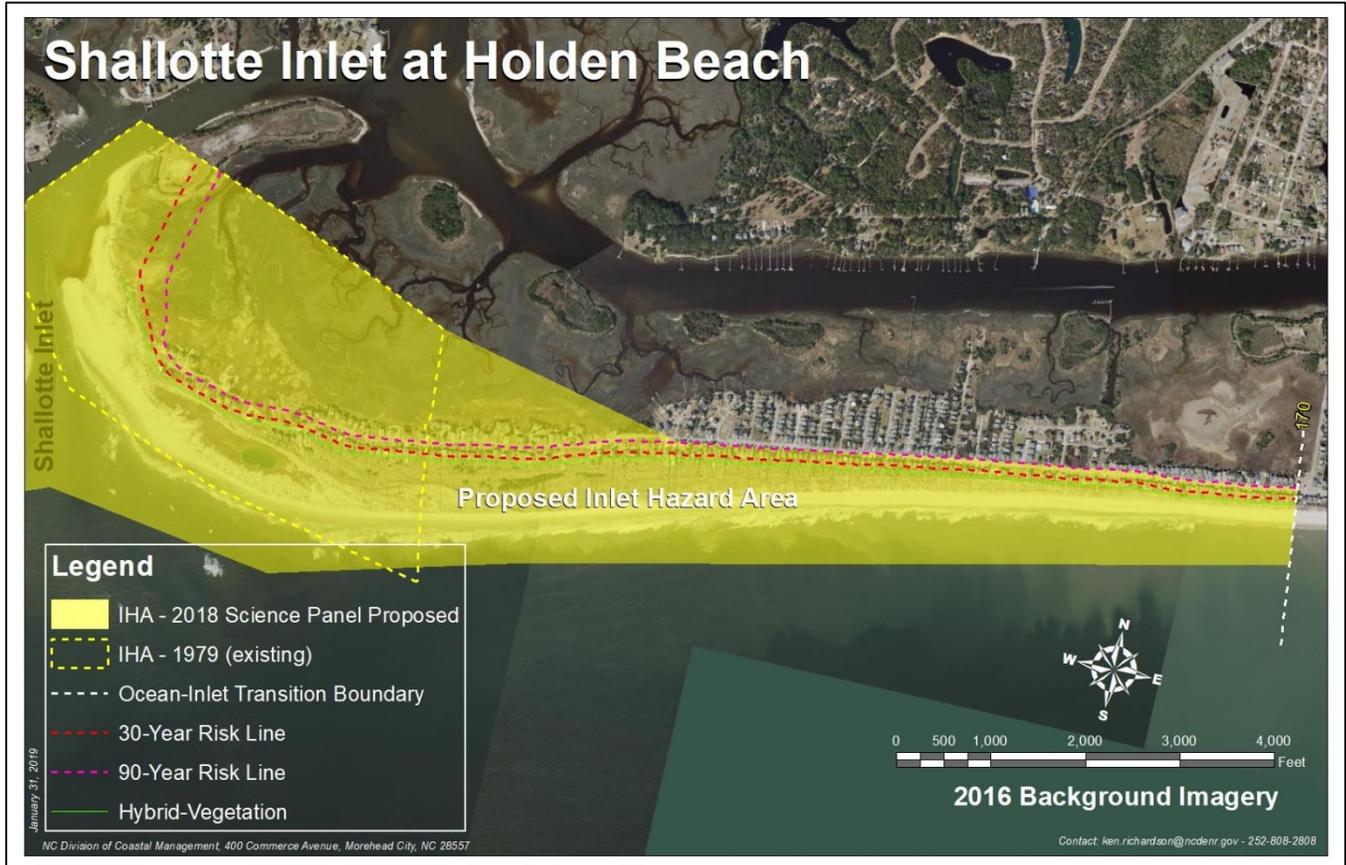
Figure 22. Shallotte Inlet at Holden Beach Hybrid-Vegetation Line and the recommended IHA boundary with the 30- and 90-Year Risk Lines. Black dashed line indicates Transect-90 where the IHA boundary was adjusted to match the existing IHA line (yellow dashed line).

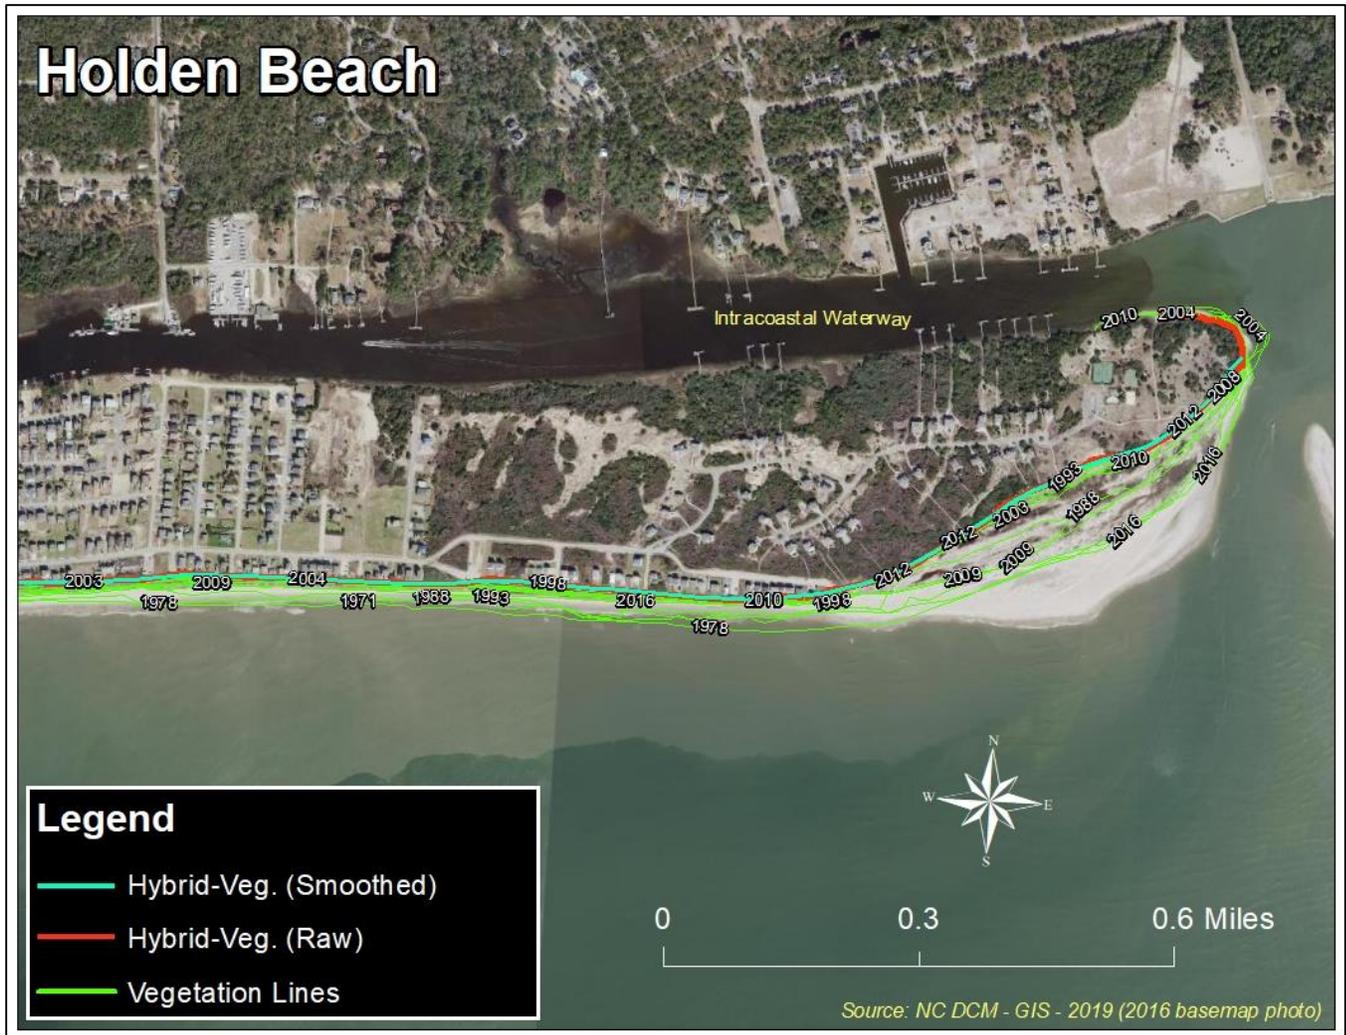
Figure 23. Lockwood Folly Inlet at Holden Beach. Vegetation Lines mapped: 1971, 1978, 1988, 1993, 1998, 2003, 2004, 2008, 2009, 2010, 2012, 2016. Vegetation line segments making up the Hybrid-Vegetation Line: 1971, 1988, 1993, 1998, 2003, 2004.

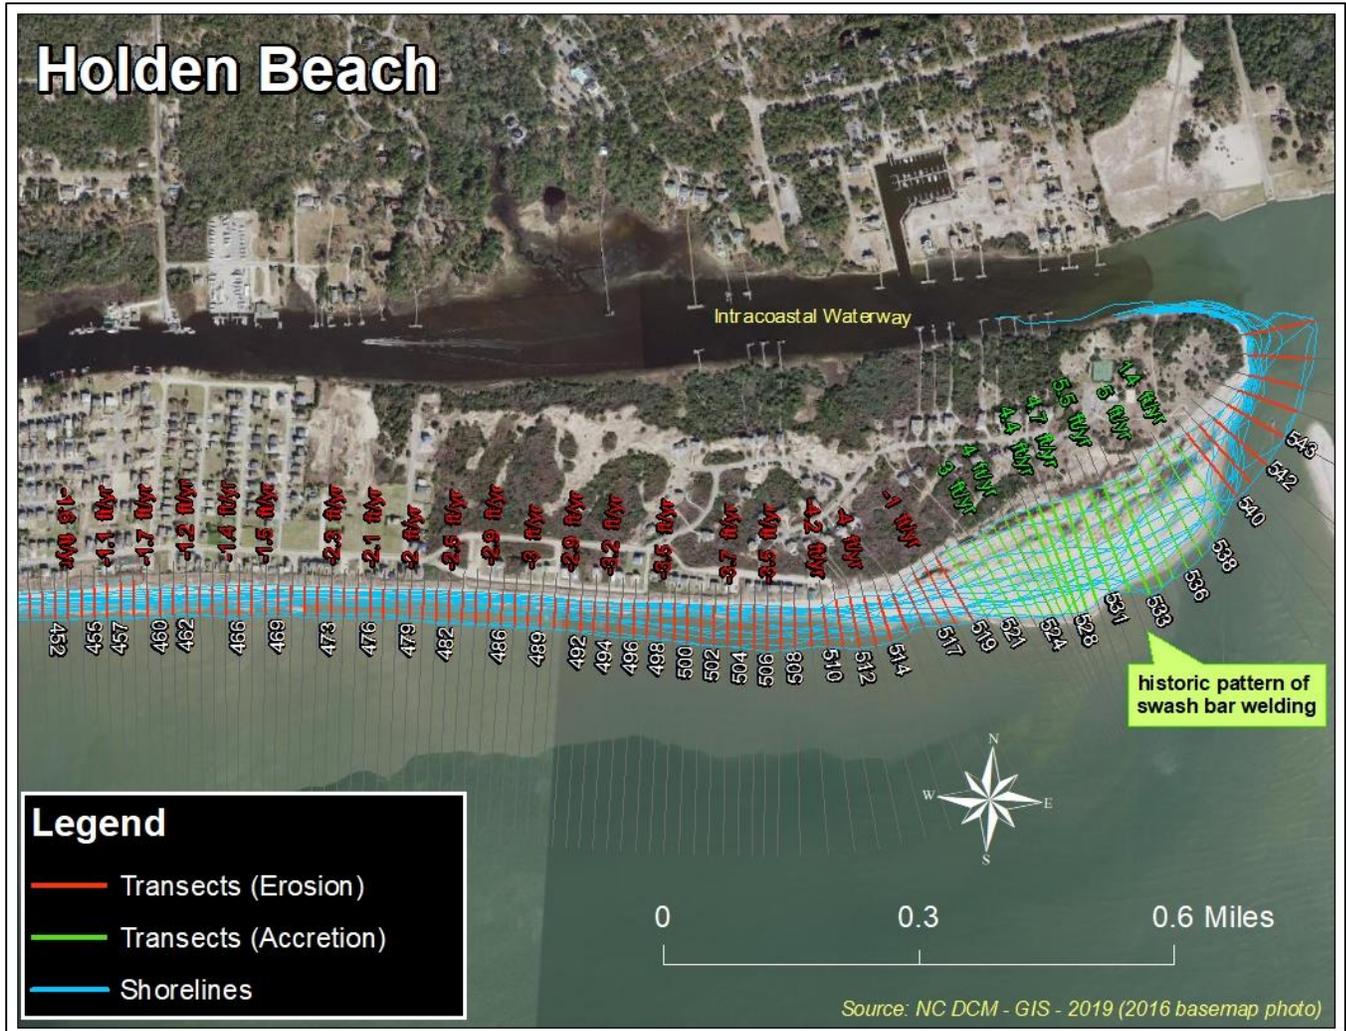
Figure 24. Lockwood Folly Inlet at Holden Beach. Shorelines included: 1970, 1971, 1978, 1988, 1993, 1997, 1998, 2003, 2004, 2006, 2008, 2009, 2010, 2012, 2016.

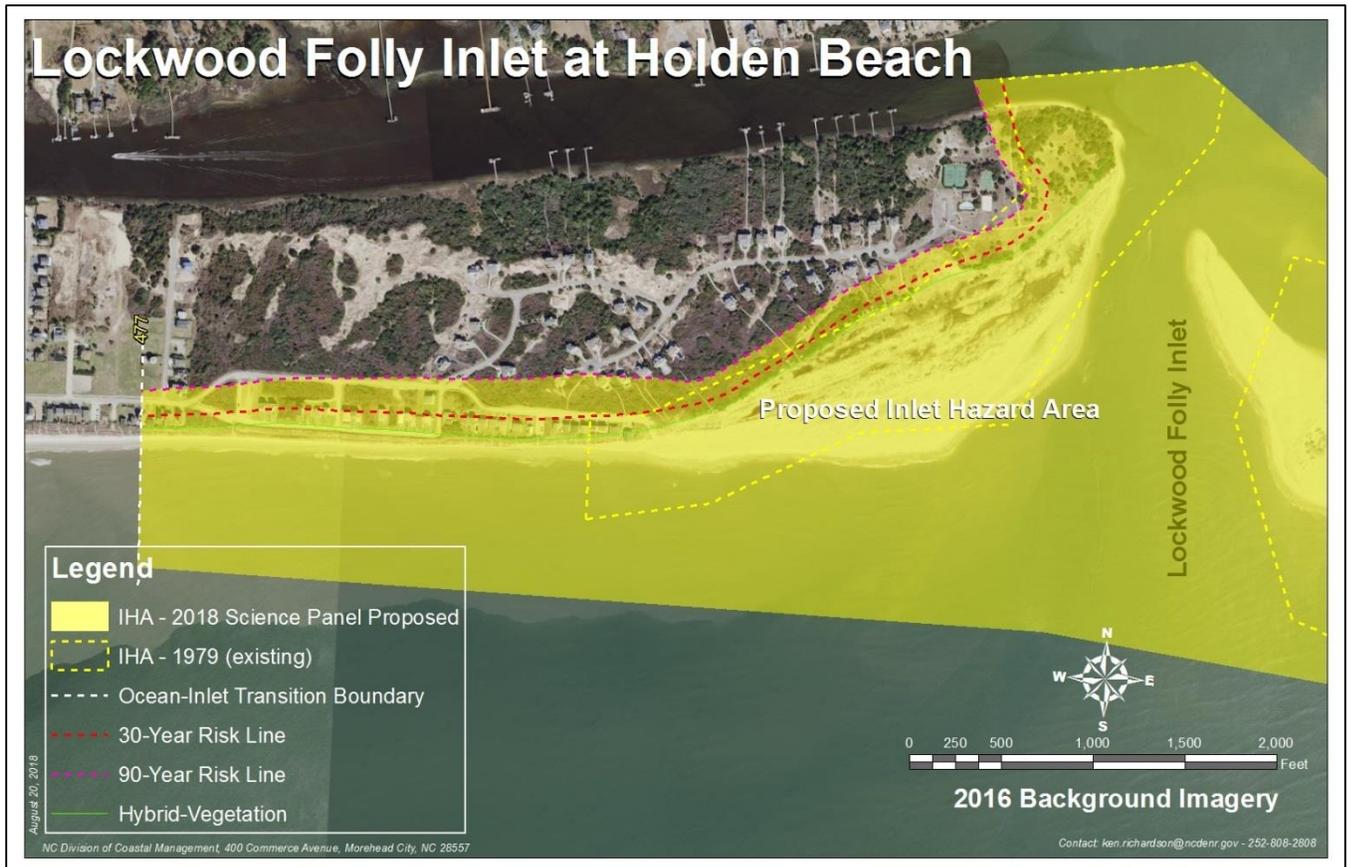
Figure 26. Lockwood Folly Inlet at Holden Beach Hybrid Vegetation Line and the recommended IHA boundary with the 30- and 90-Year Risk Lines.
