Inlet Hazard Area Boundary, 2019 Update:

Science Panel Recommendations to the
North Carolina Coastal Resources Commission

February 12, 2019

NC Coastal Resources Commission's Science Panel on Coastal Hazards
& NC Division of Coastal Management

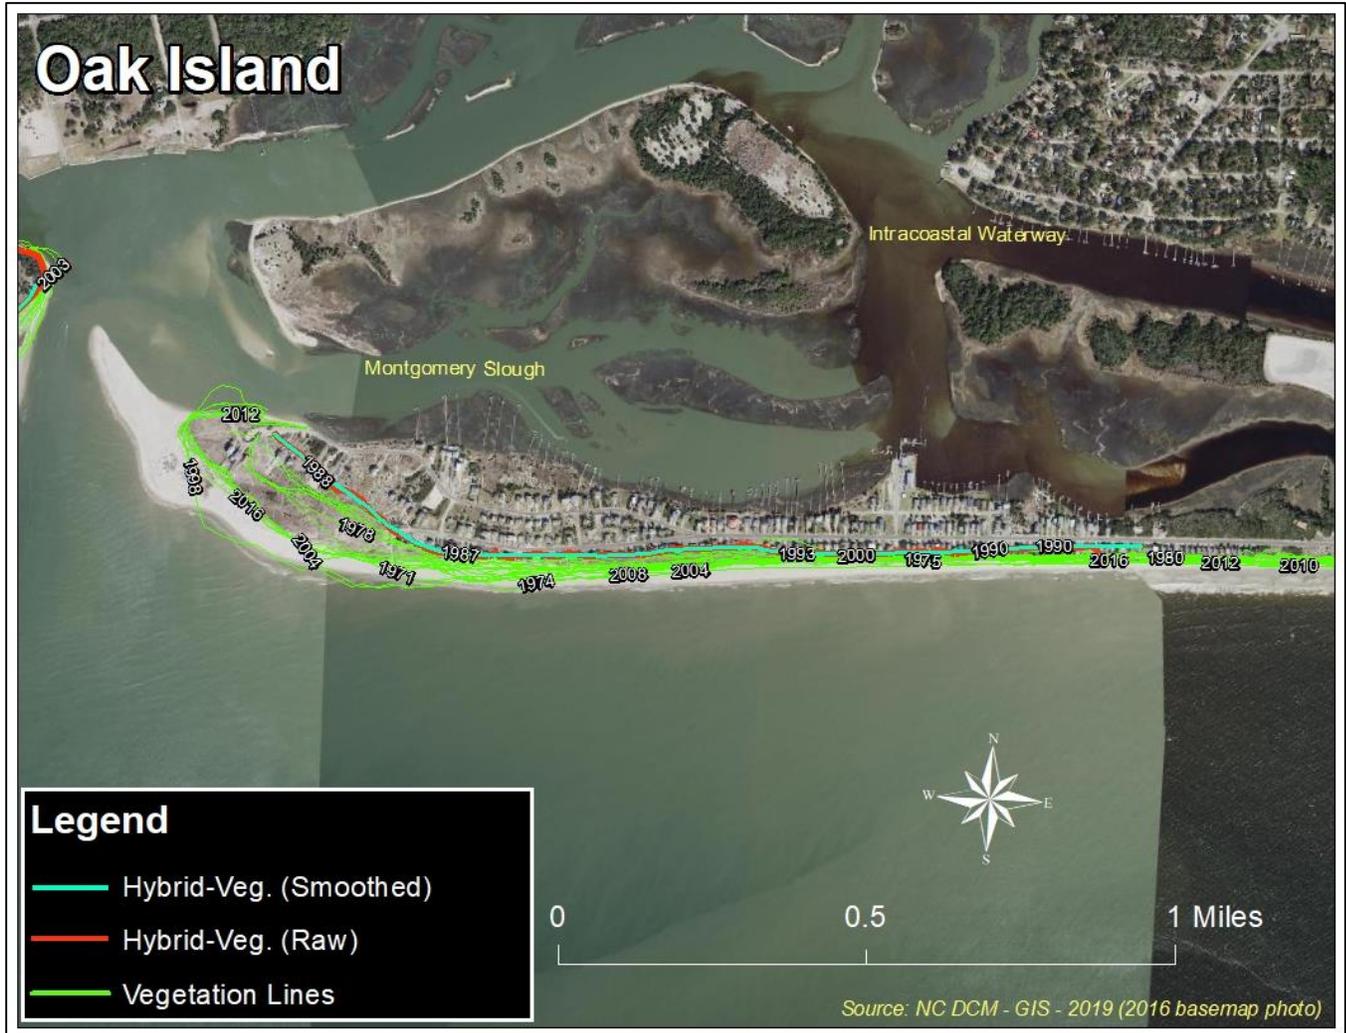
Figure 27. Lockwood Folly Inlet at Oak Island. Vegetation Lines mapped: 1971, 1974, 1975, 1978, 1979, 1980, 1987, 1988, 1990, 1993, 1998, 2000, 2003, 2004, 2008, 2009, 2010, 2012, 2016. Vegetation line segments making up the Hybrid-Vegetation Line: 1971, 1987, 1988, 1990, 1993, 2016.

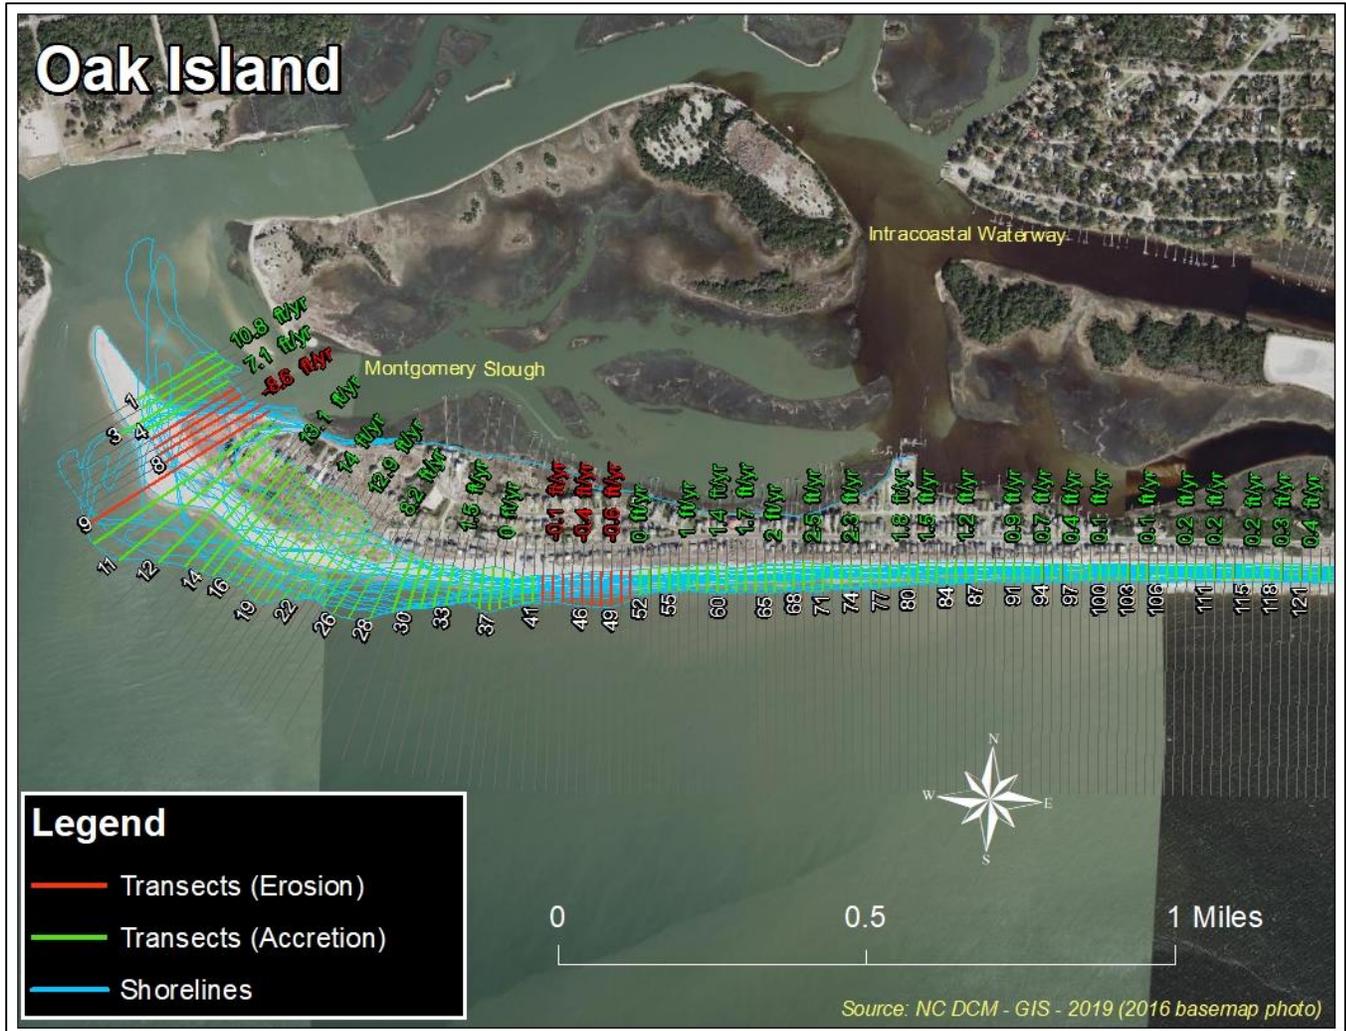
Figure 28. Lockwood Folly Inlet at Oak Island. Shorelines included: 1970, 1971, 1974, 1975, 1978, 1979, 1980, 1981, 1987, 1988, 1990, 1993, 1997, 1998, 2000, 2003, 2004, 2006, 2008, 2009, 2010, 2012, 2016.

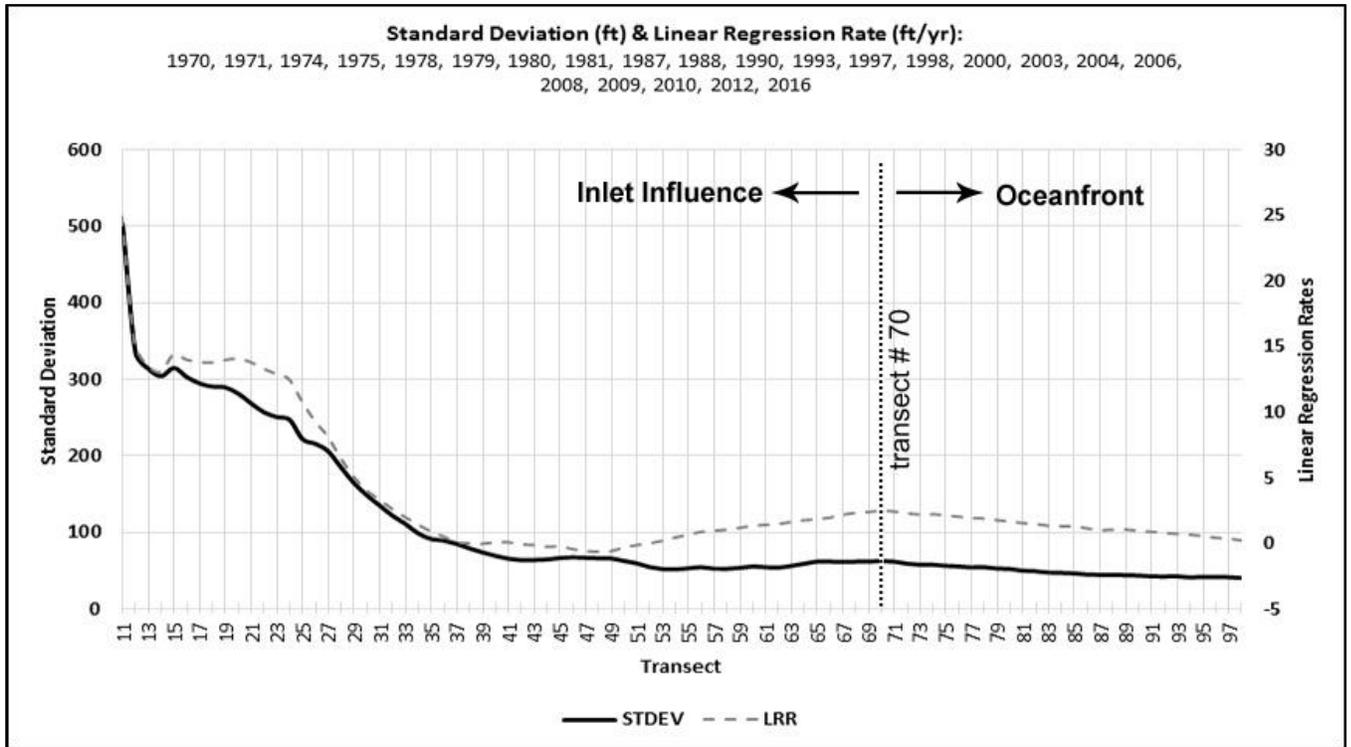
Figure 29. At Lockwood Folly Inlet-Oak Island, inlet transect-70 is recommended as the inlet-ocean transition boundary along the shoreline. Negative Linear Regression rates indicate erosion, while positive values represent accretion (right axis).

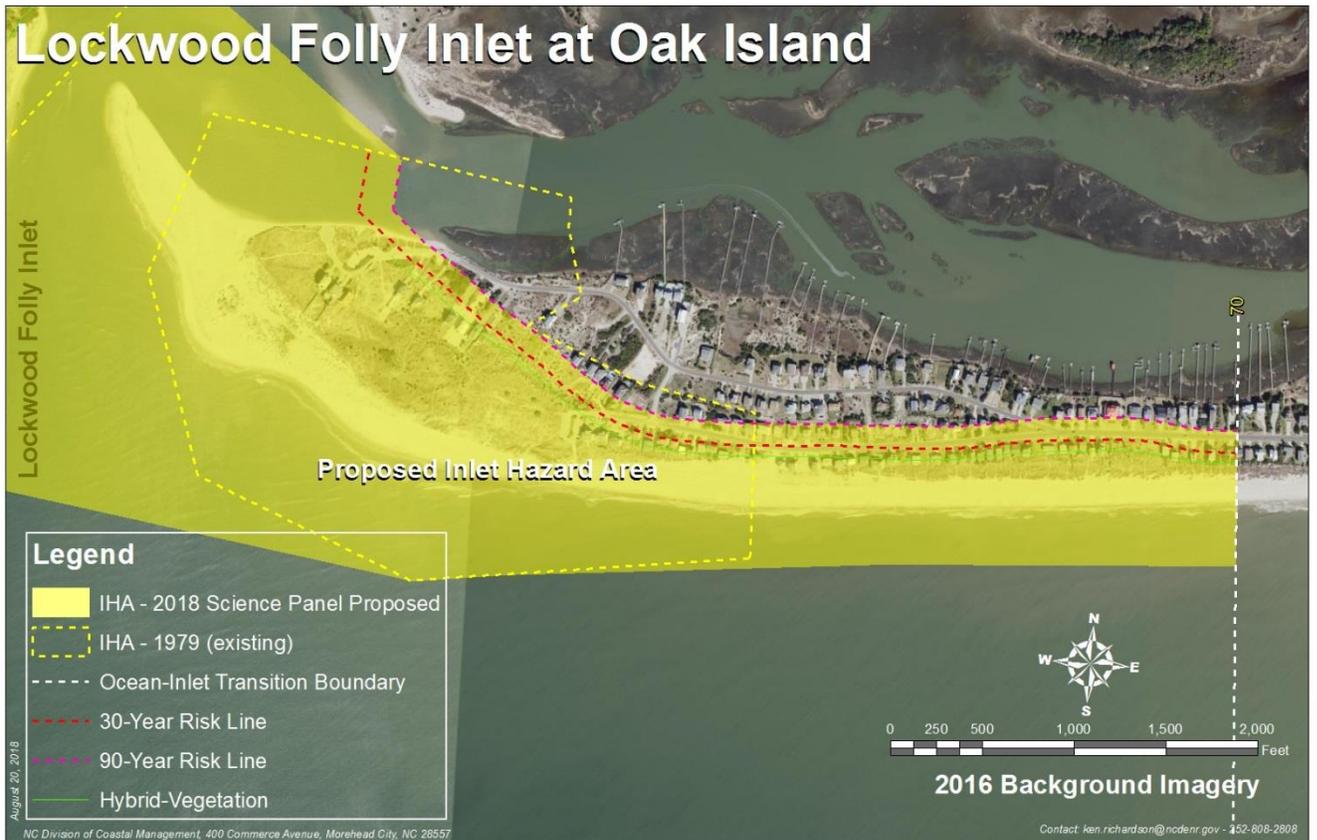
Figure 30. Lockwood Folly Inlet at Oak Island Hybrid Vegetation Line and the recommended IHA boundary with the 30- and 90-Year Risk Lines.

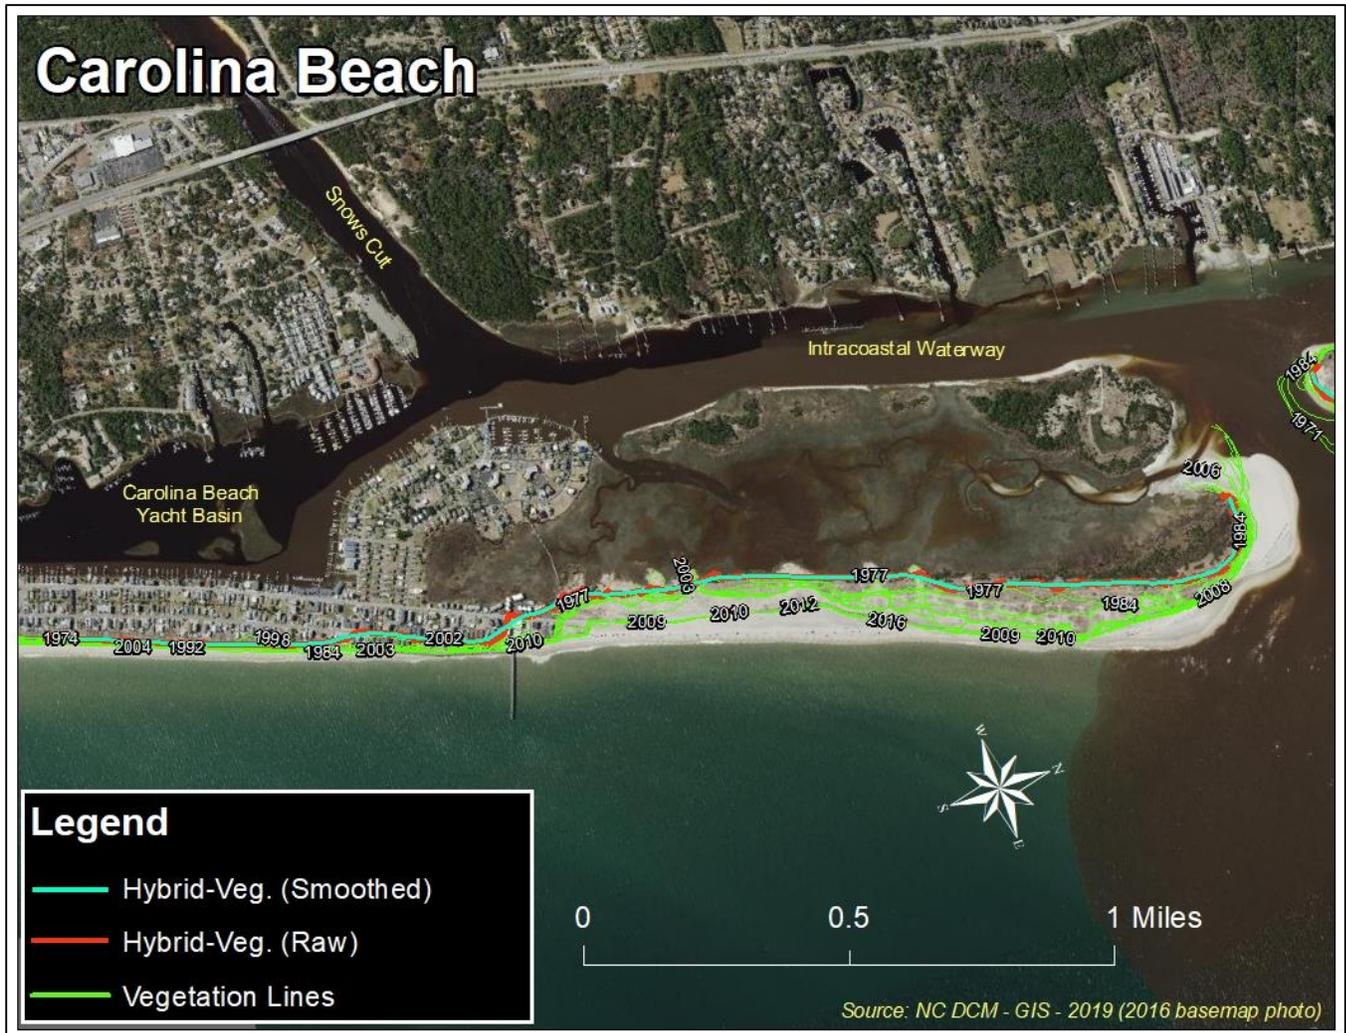
Figure 31. Carolina Beach Inlet at Carolina Beach. Vegetation Lines mapped: 1971, 1974, 1977, 1984, 1992, 1998, 2002, 2003, 2004, 2006, 2008, 2009, 2010, 2012, 2016. Vegetation line segments making up the Hybrid-Vegetation Line: 1971, 1974, 1977, 1984, 1992, 1998, 2002, 2006, 2008, 2009, 2012.

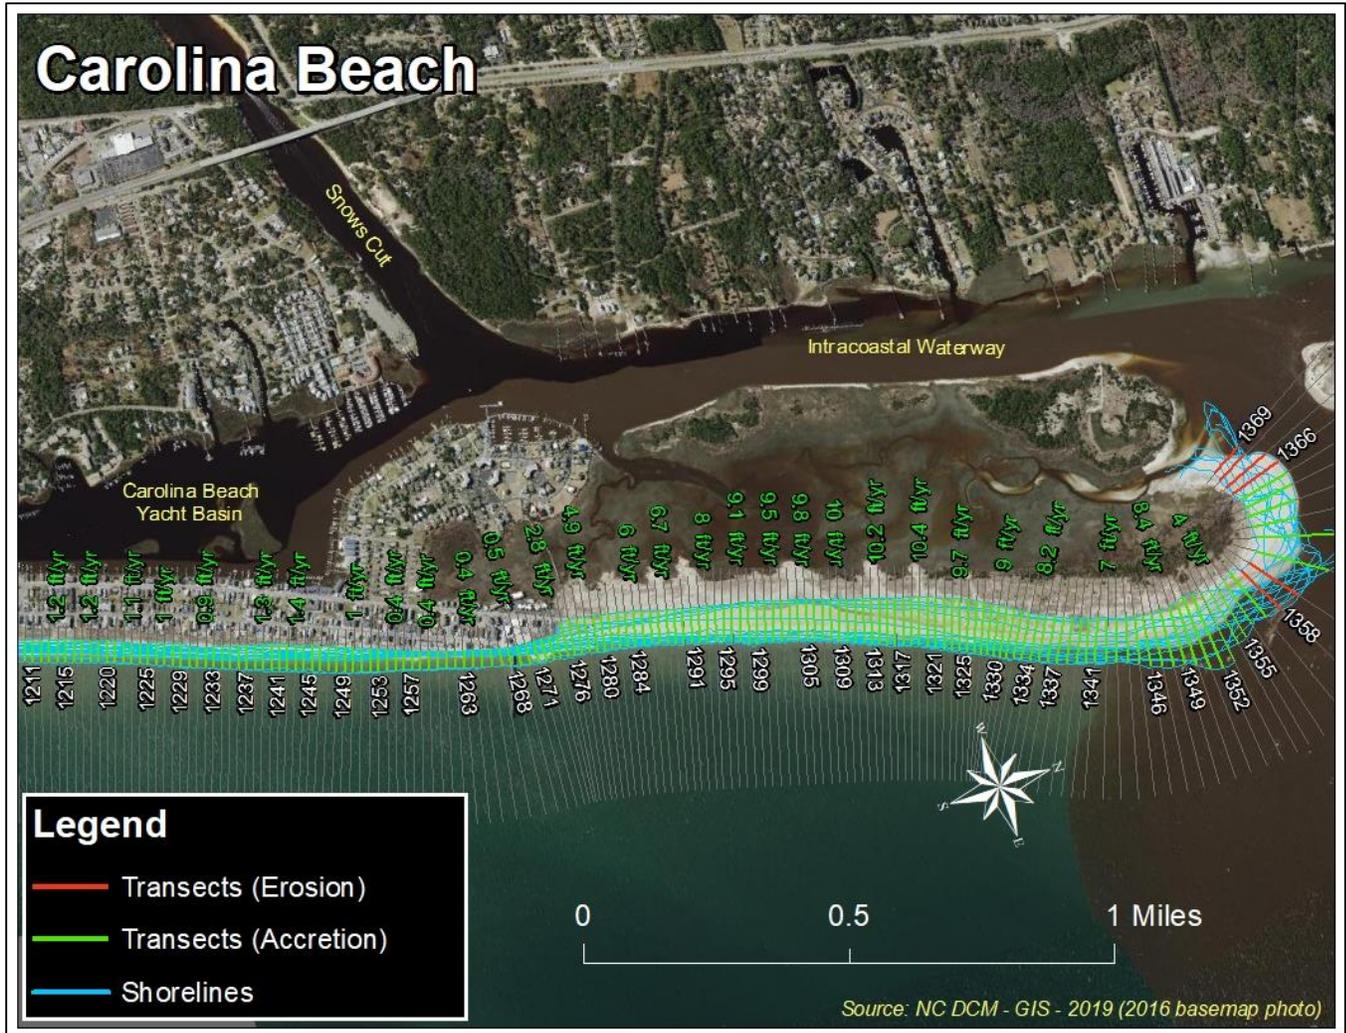
Figure 32. Carolina Beach Inlet at Carolina Beach. Shorelines included in the analysis: 1971, 1973, 1974, 1977, 1984, 1992, 1997, 1998, 2002, 2003, 2004, 2006, 2008, 2009, 2010, 2012, 2016.

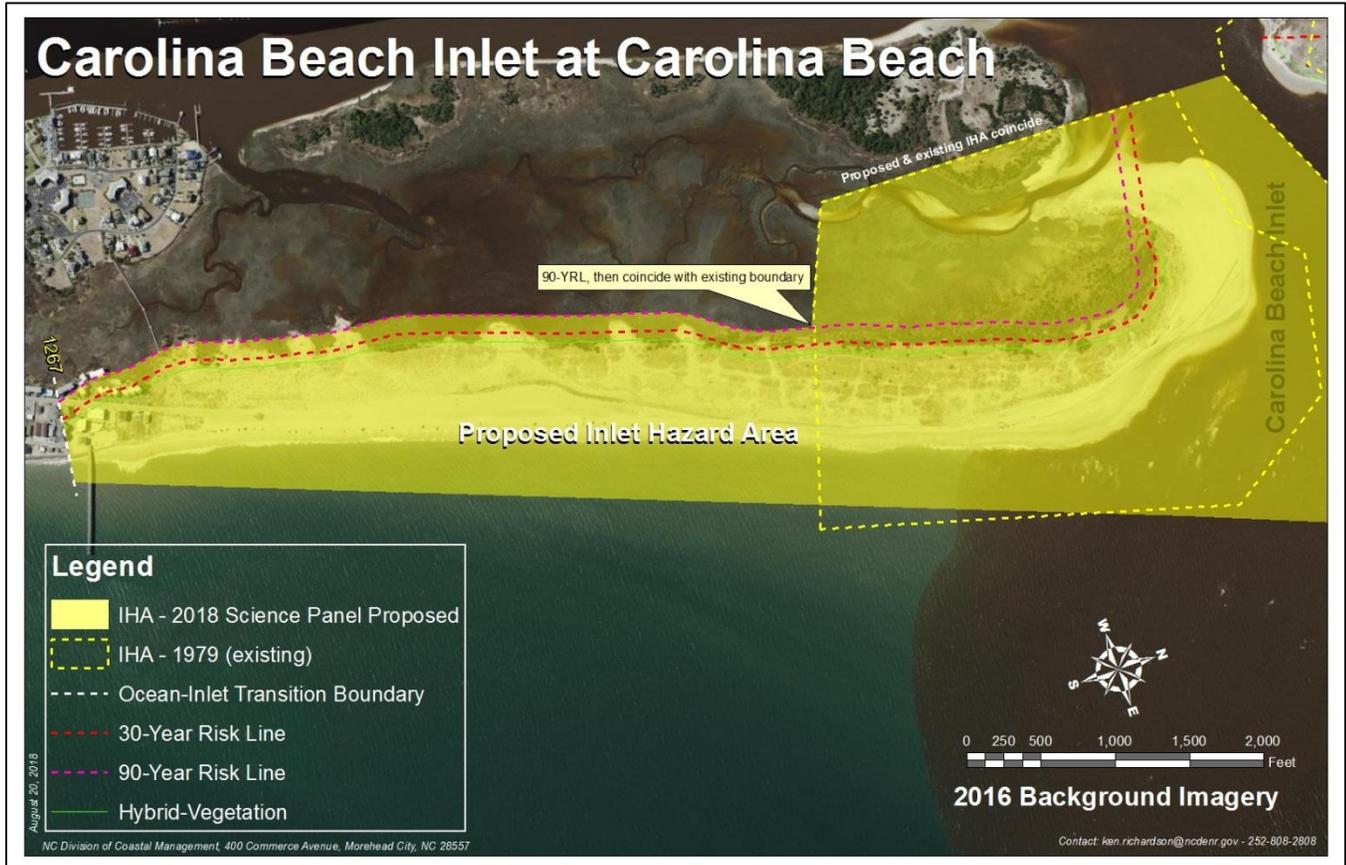
Figure 34. Carolina Beach Inlet at Carolina Beach Hybrid Vegetation Line and the recommended IHA boundary with the 30- and 90-Year Risk Lines.

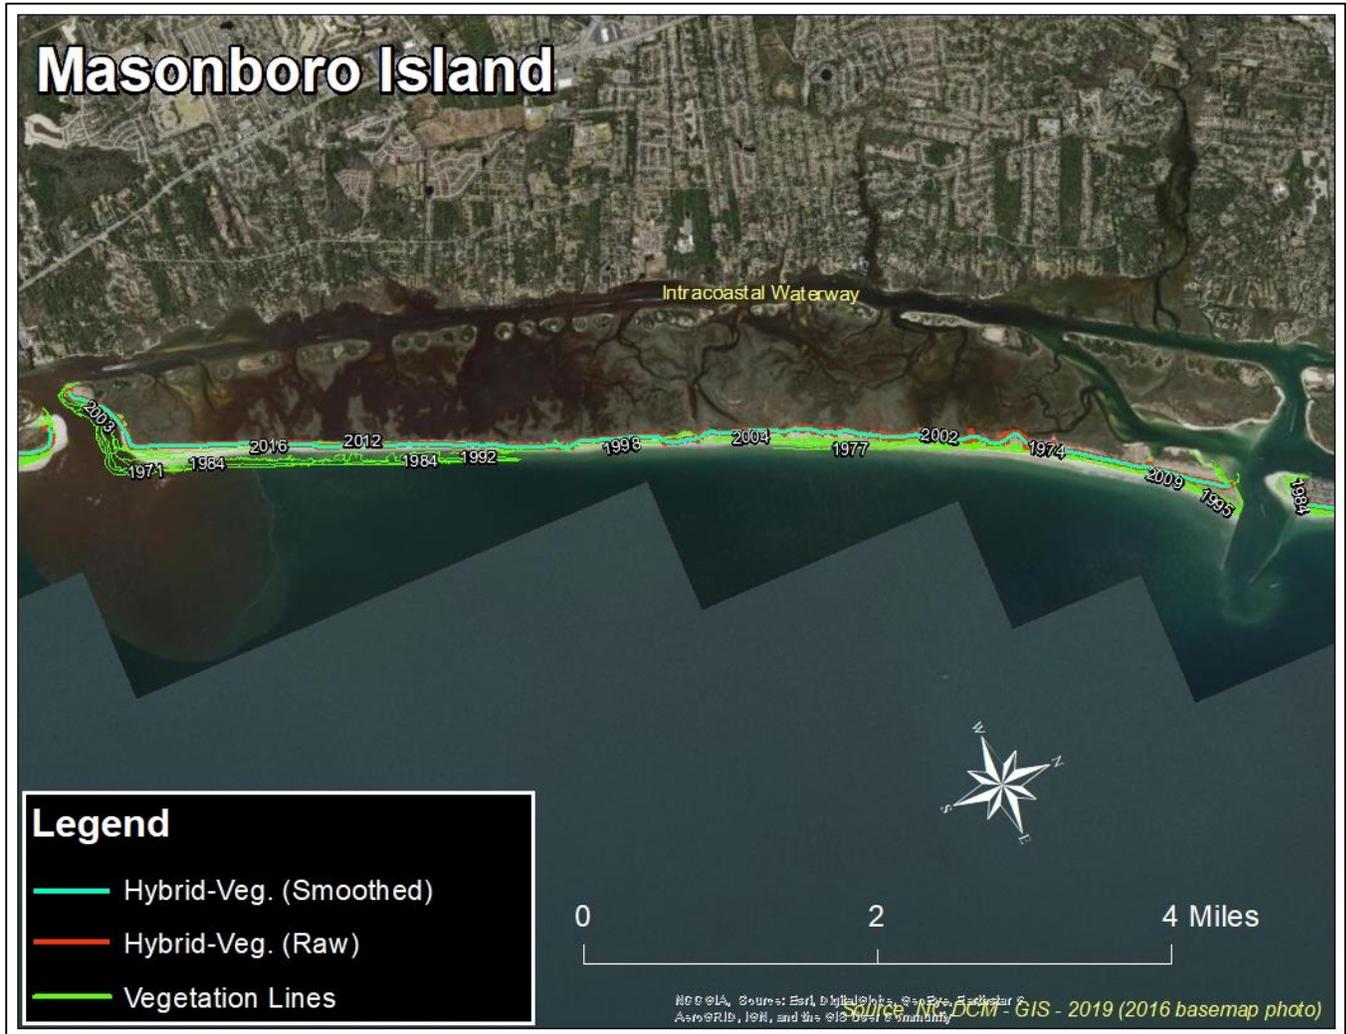
Figure 35. Carolina Beach and Masonboro Inlets at Masonboro Island. Vegetation Lines mapped: 1971, 1974, 1977, 1984, 1992, 1998, 2000, 2002, 2003, 2004, 2006, 2008, 2009, 2010, 2012, 2016. Vegetation line segments making up the Hybrid-Vegetation Line: 1974, 1977, 1984, 1998, 2000, 2002, 2003, 2004, 2006, 2008, 2010, 2012, 2016.

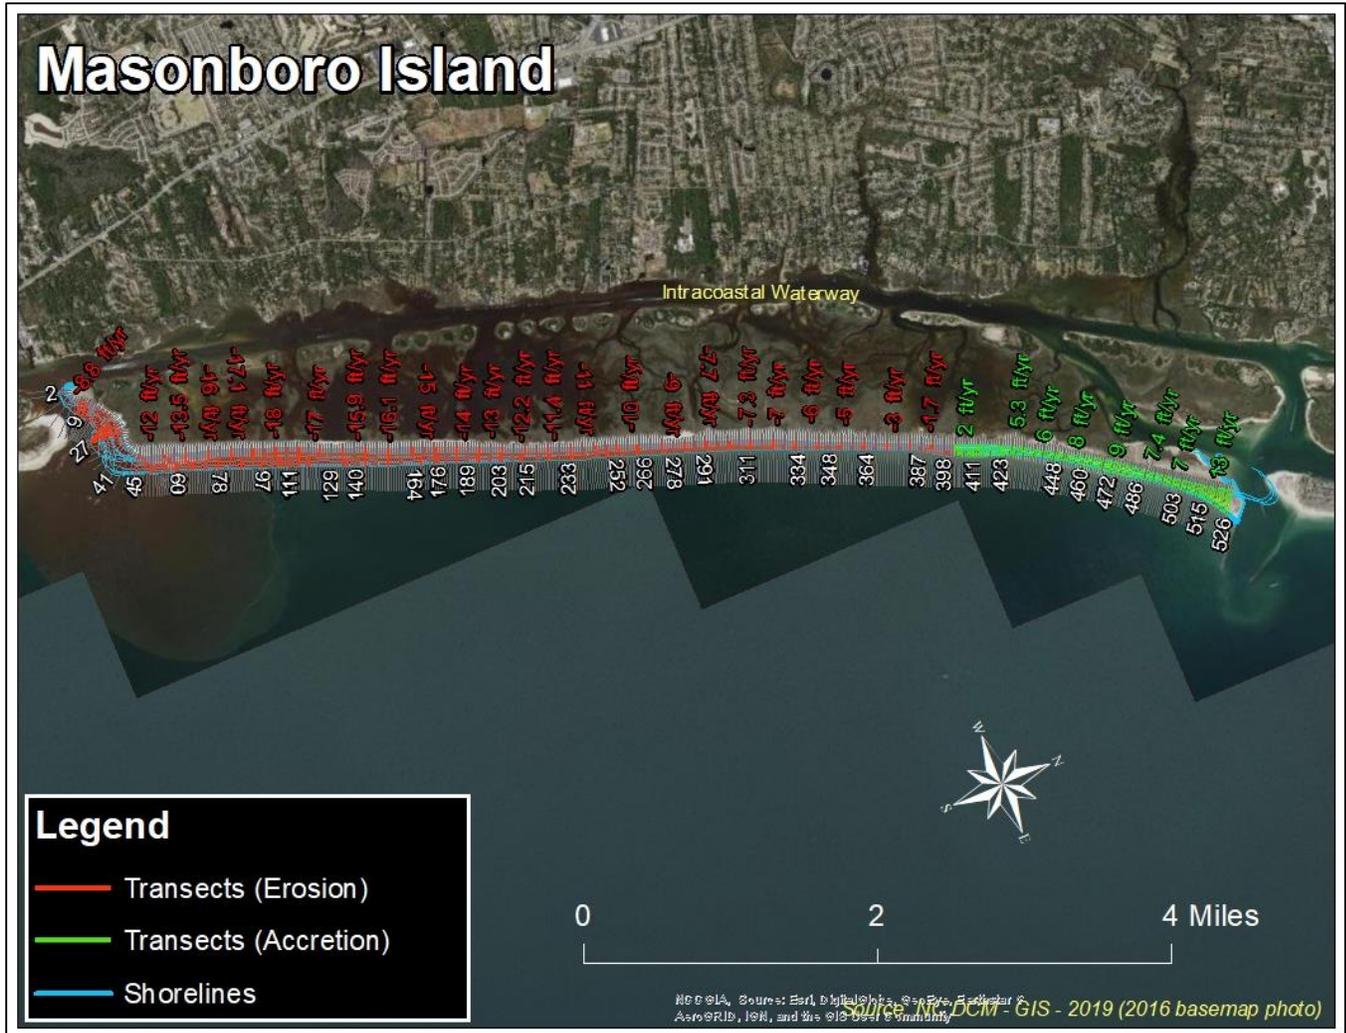
Figure 36. Carolina Beach and Masonboro Inlets at Masonboro Island. Shorelines included in the analysis: 1971, 1974, 1977, 1984, 1992, 1997, 1998, 2000, 2002, 2003, 2004, 2006, 2008, 2009, 2010, 2012, 2016.

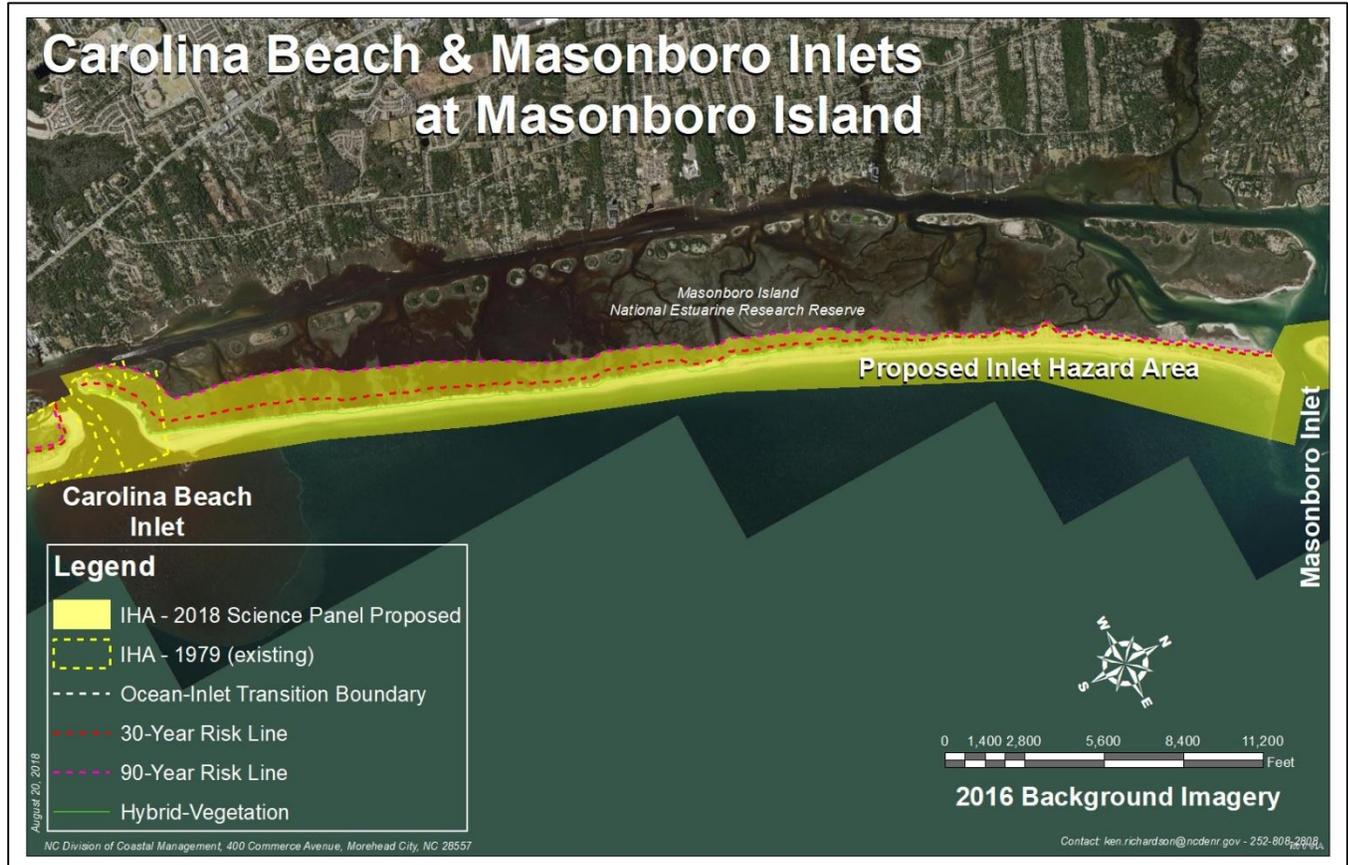
Figure 38. Carolina Beach and Masonboro Inlets at Masonboro Island Hybrid Vegetation Line and the recommended IHA boundary with the 30- and 90-Year Risk Lines.

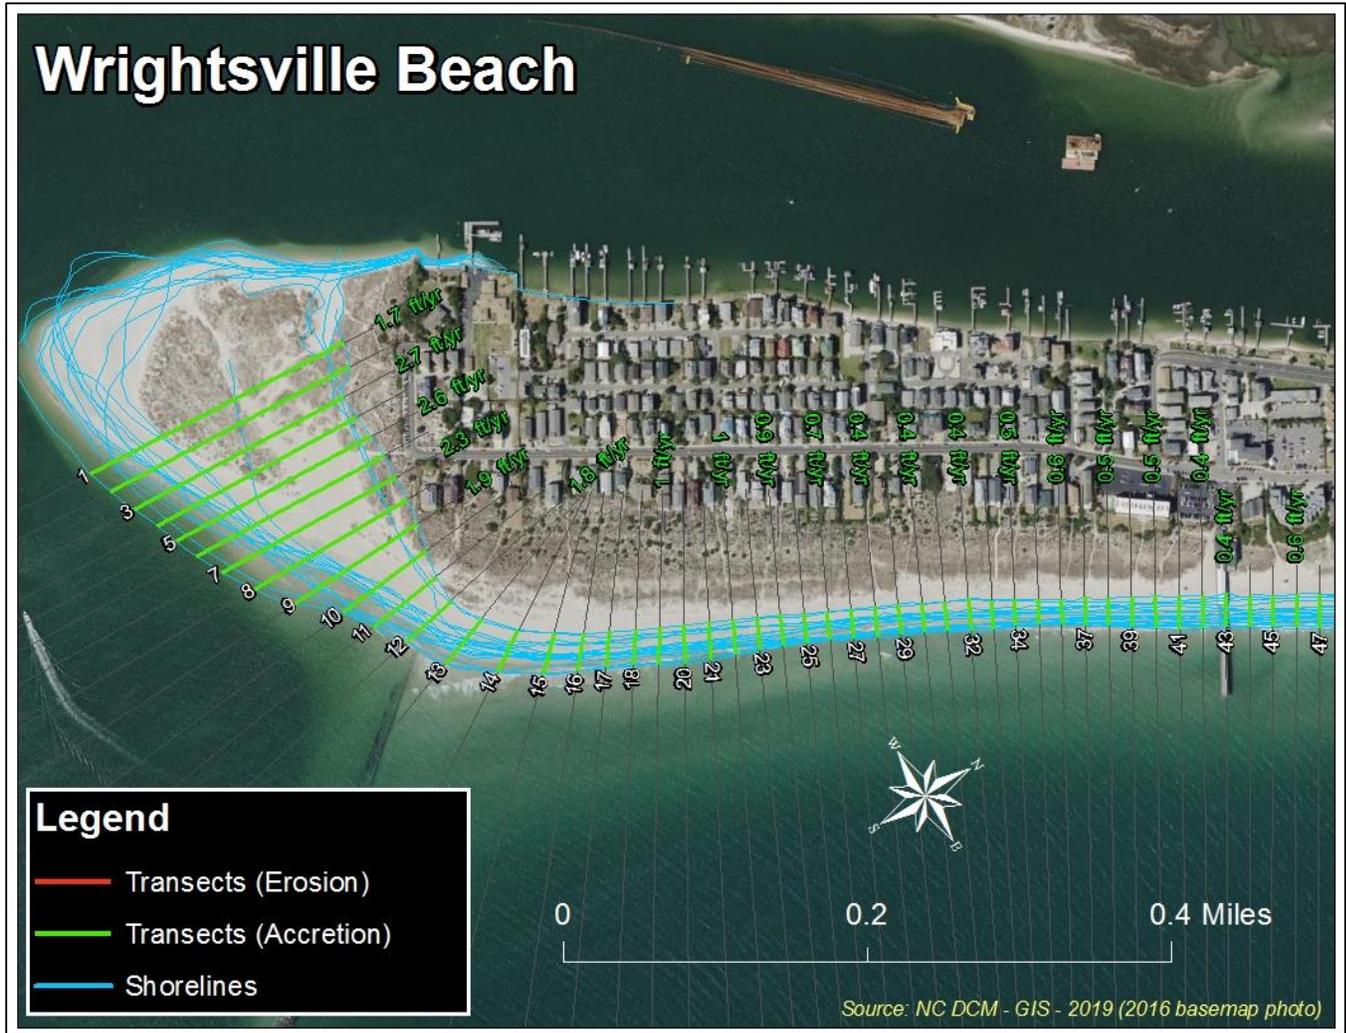
Figure 40. Masonboro Inlet at Wrightsville Beach. Shorelines included: 1973, 1974, 1977, 1984, 1992, 1995, 1997, 1998, 2000, 2002, 2003, 2004, 2006, 2009, 2010, 2012, 2016.

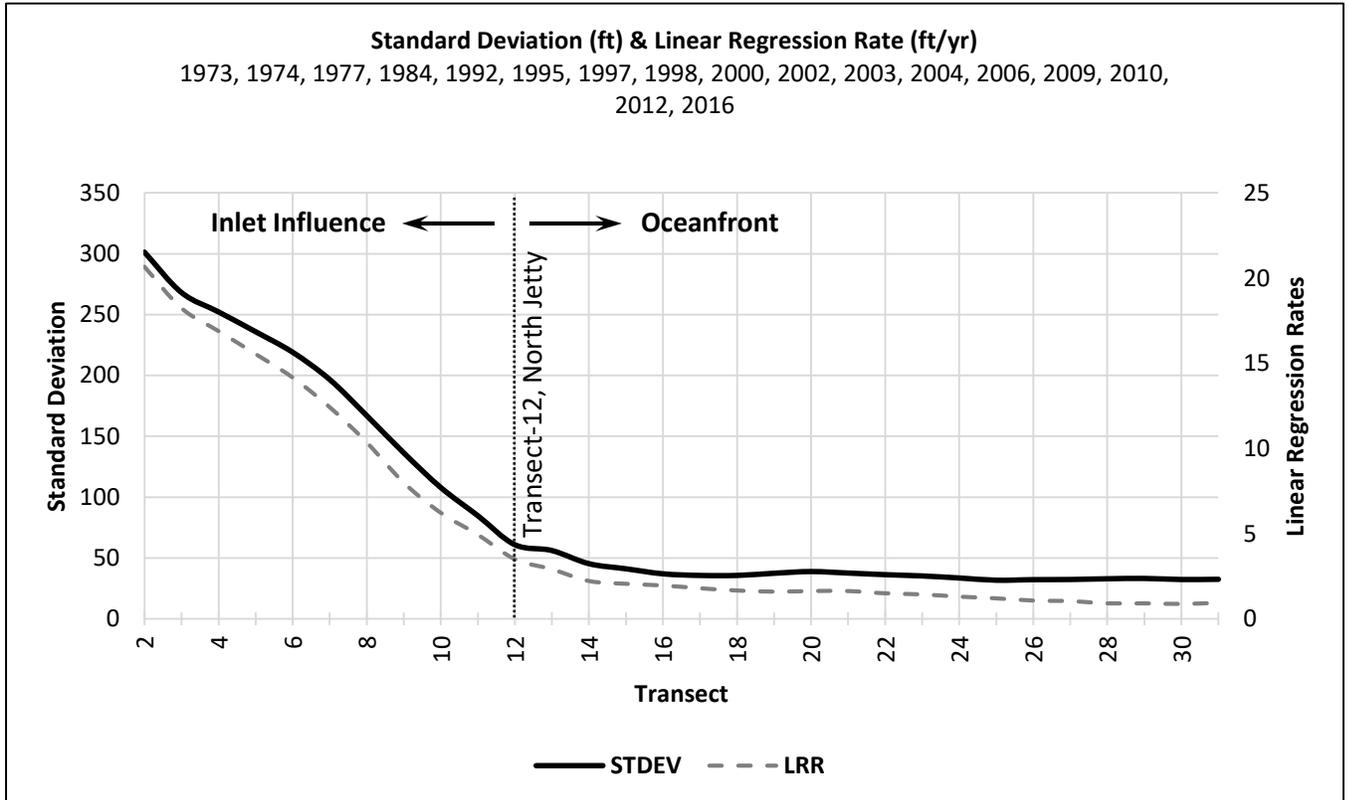
Figure 41. At Masonboro Inlet-Wrightsville Beach, the standard deviation of shoreline position has a break in slope around transect-16. Transect-12 is the anchor point of the north inlet jetty, and since its standard deviation is only slightly higher it is recommended as the IHA boundary between inlet and oceanfront influence. Negative Linear Regression rates indicate erosion, while positive values represent accretion (right axis).

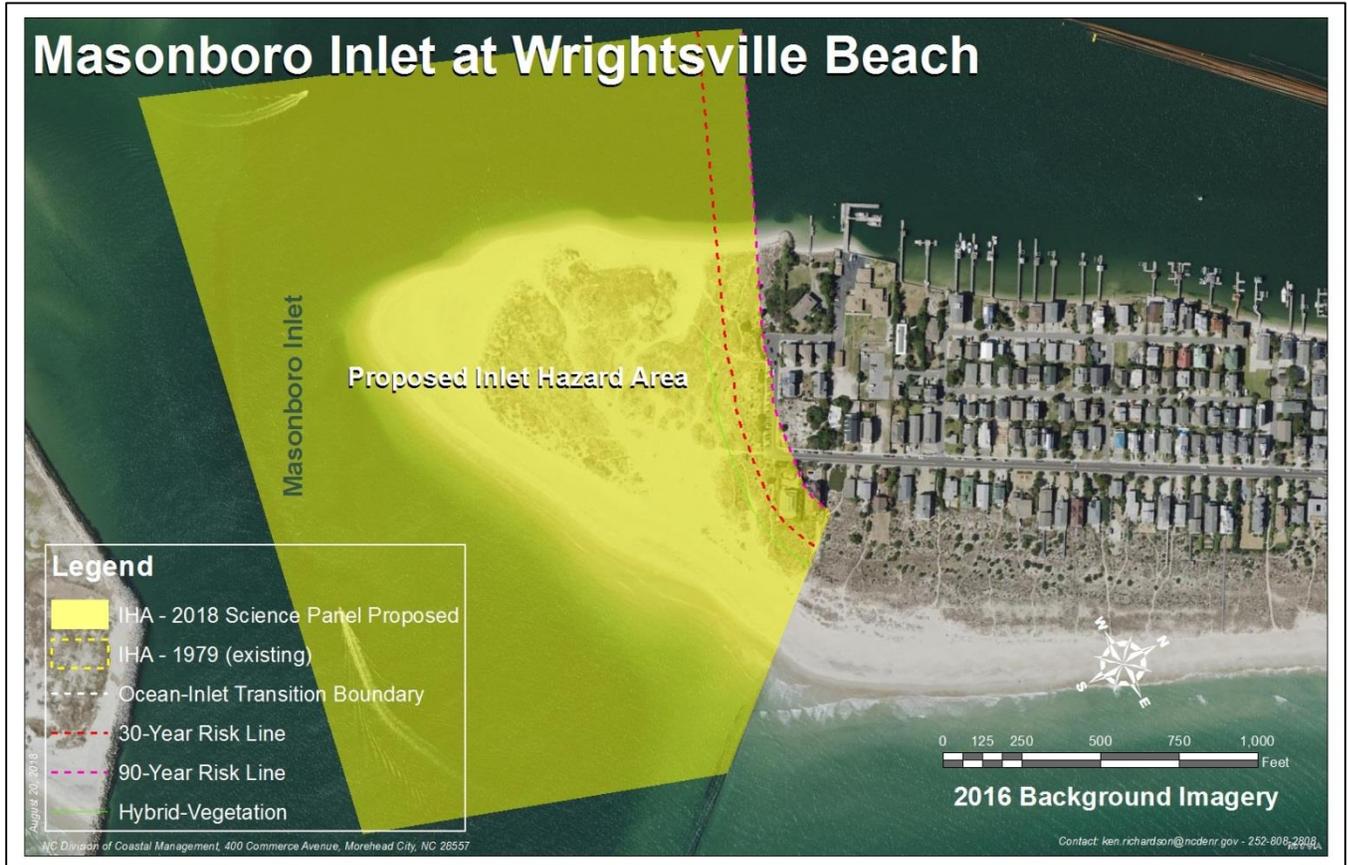
Figure 42. Masonboro Inlet at Wrightsville Beach Hybrid-Vegetation Line and the recommended IHA boundary with the 30- and 90-Year Risk Lines.

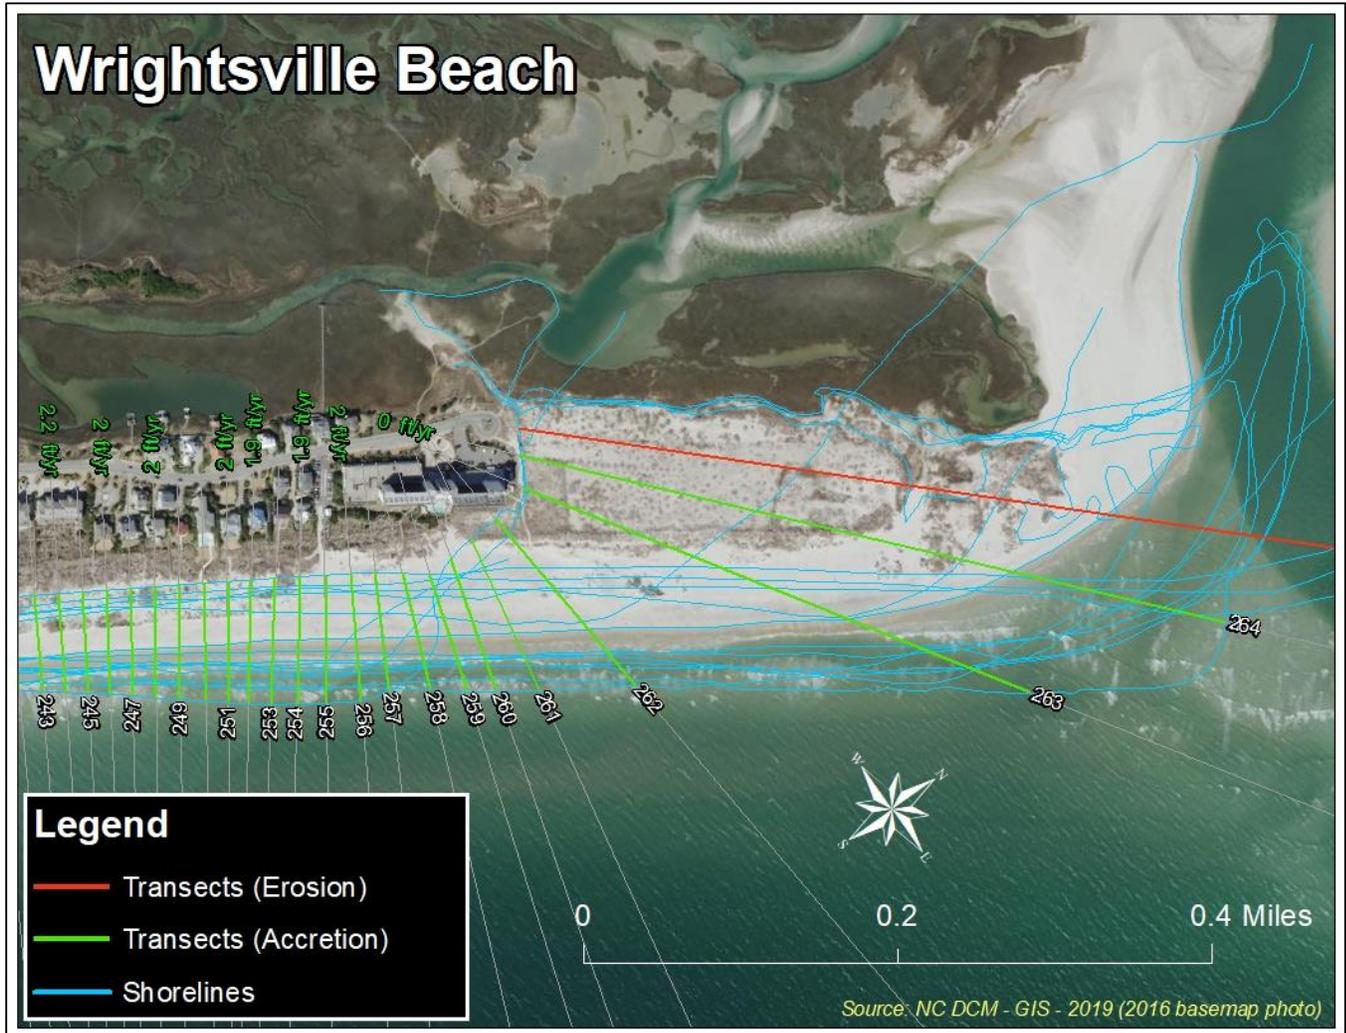
Figure 44. Mason Inlet at Wrightsville Beach. Shorelines included: 1971, 1973, 1974, 1977, 1984, 1987, 1992, 1995, 1997, 1998, 2000, 2002, 2003, 2004, 2006, 2009, 2010, 2012, 2016.

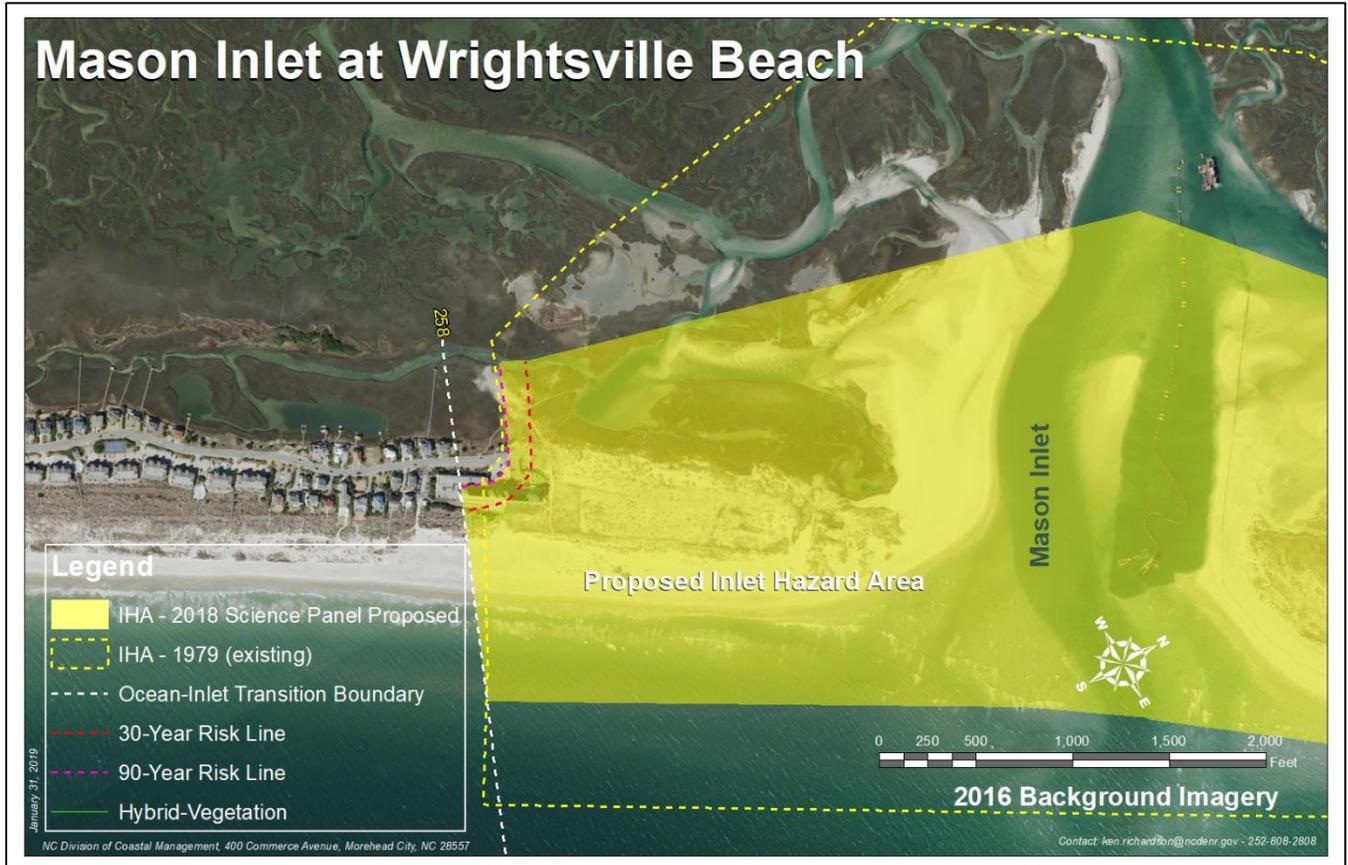
Figure 46. Mason Inlet at Wrightsville Beach Hybrid-Vegetation Line and the recommended IHA boundary with the 30- and 90-Year Risk Lines.

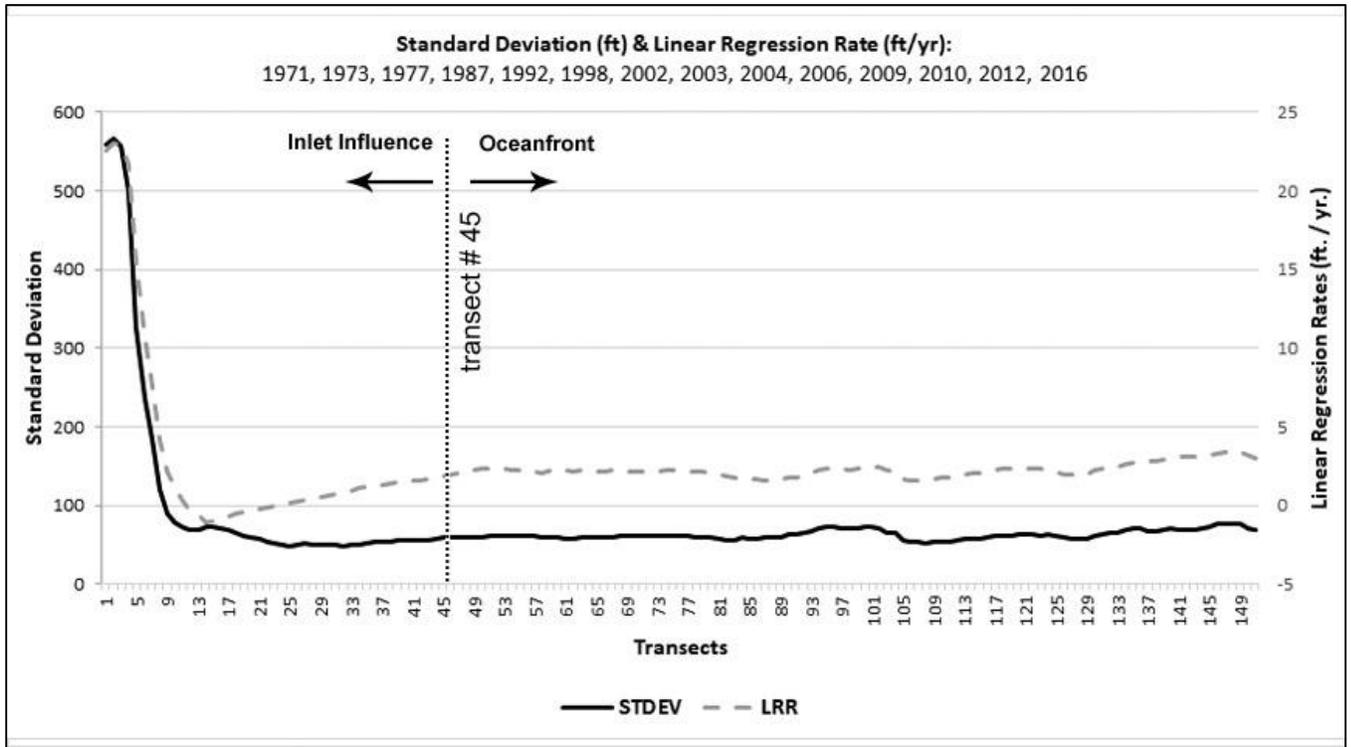
Figure 49. Based on the increased potential for erosion at Mason Inlet-Figure Eight Island, transect-45 is recommended as the inlet-ocean transition boundary along the shoreline. Negative Linear Regression rates indicate erosion, while positive values represent accretion (right axis).

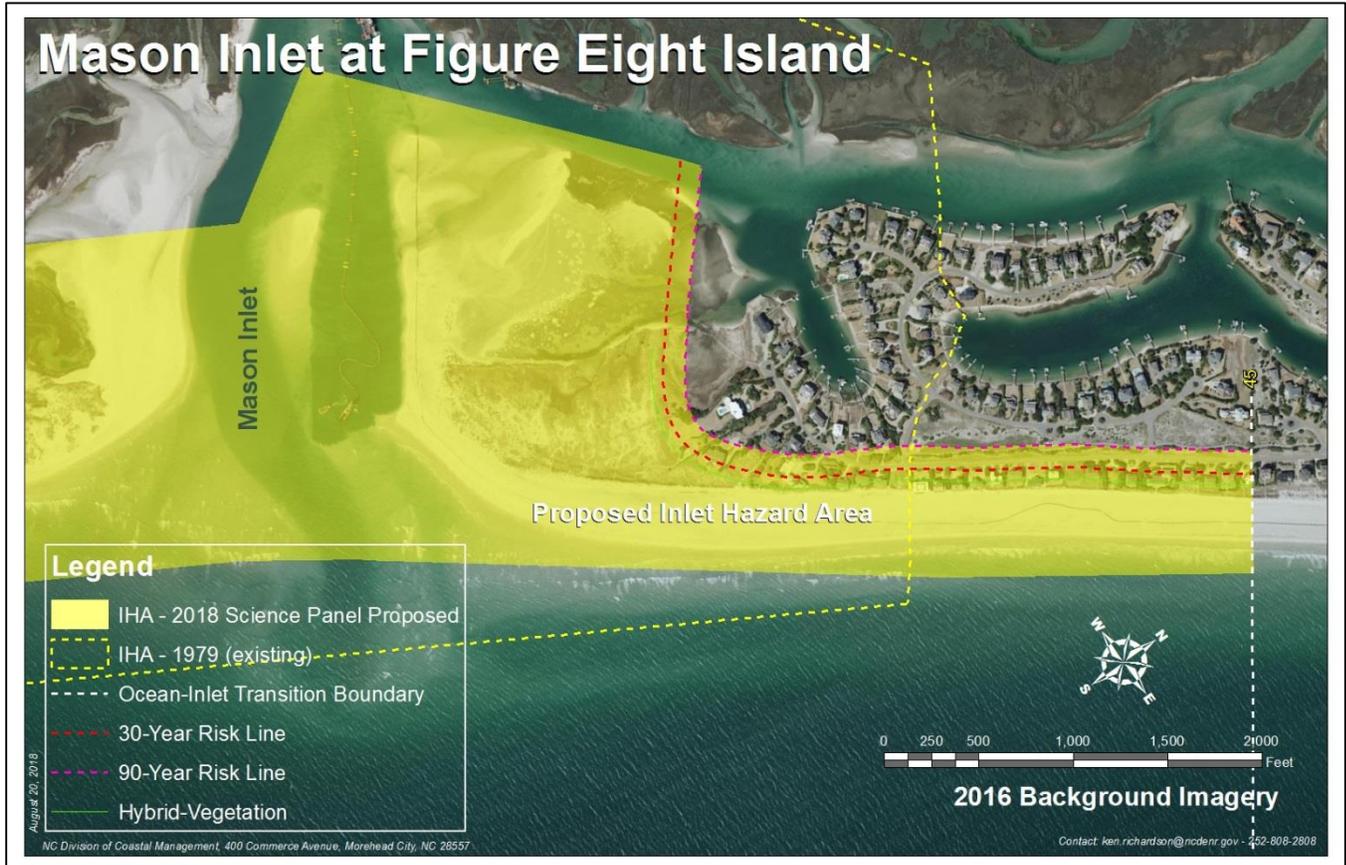
Figure 50. Map of Mason Inlet at Figure Eight Island Hybrid-Vegetation Line and the recommended IHA boundary with the 30- and 90-Year Risk Lines.
