Inlet Hazard Area Boundary, 2019 Update:

Science Panel Recommendations to the
North Carolina Coastal Resources Commission

February 12, 2019

NC Coastal Resources Commission's Science Panel on Coastal Hazards
& NC Division of Coastal Management

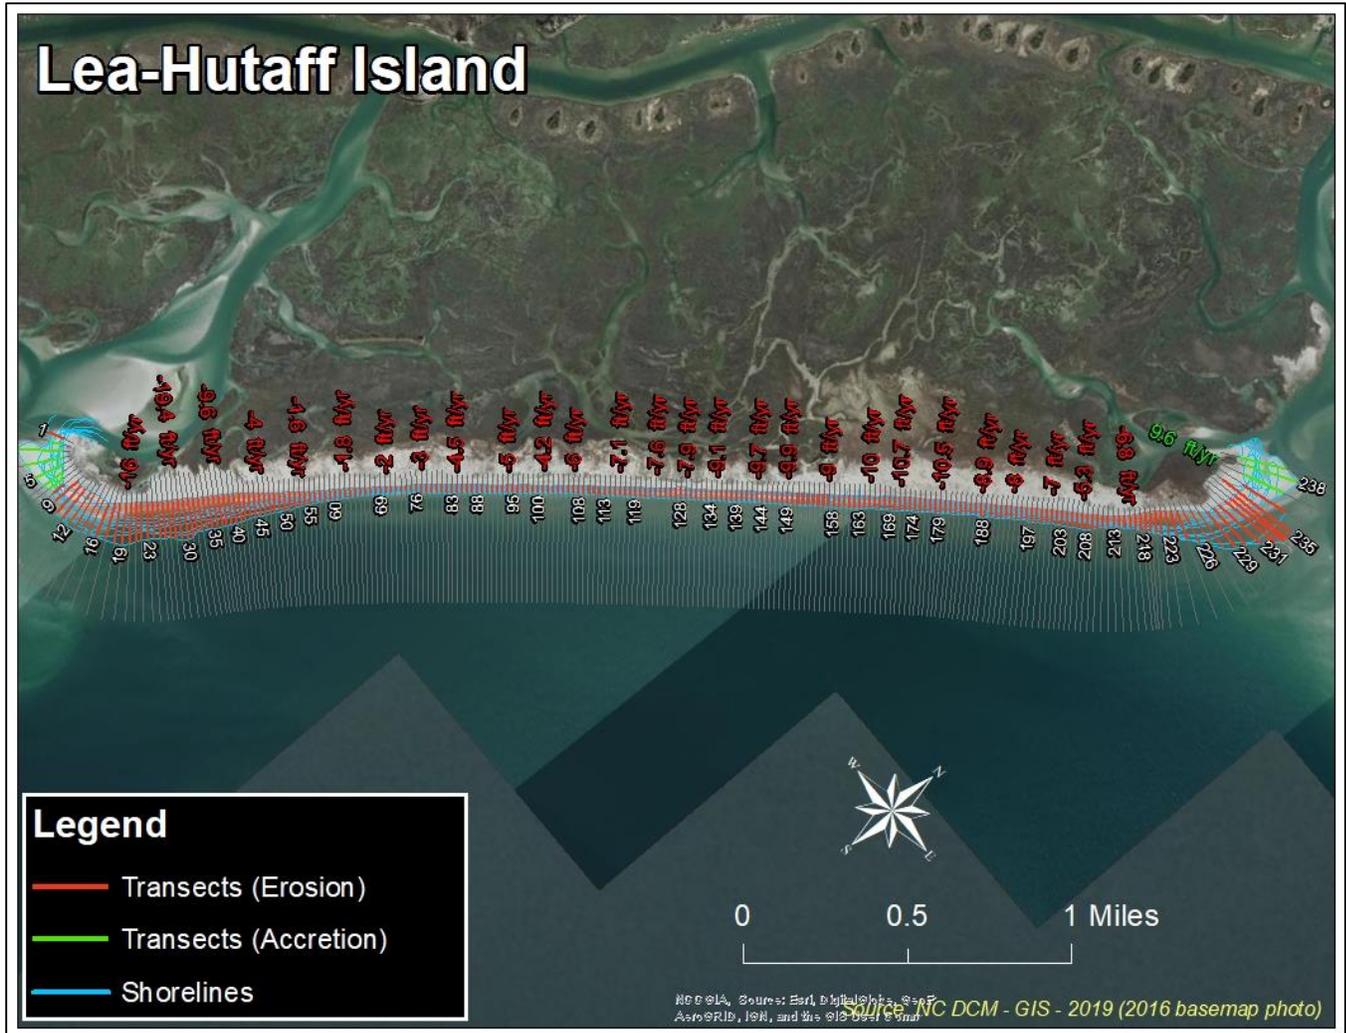
Figure 56. Shorelines included in the analysis: 1997, 1998, 2000, 2004, 2006, 2008, 2009, 2010, 2012, 2016.

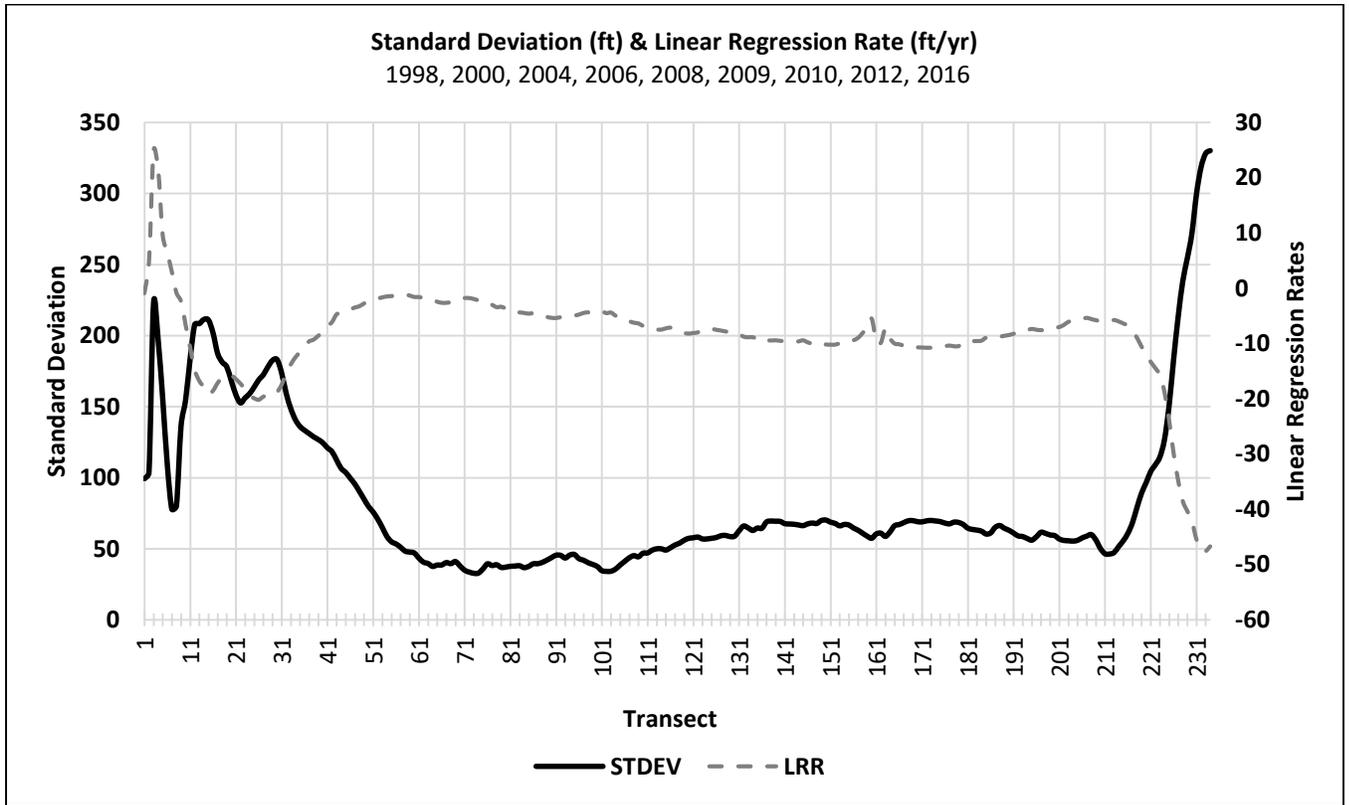
Figure 57. Because Lea and Hutaff Island welded together in 1997, have low topography and are heavily influenced by both Rich and New Topsail Inlets, the Panel recommends including all Lea-Hutaff Island in the IHA. Negative Linear Regression rates indicate erosion, while positive values represent accretion (right axis).

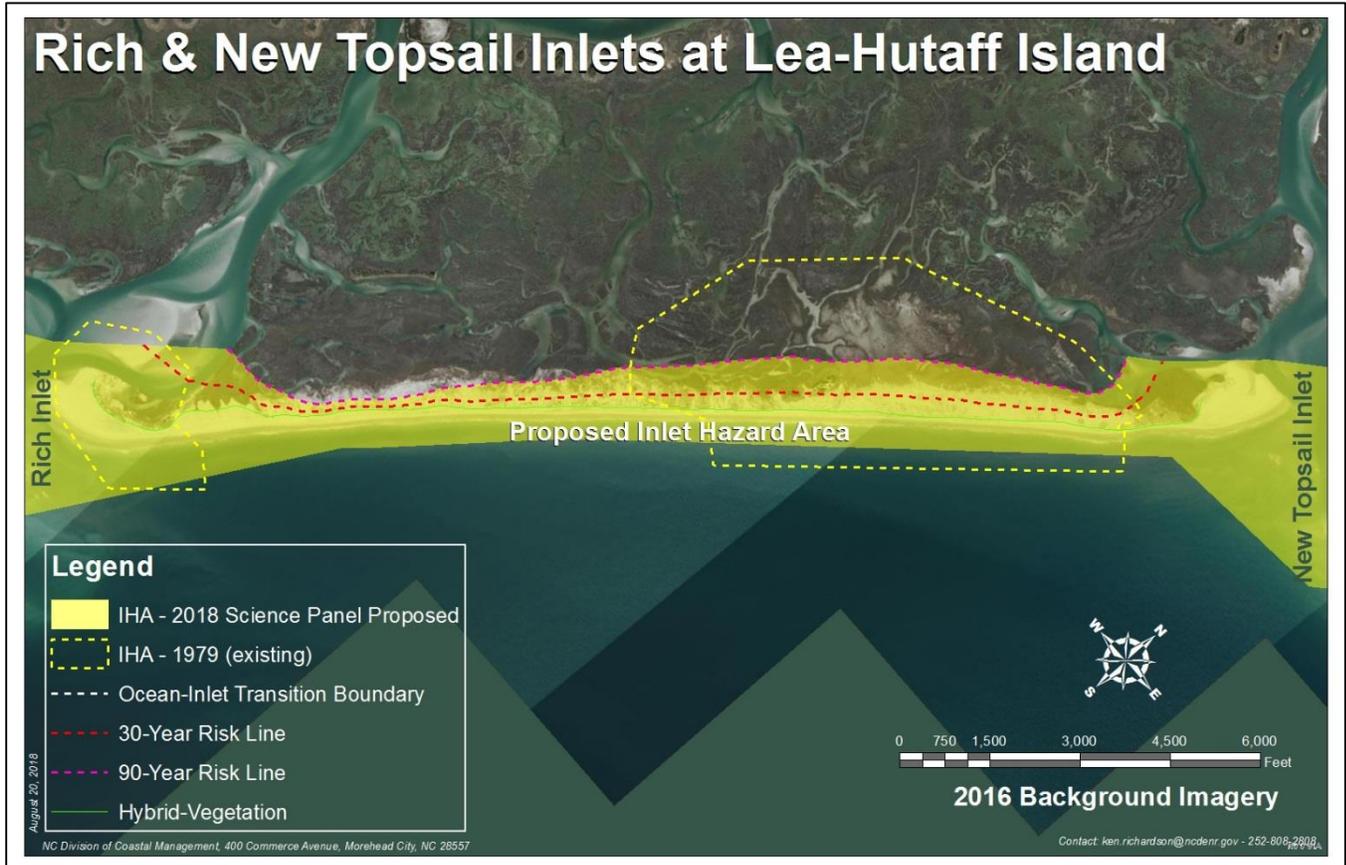
Figure 58. Rich and New Topsail Inlets at Lea-Hutaff Island Hybrid-Vegetation Line and the recommended IHA boundary with the 30- and 90-Year Risk Lines.

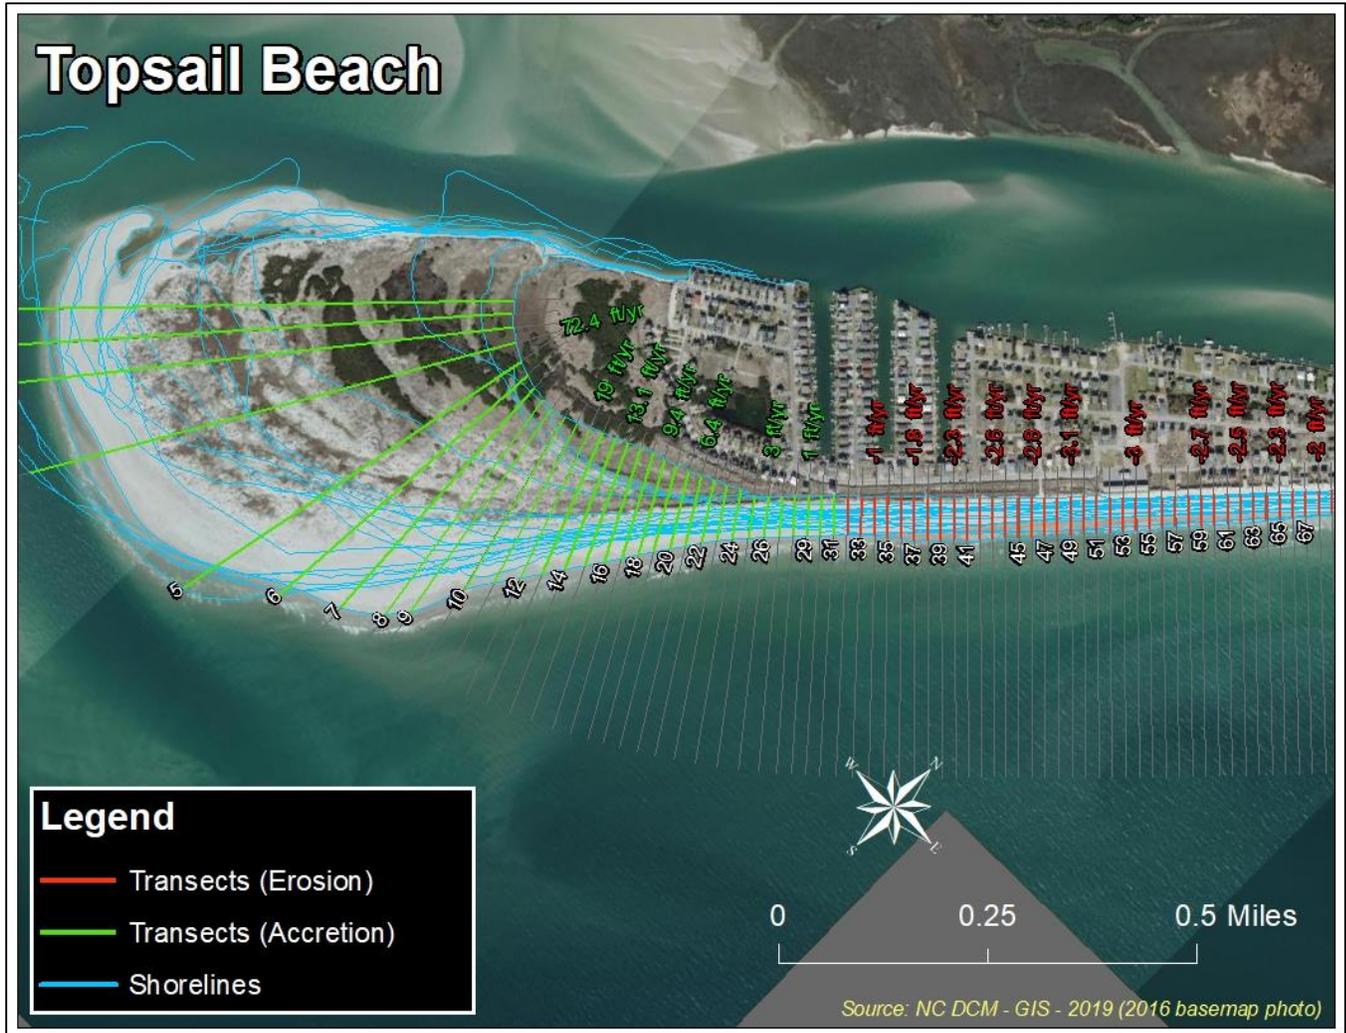
Figure 60. New Topsail Inlet at Topsail Beach Shorelines included: 1971, 1973, 1974, 1976, 1984, 1992, 1995, 1997, 1998, 2000, 2003, 2004, 2006, 2008, 2009, 2010, 2011, 2012, 2016.

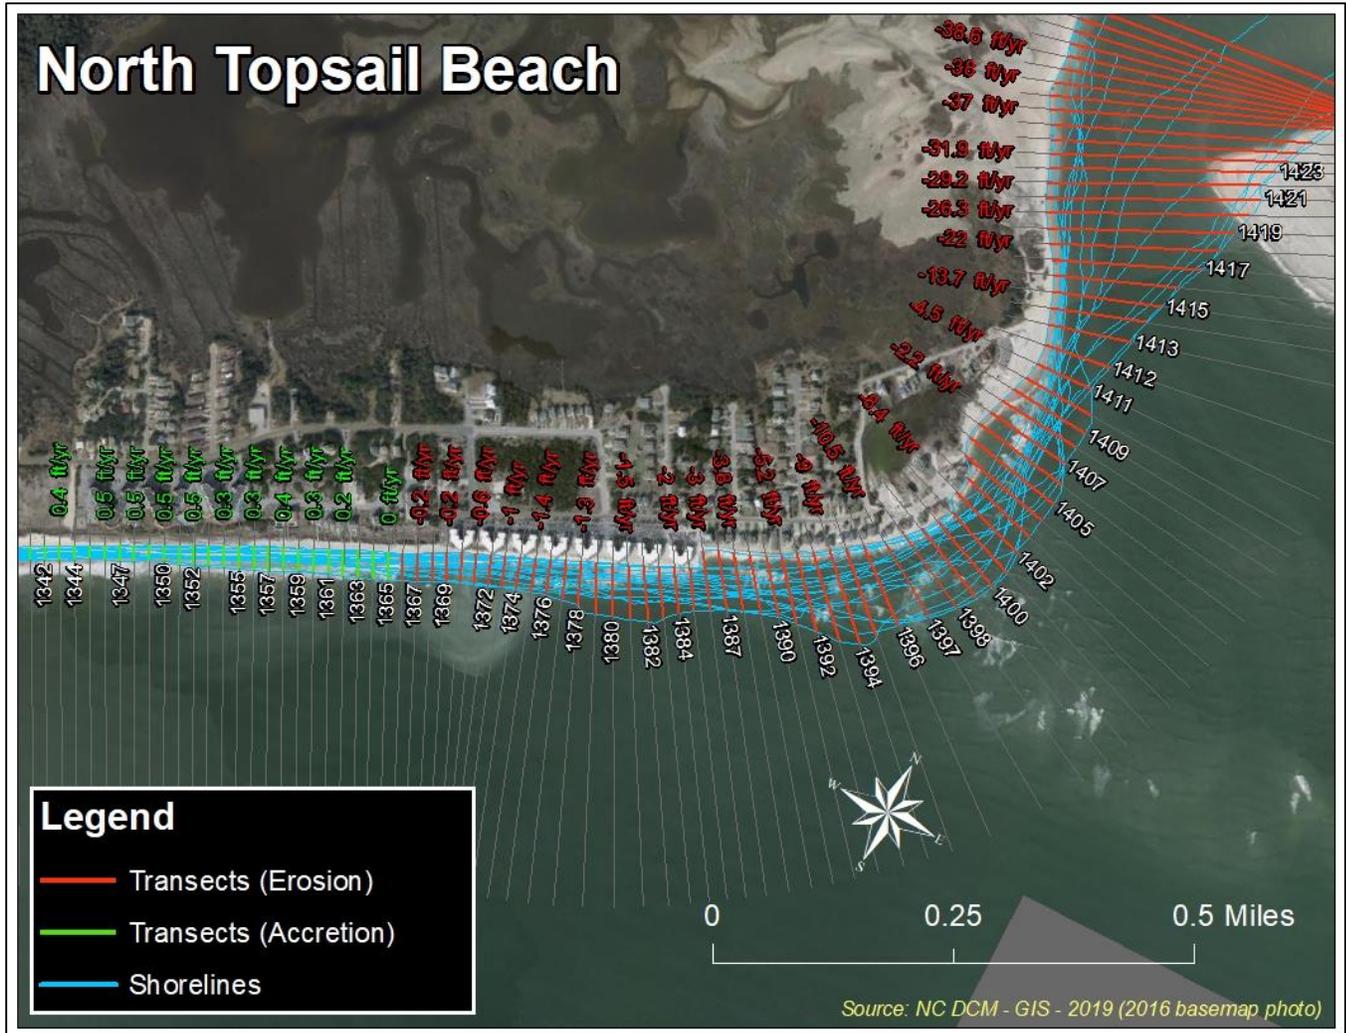
Figure 64. New River Inlet at North Topsail Beach. Shorelines included: 1971, 1973, 1974, 1977, 1984, 1992, 1995, 1997, 1998, 2000, 2003, 2004, 2006, 2009, 2010, 2012, 2016.

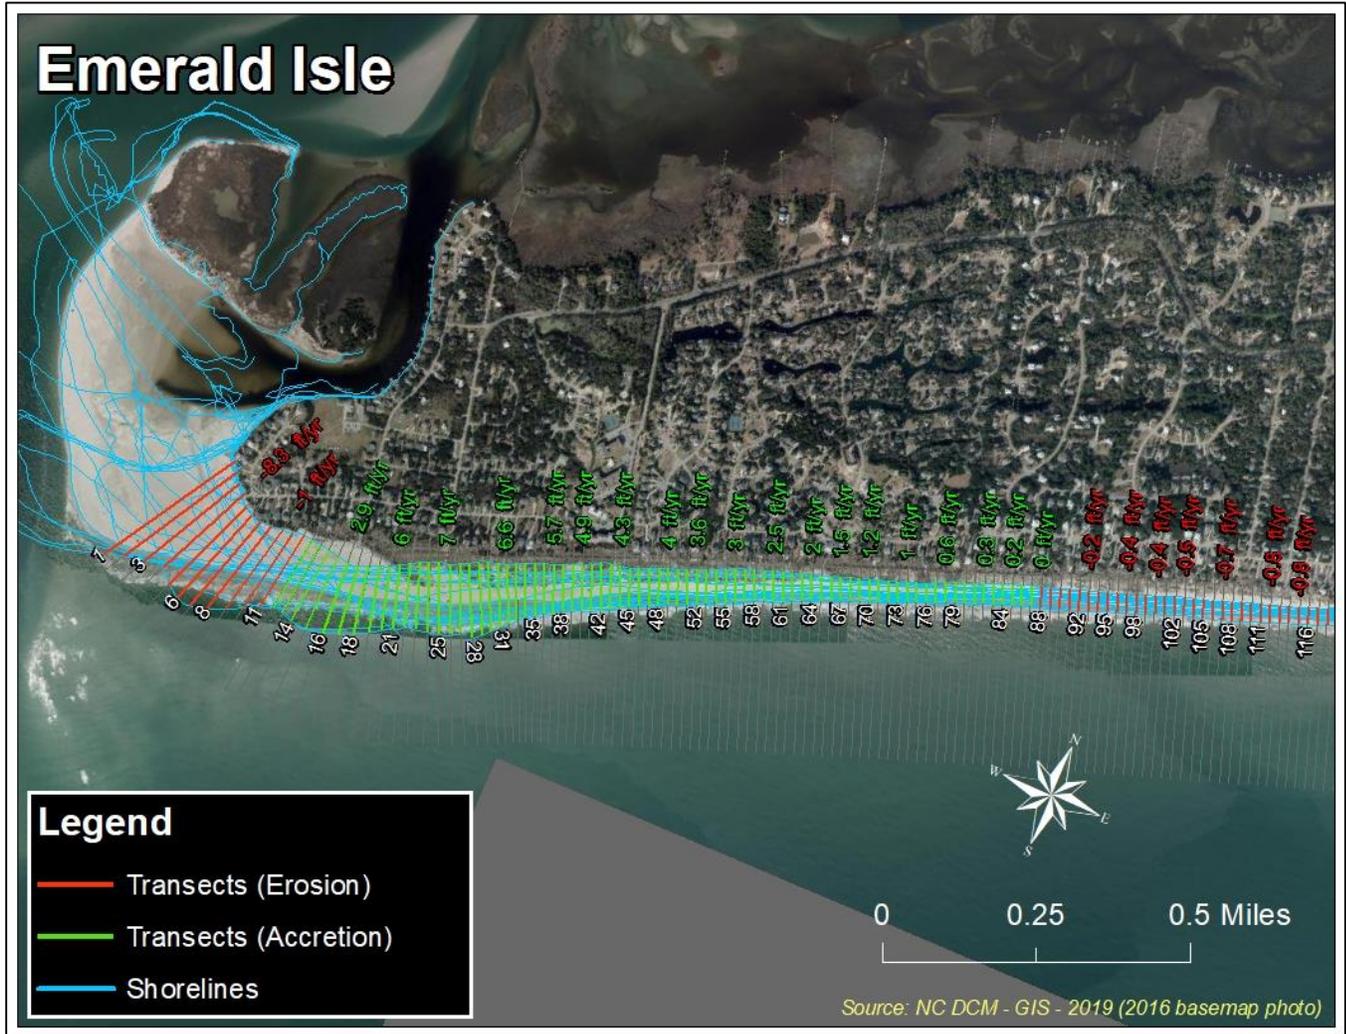
Figure 68. Shorelines included in the analysis: 1949, 1956, 1958, 1960, 1971, 1973, 1976, 1987, 1992, 1997, 1998, 2003, 2004, 2006, 2009, 2010, 2012, 2016.

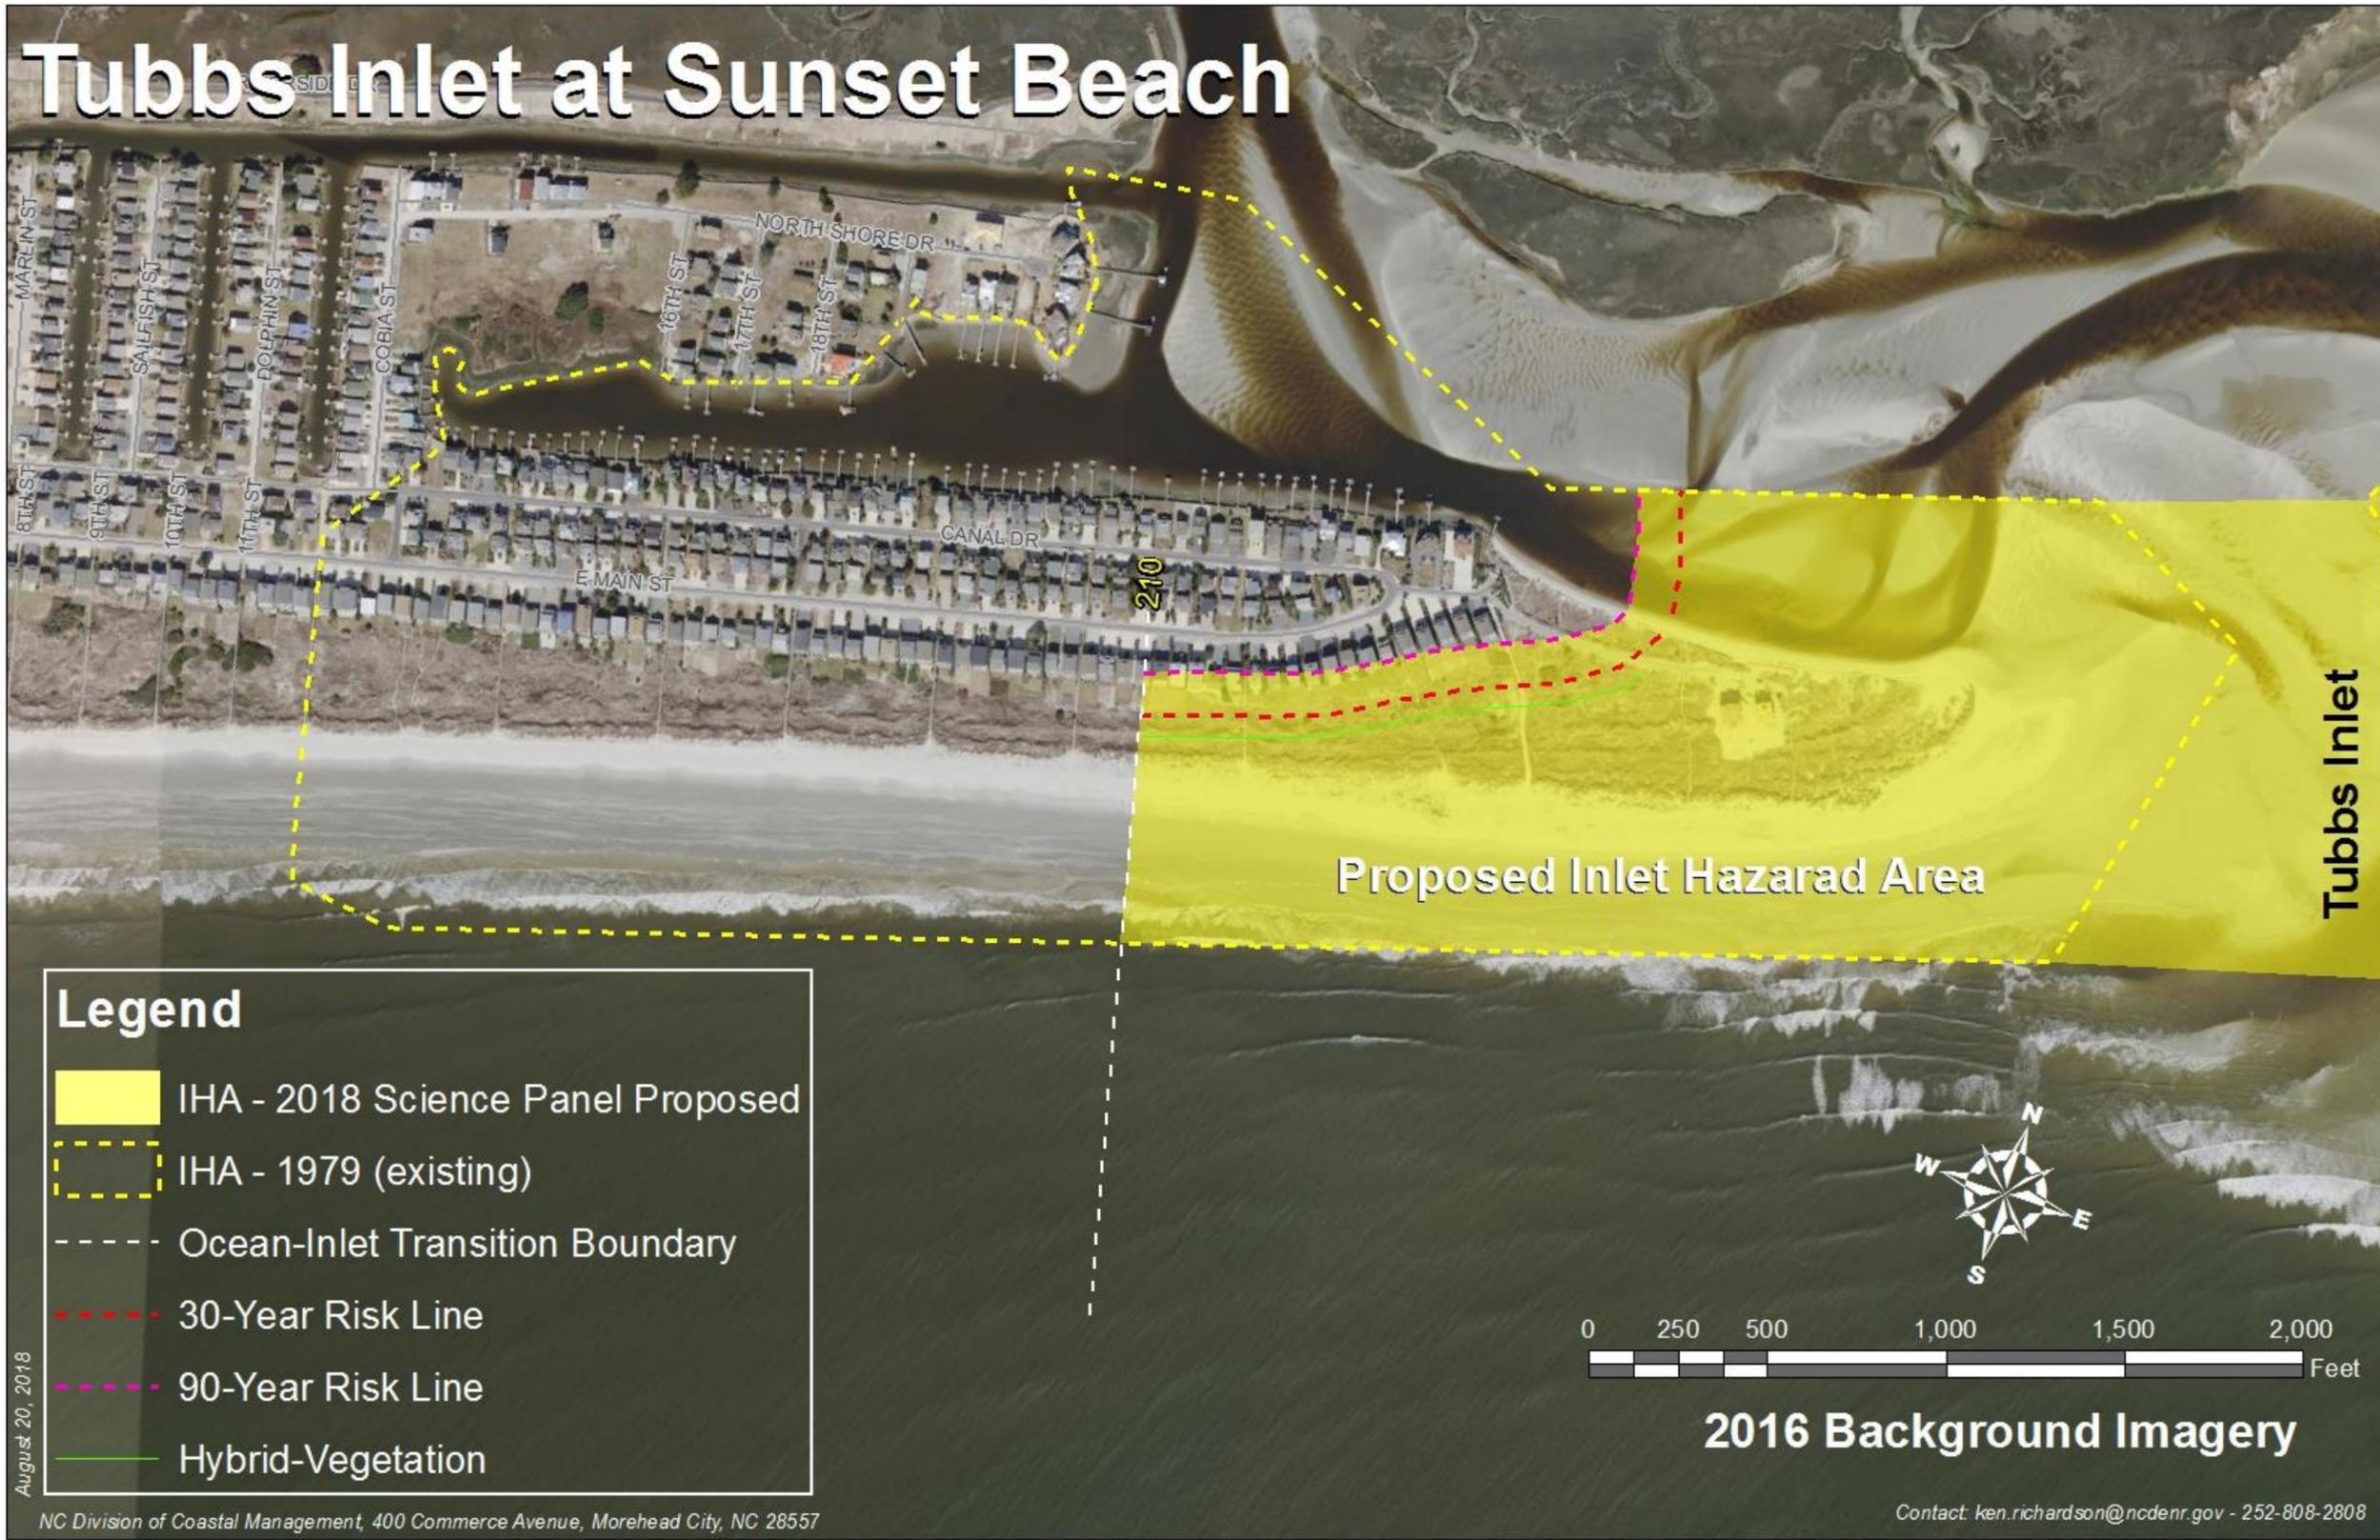
Figure C1. Proposed Inlet Hazard Area at Tubbs Inlet (Sunset Beach).

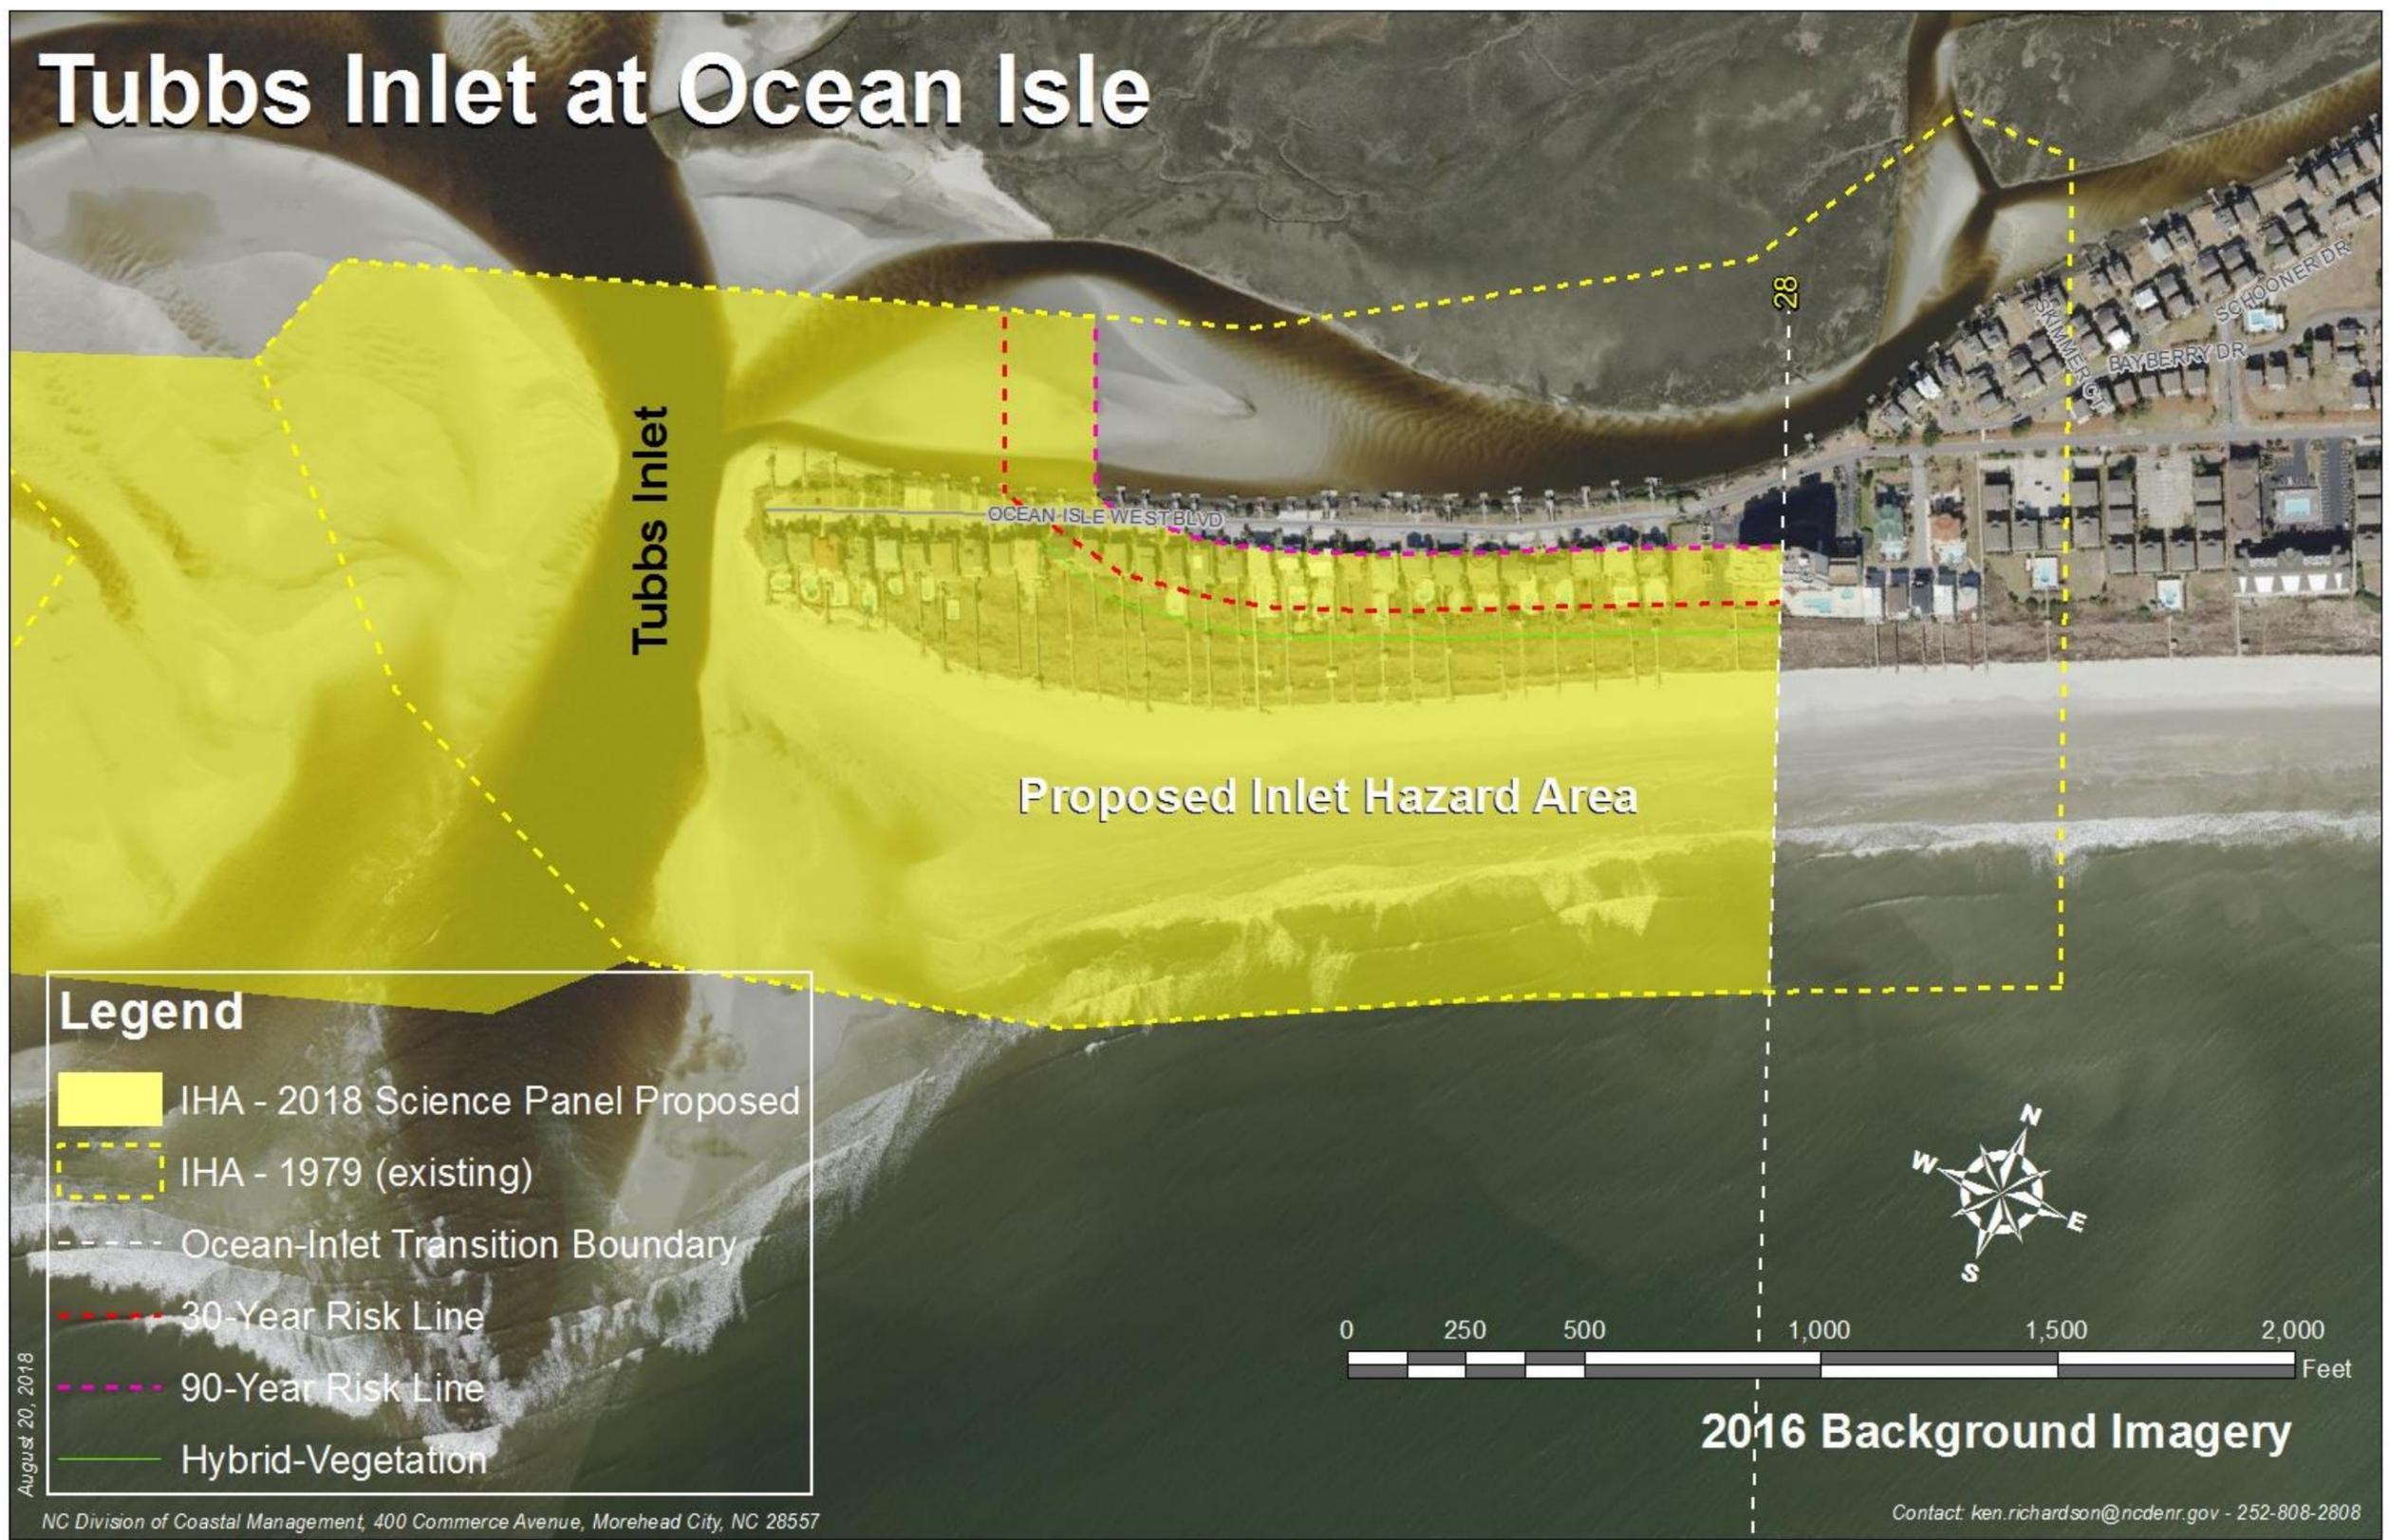
Figure C2. Proposed Inlet Hazard Area at Tubbs Inlet (Ocean Isle Beach).

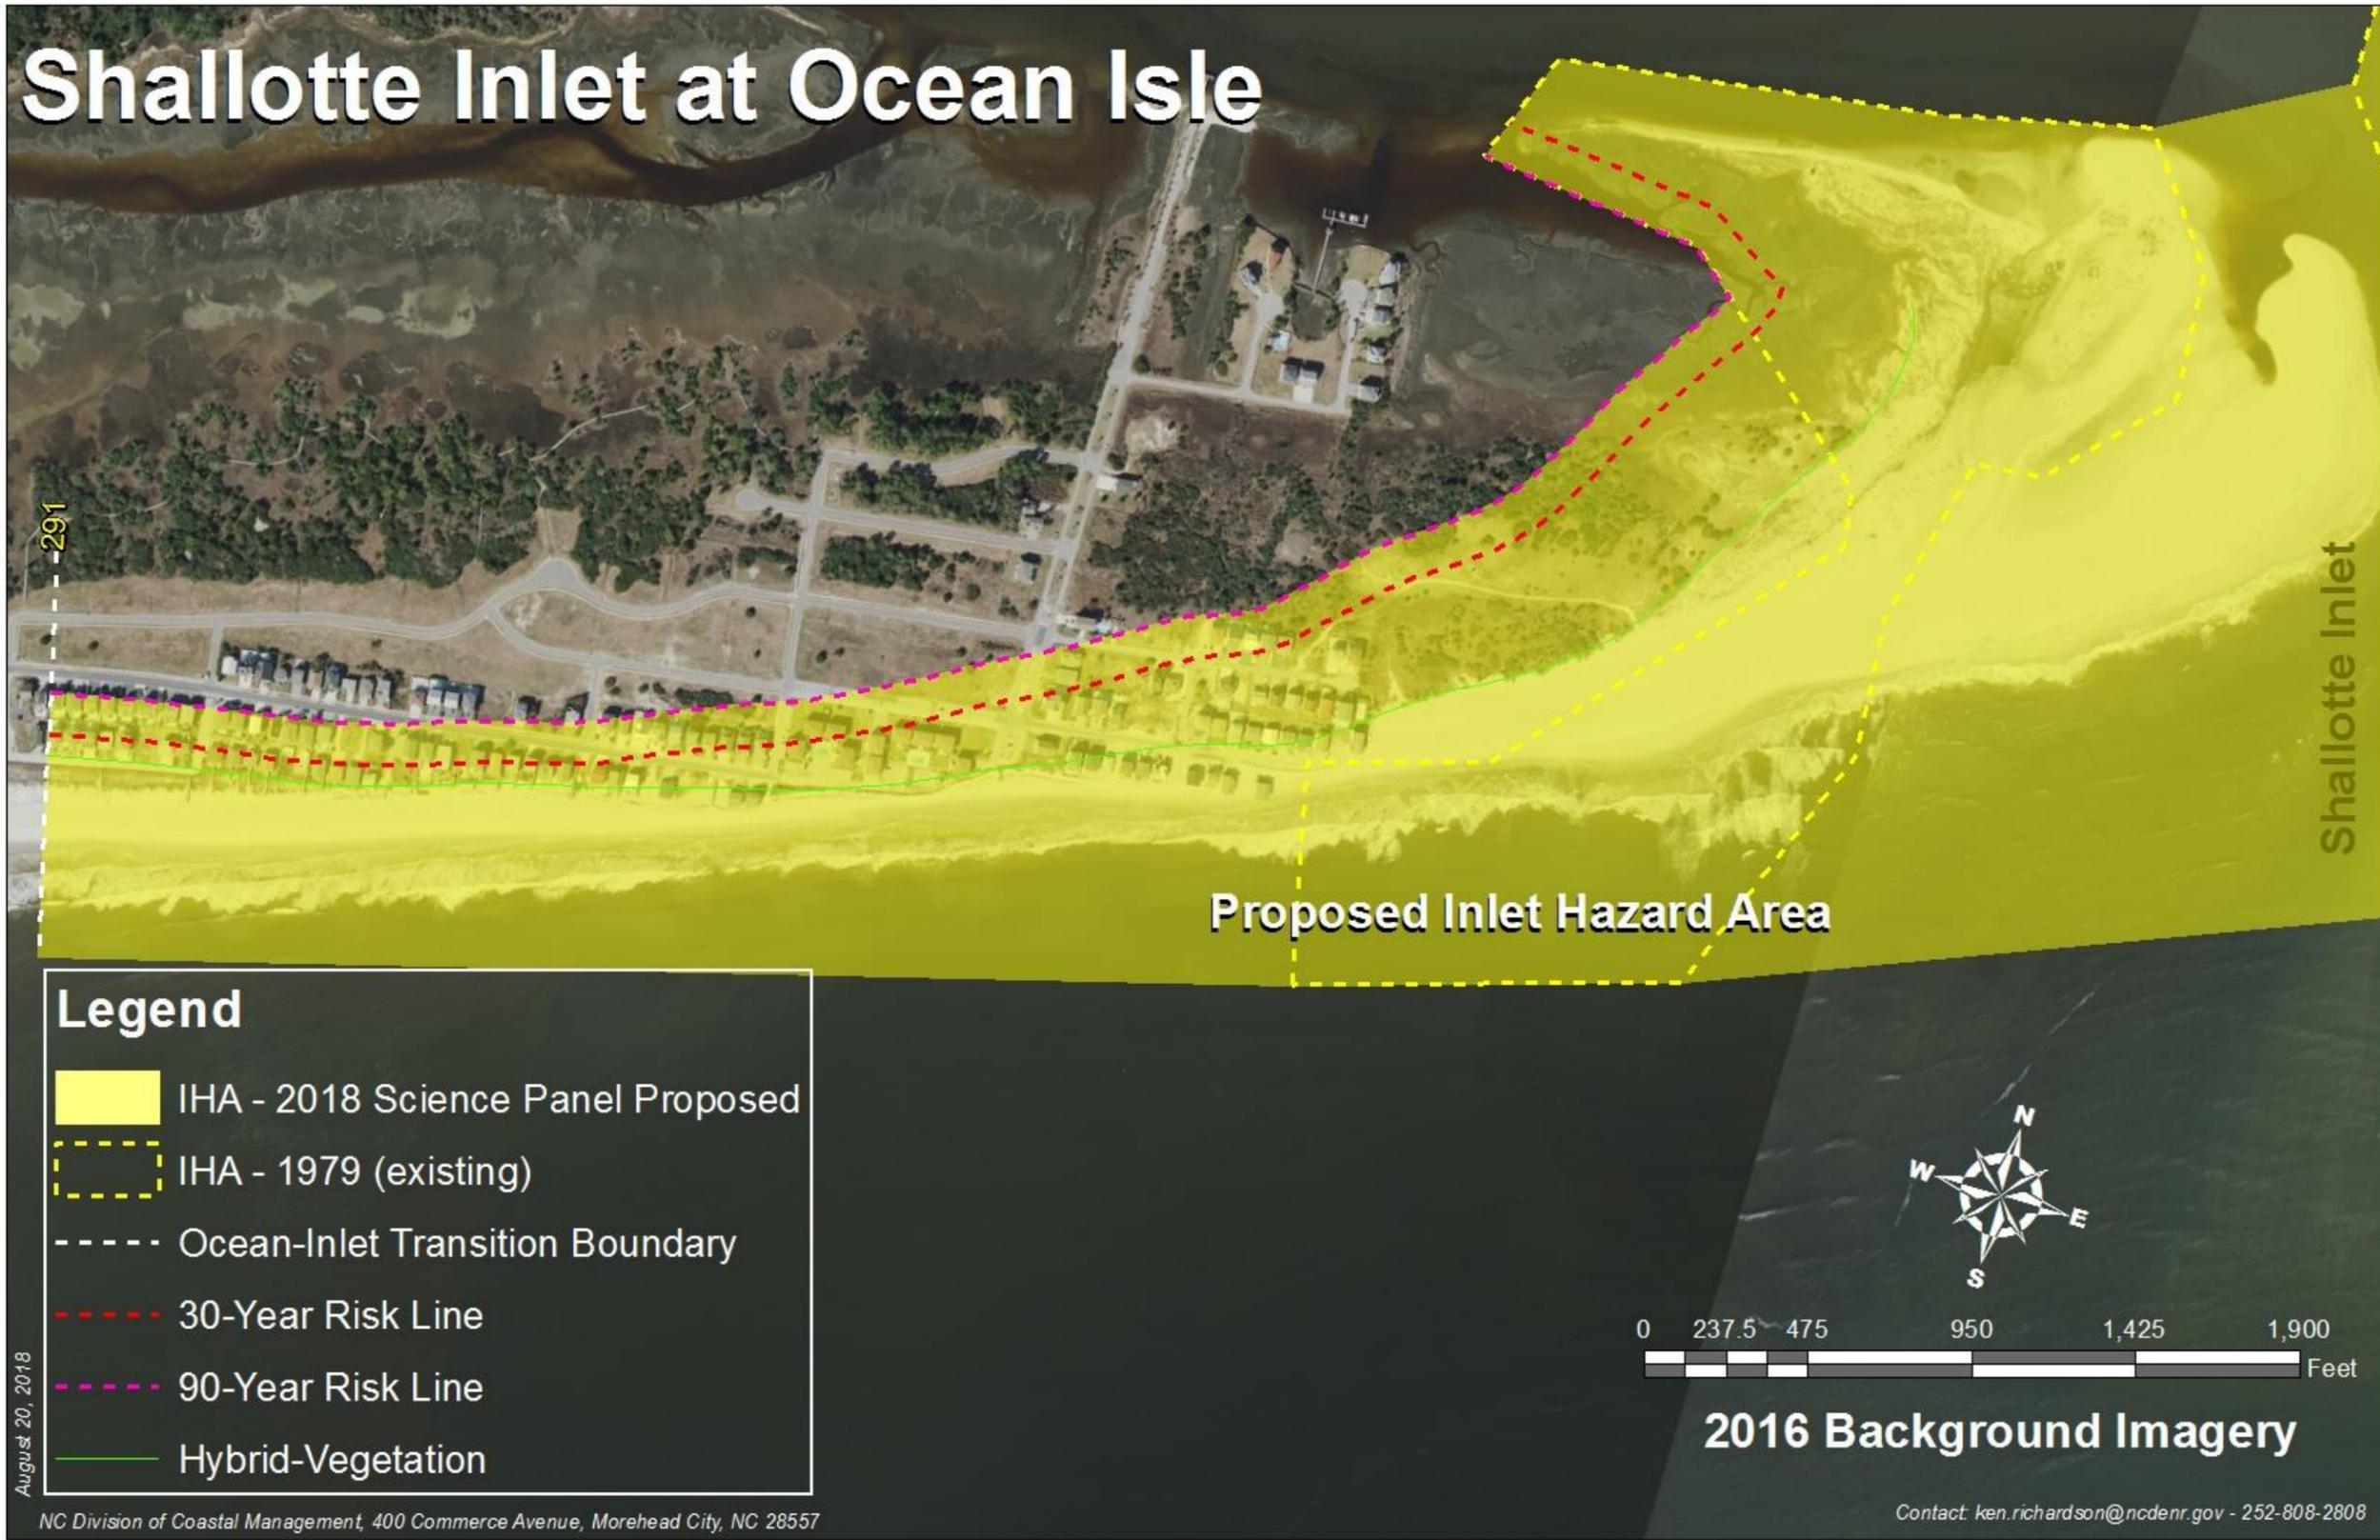
Figure C3. Proposed Inlet Hazard Area at Shallotte Inlet (Ocean Isle).

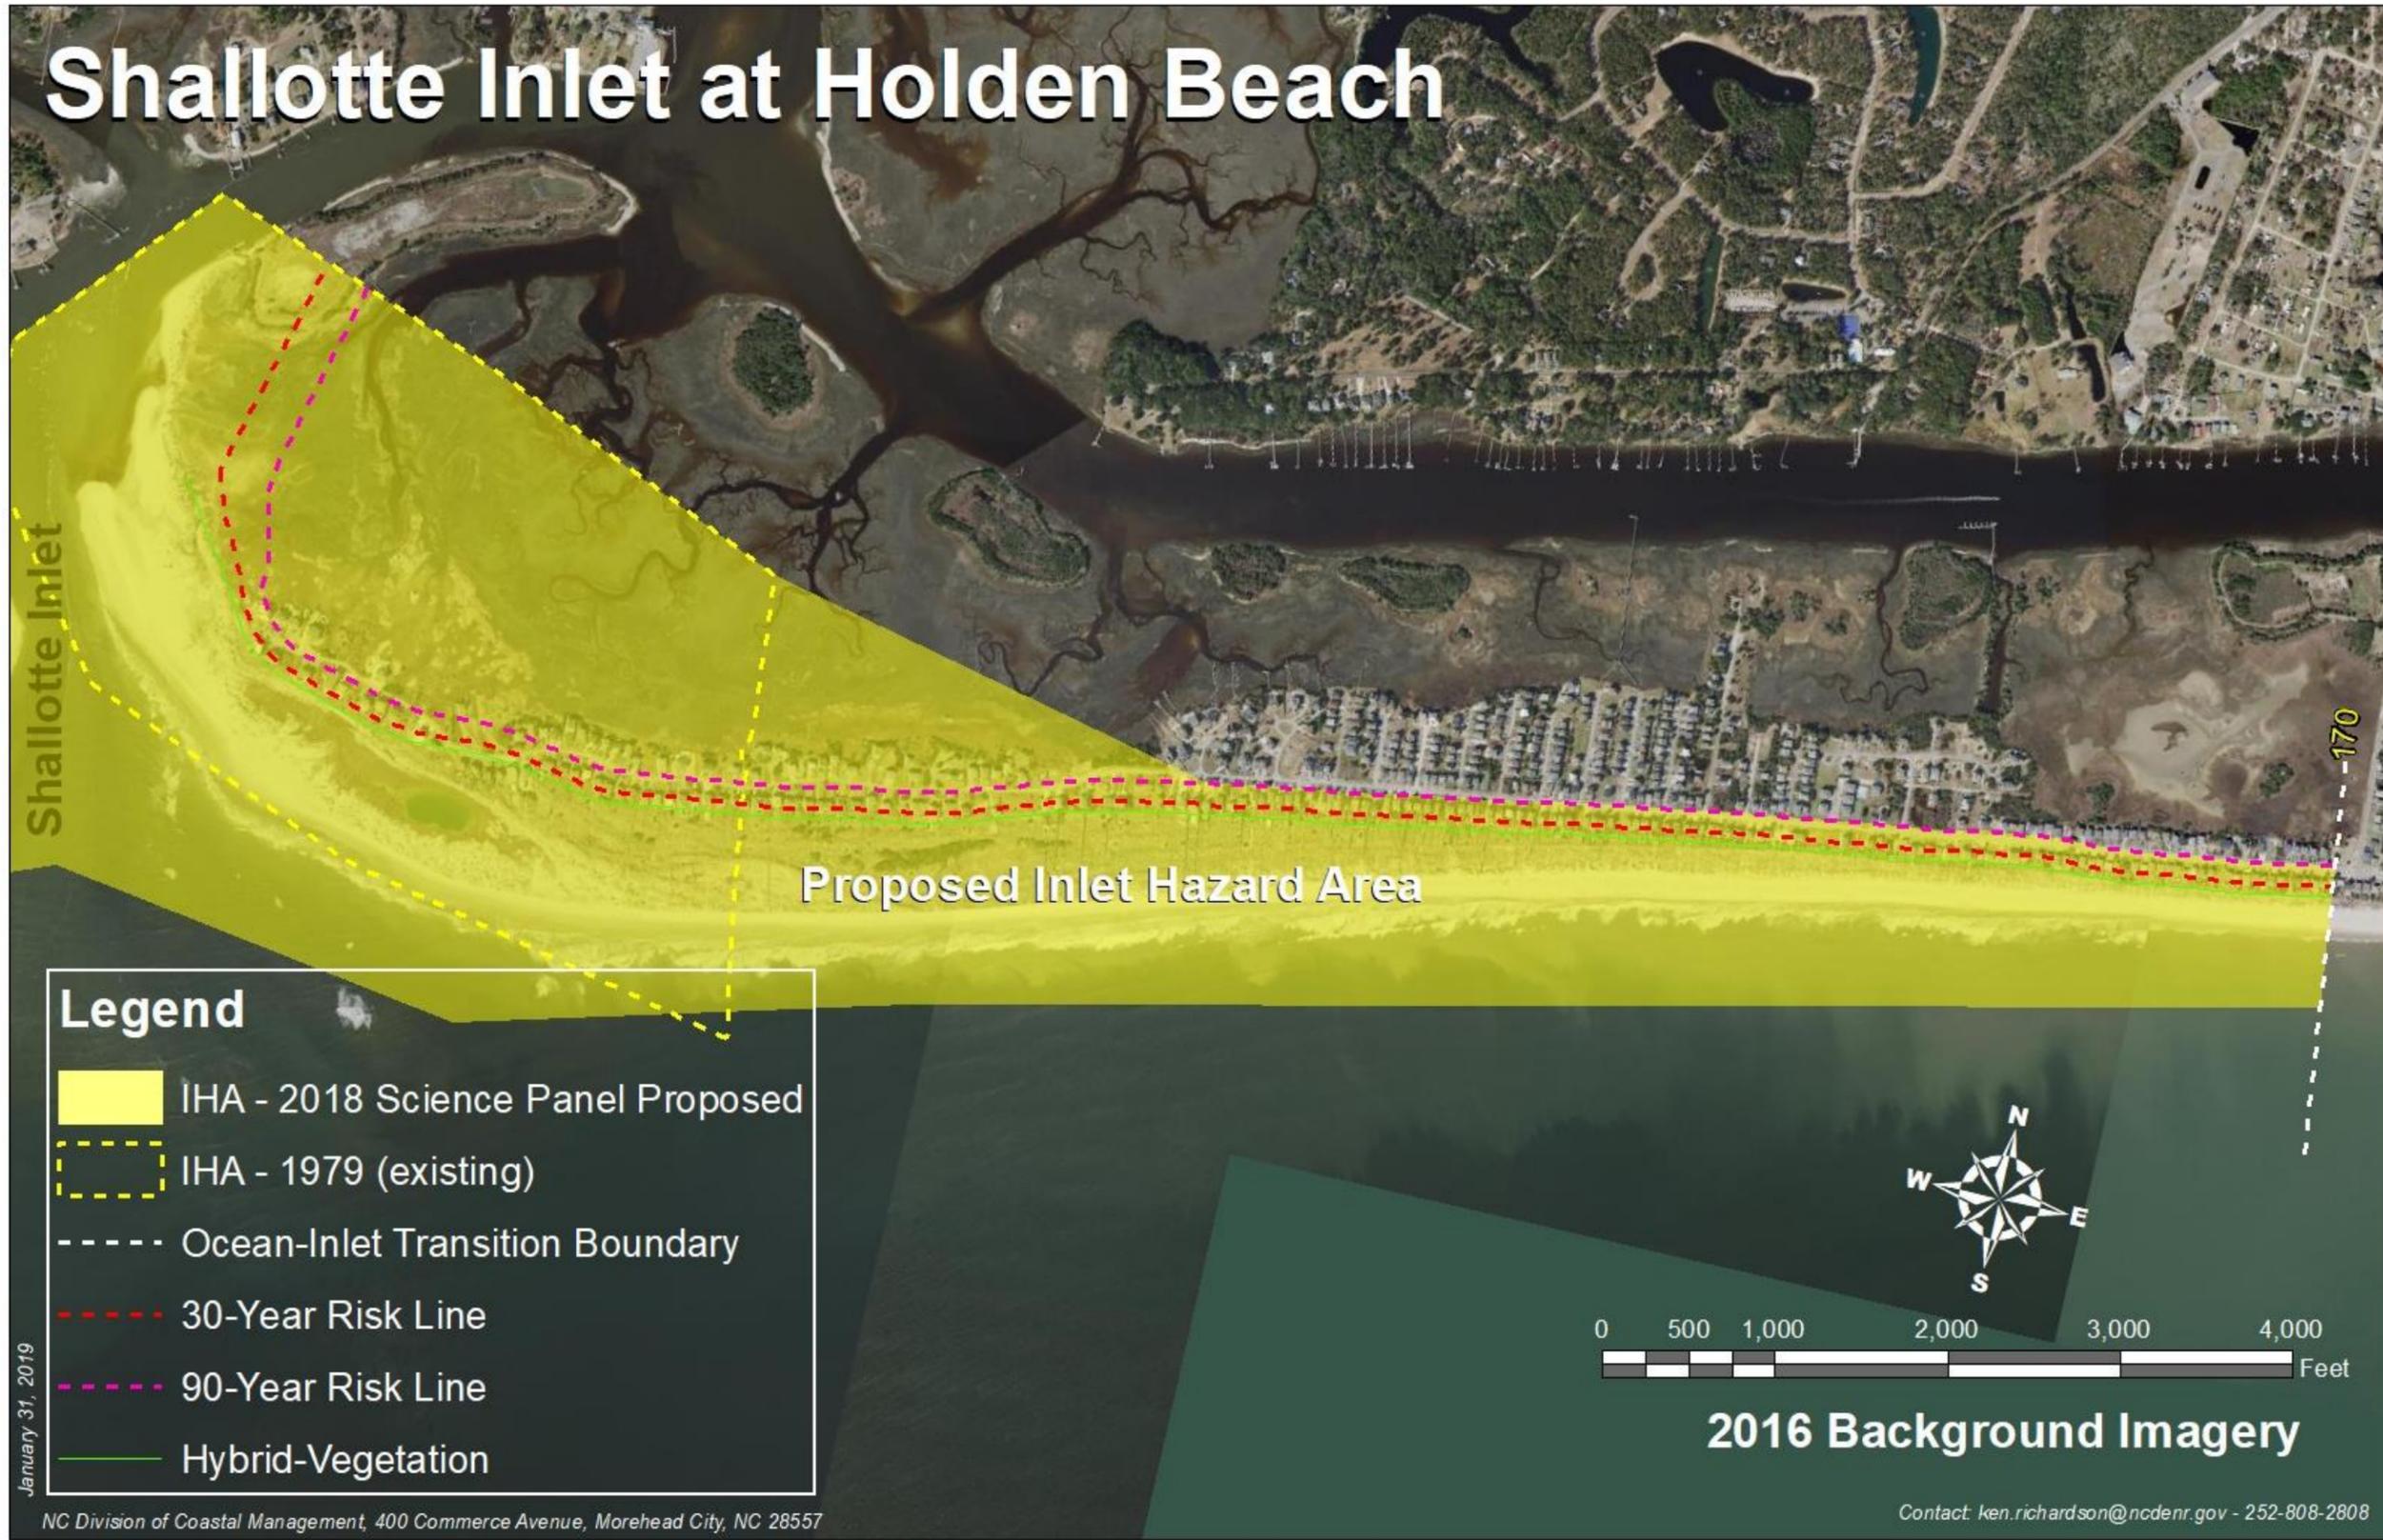
Figure C4. Proposed Inlet Hazard Area at Shallotte Inlet (Holden Beach).
