Inlet Hazard Area Boundary, 2019 Update:

Science Panel Recommendations to the
North Carolina Coastal Resources Commission

February 12, 2019

NC Coastal Resources Commission's Science Panel on Coastal Hazards
& NC Division of Coastal Management

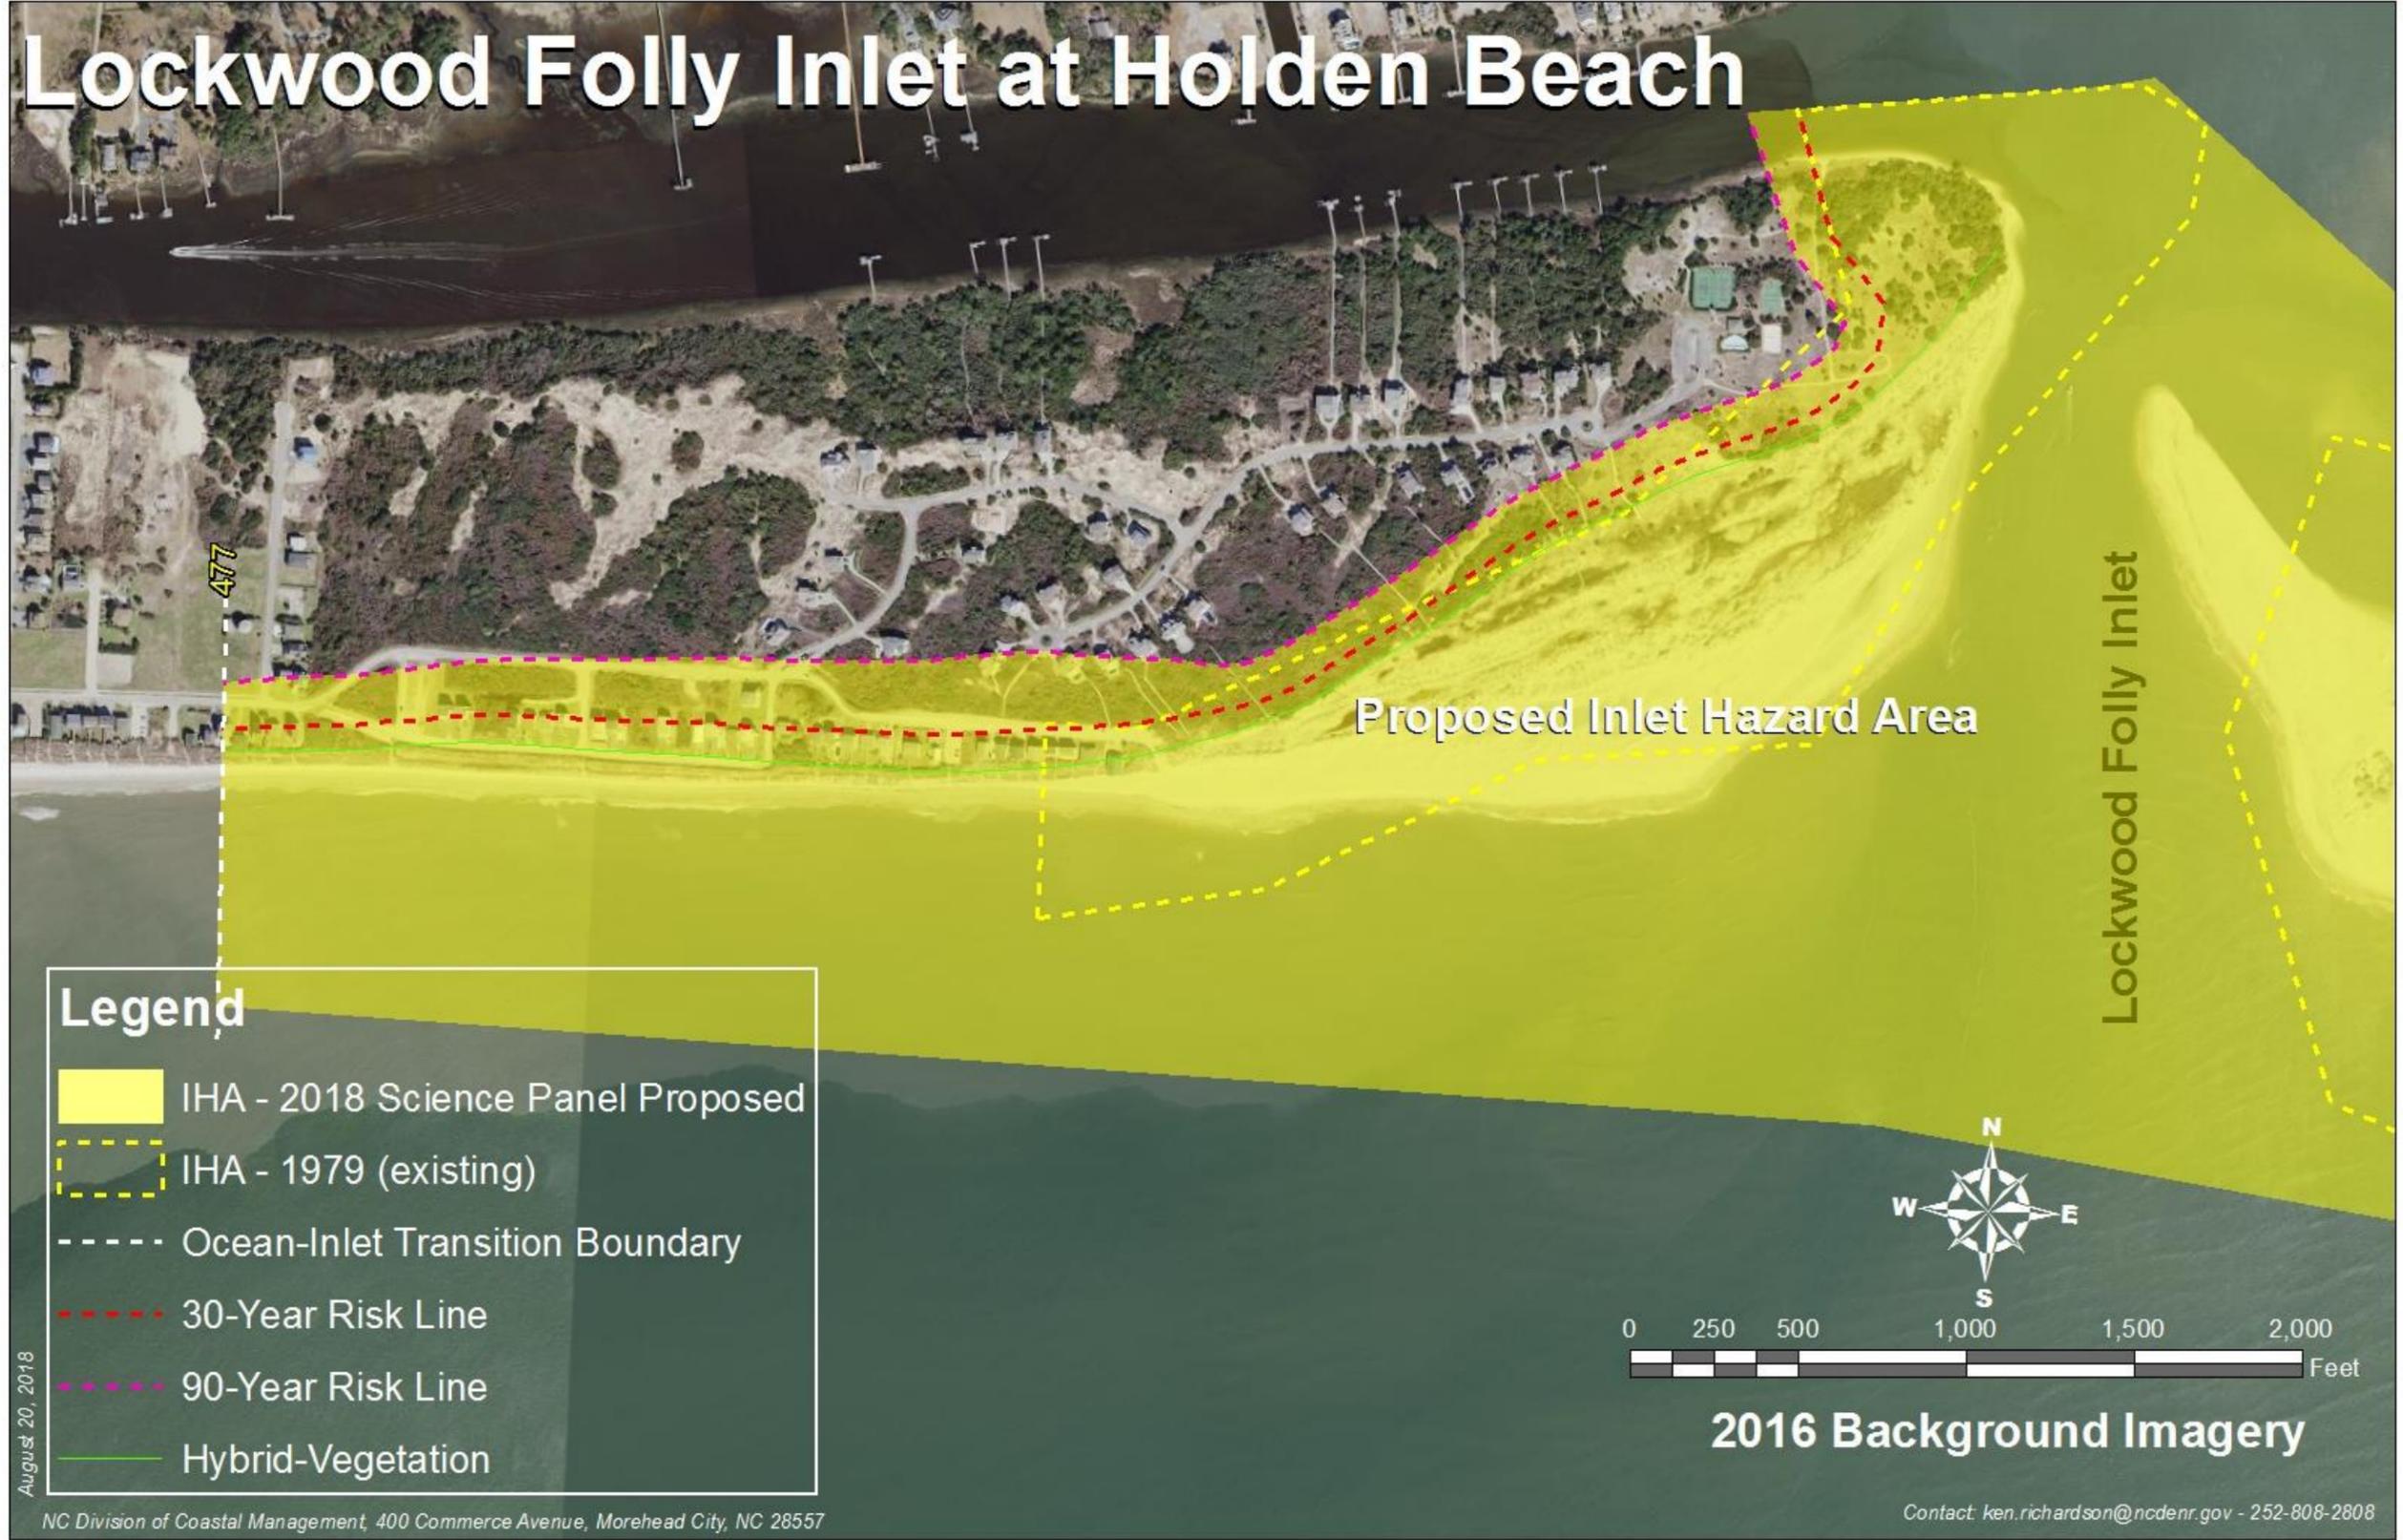
Figure C5. Proposed Inlet Hazard Area at Lockwood Folly Inlet (Holden Beach).

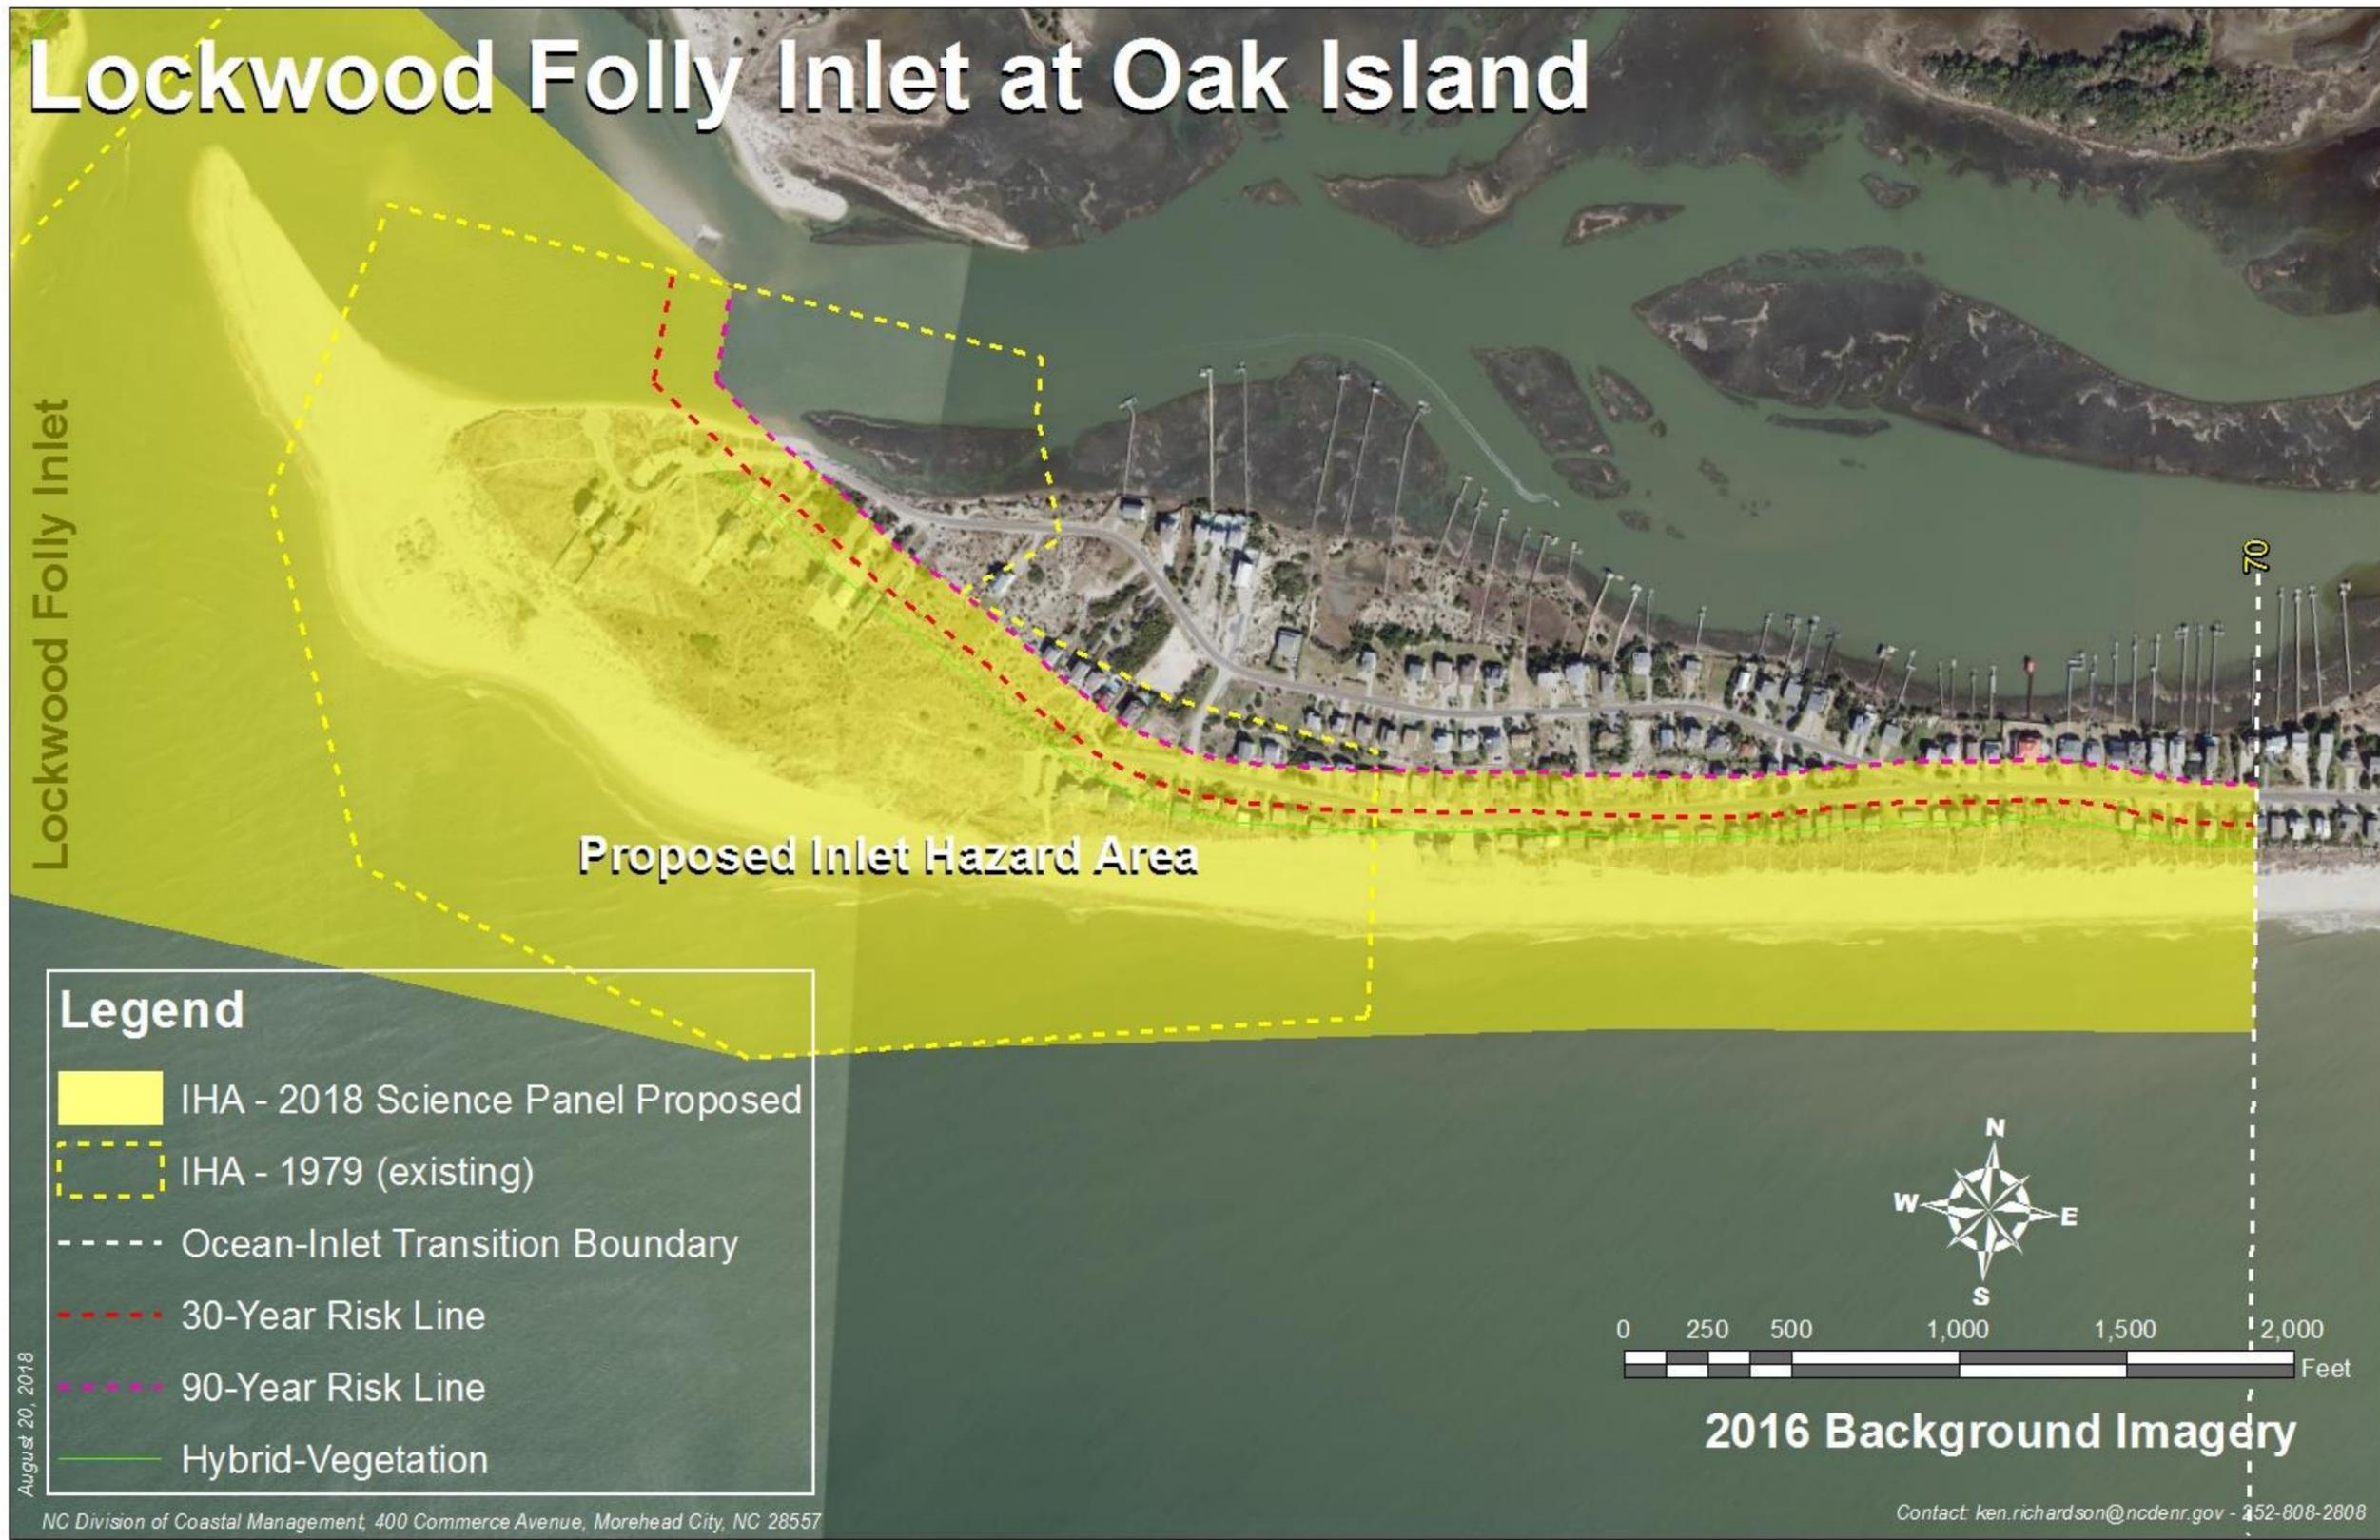
Figure C6. Proposed Inlet Hazard Area at Lockwood Folly Inlet (Oak Island).

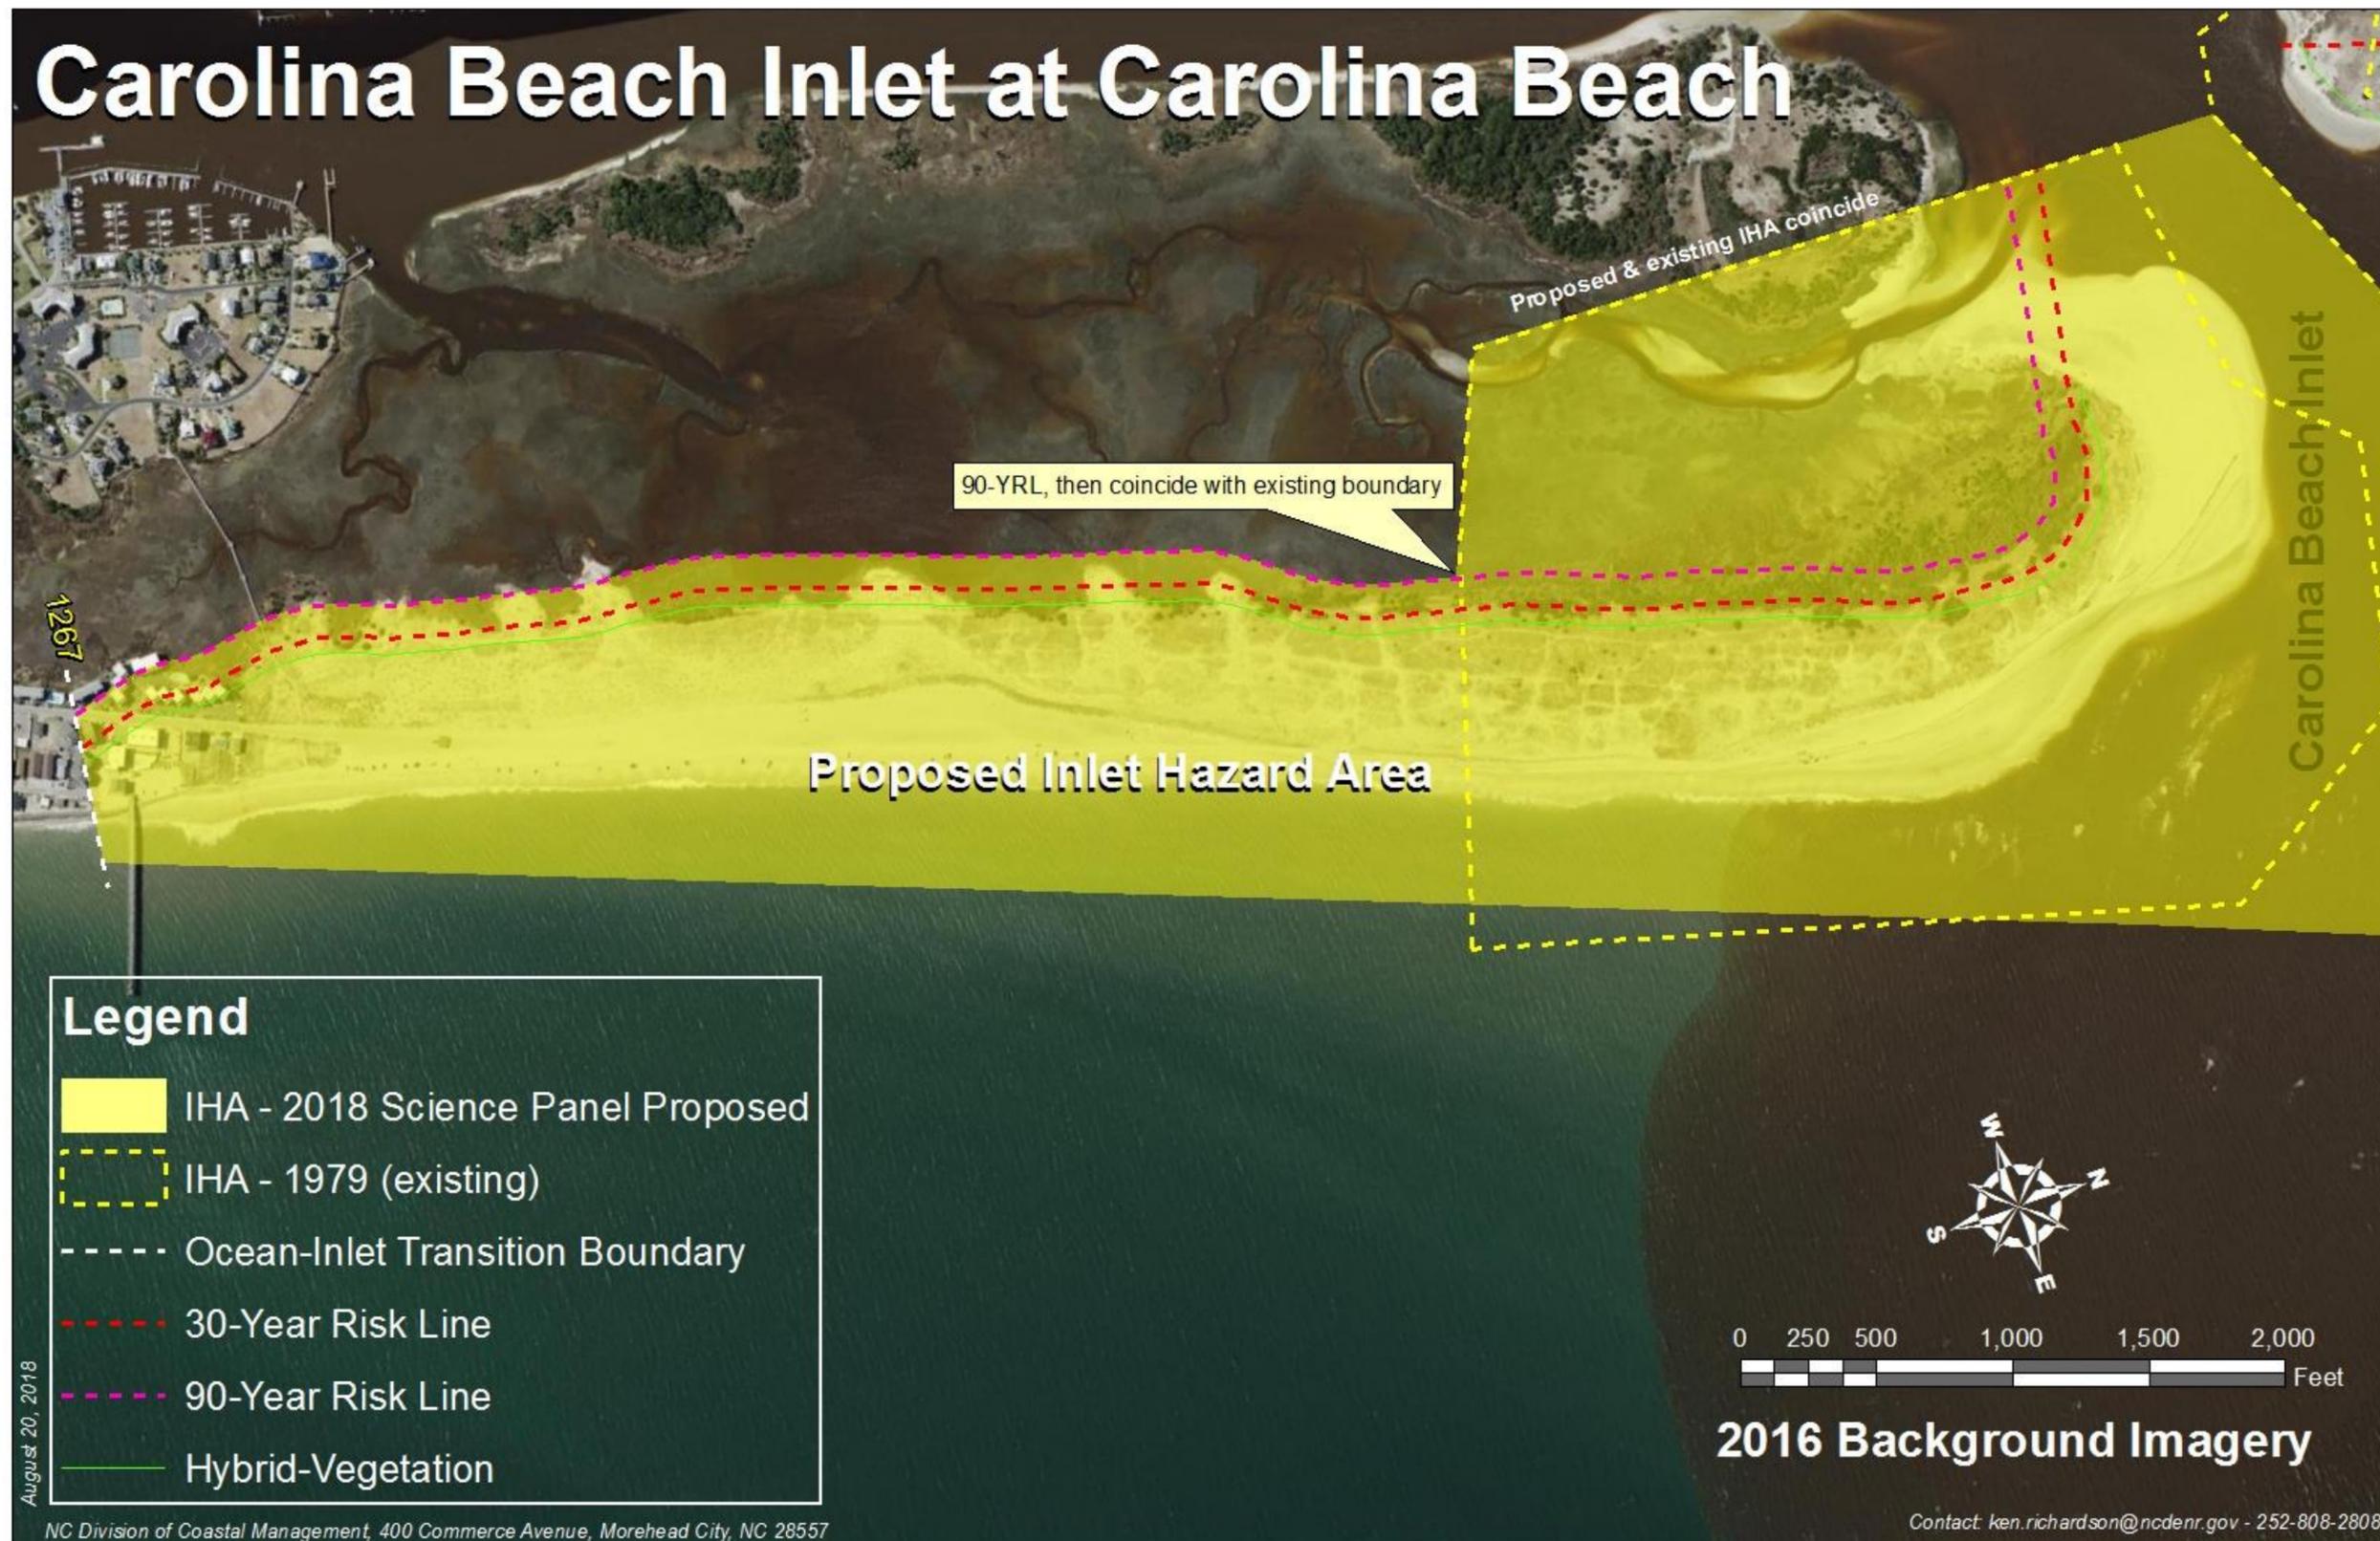
Figure C7. Proposed Inlet Hazard Area at Carolina Beach Inlet (Carolina Beach).

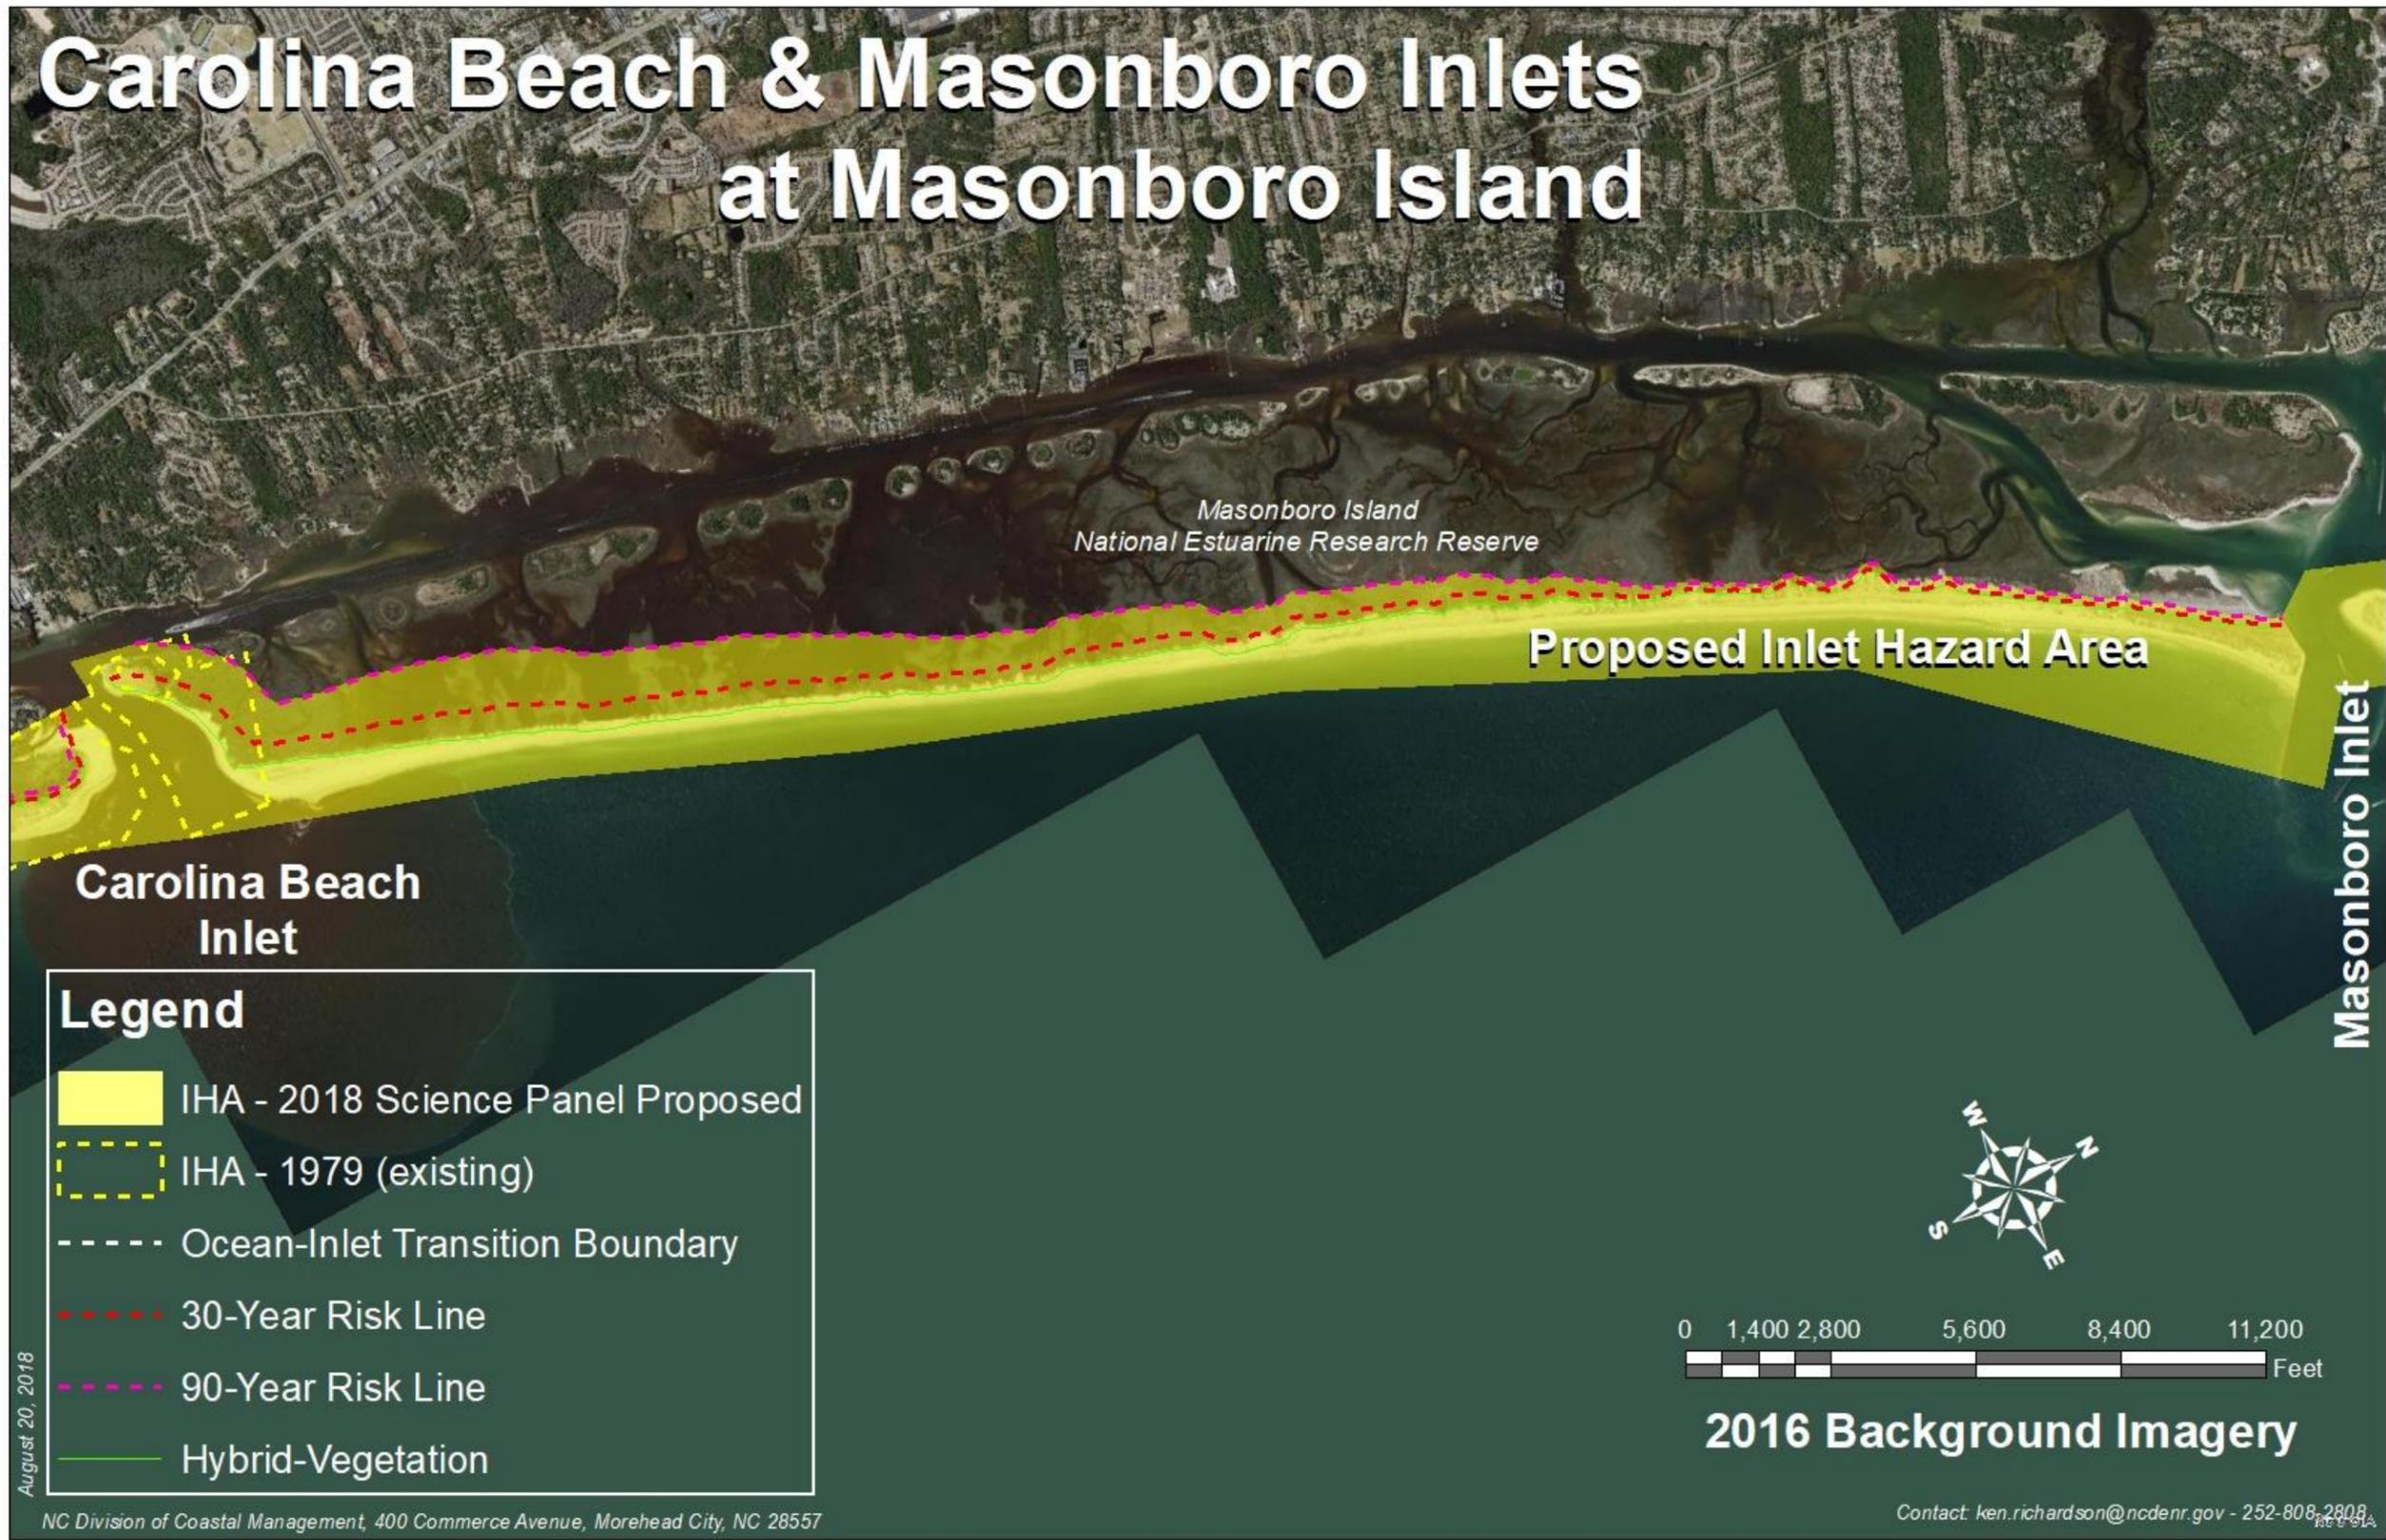
Figure C8. Proposed Inlet Hazard Area for Masonboro Island.

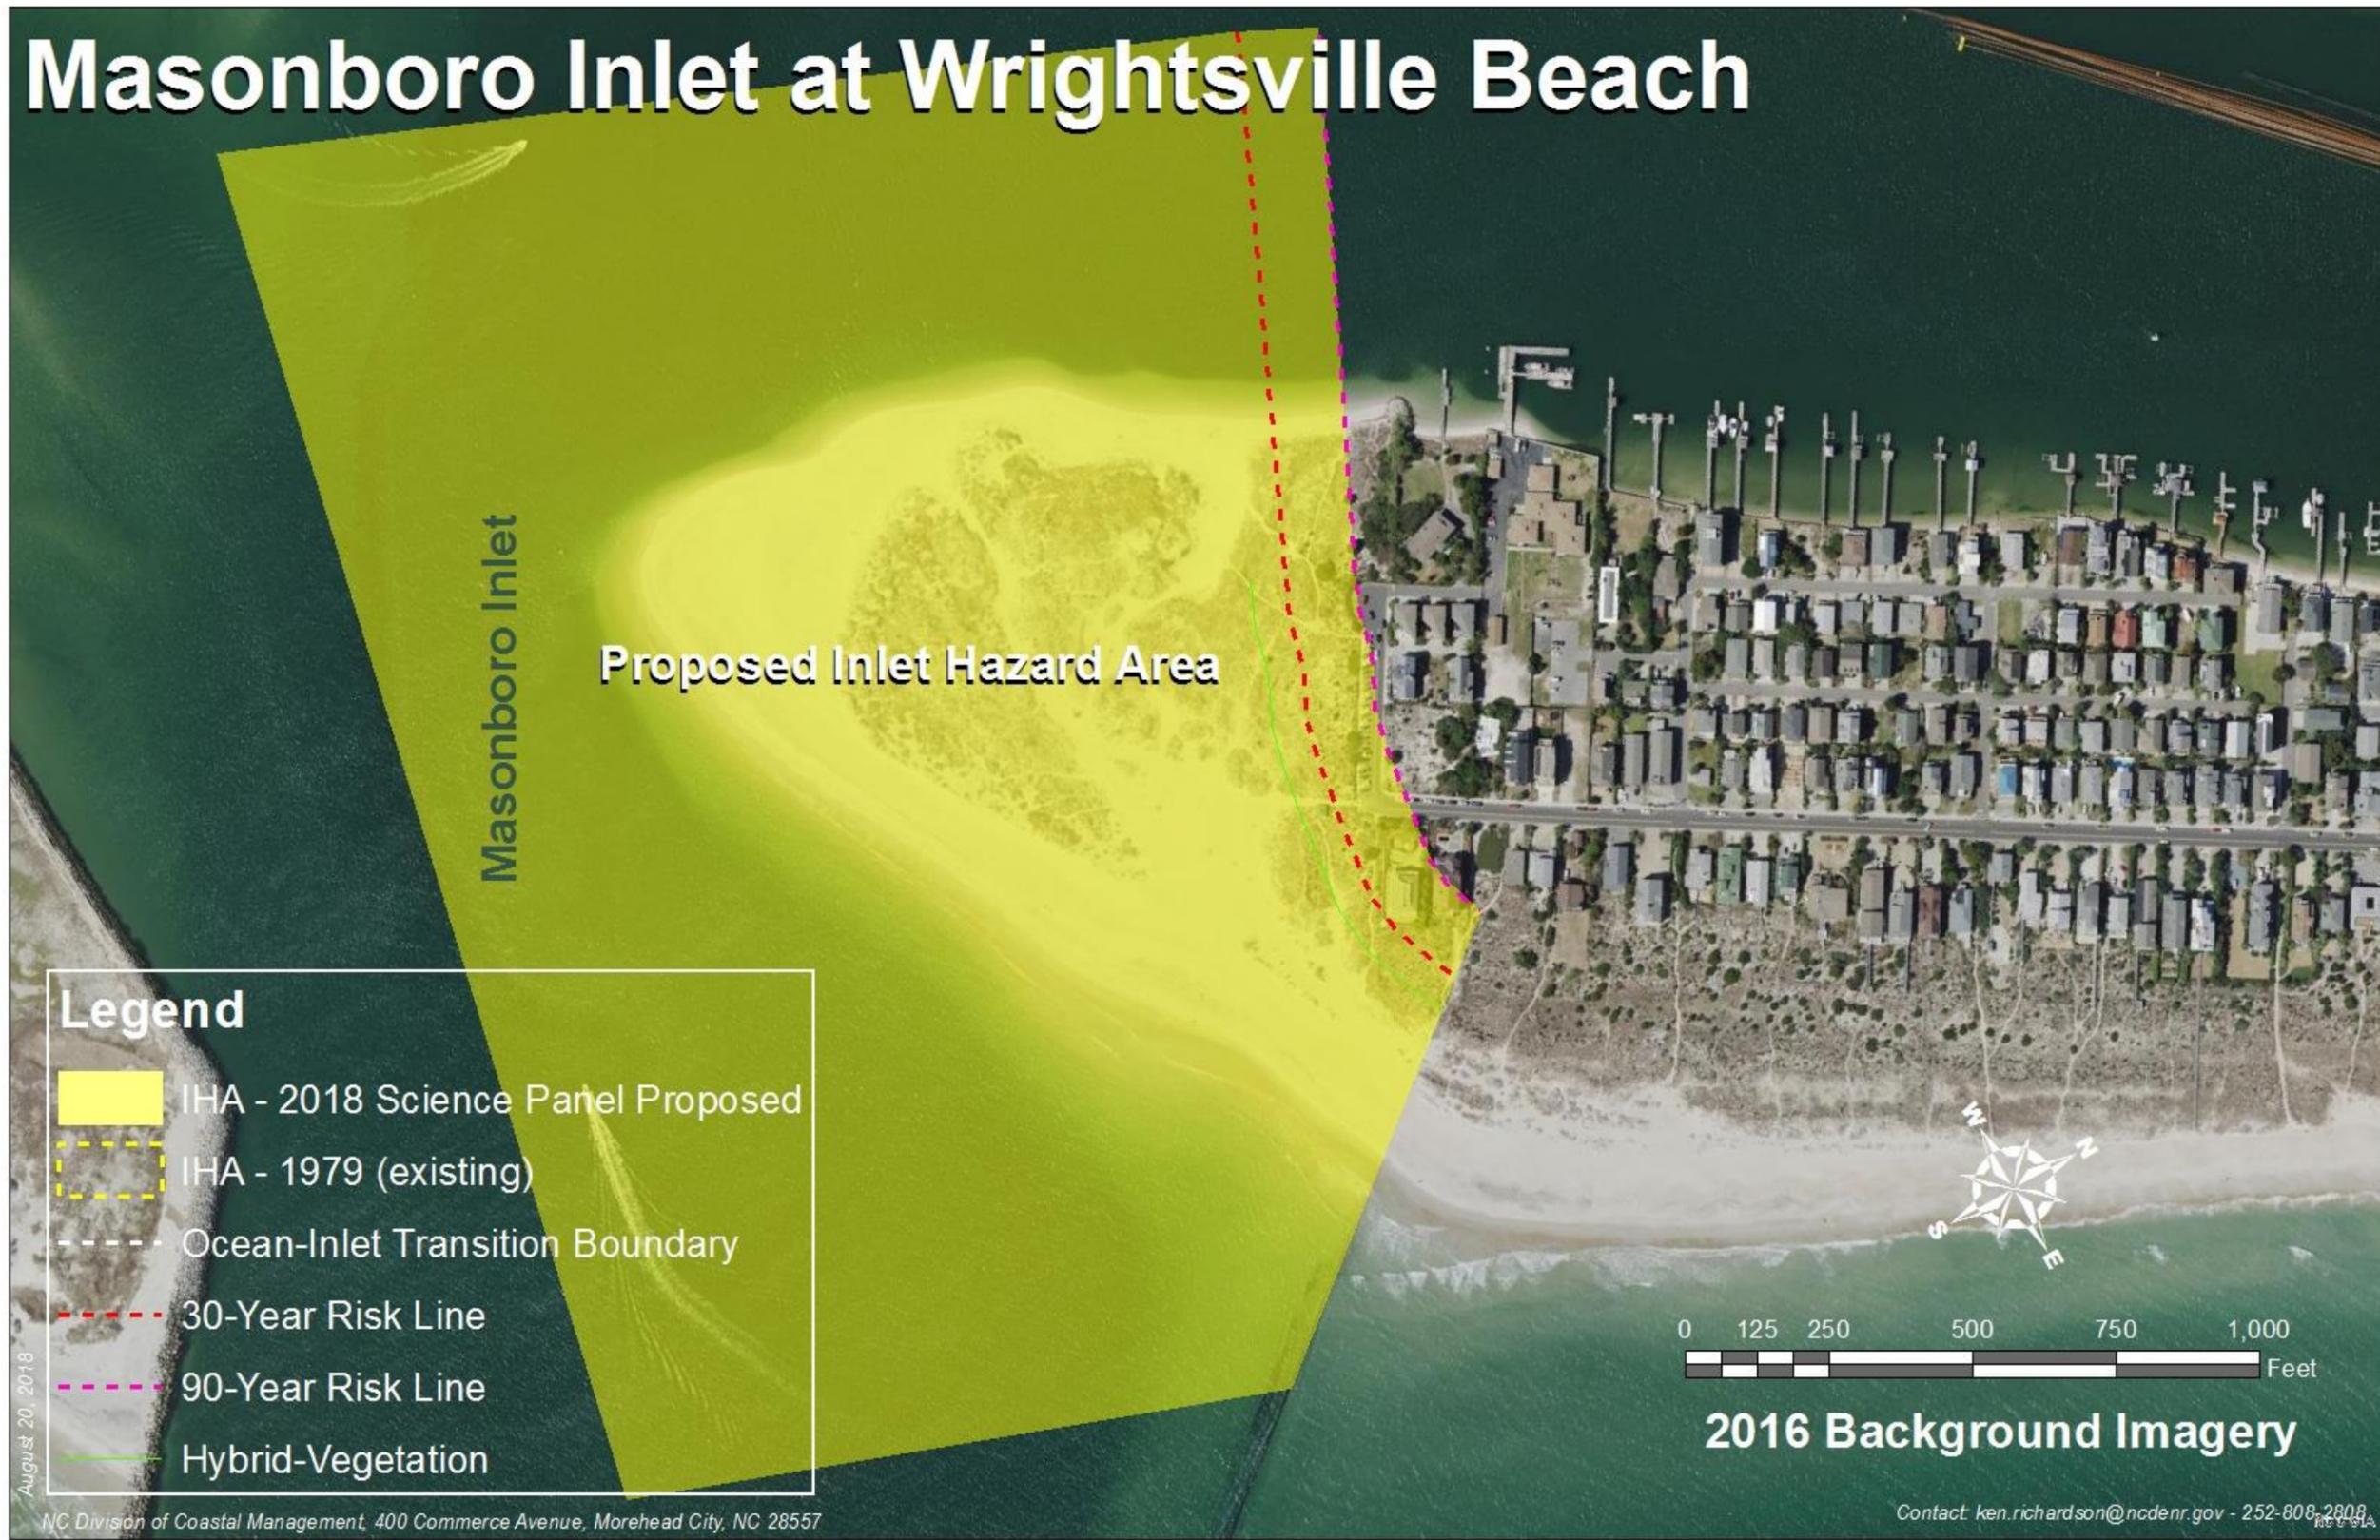
Figure C9. Proposed Inlet Hazard Area at Masonboro Inlet (Wrightsville Beach).

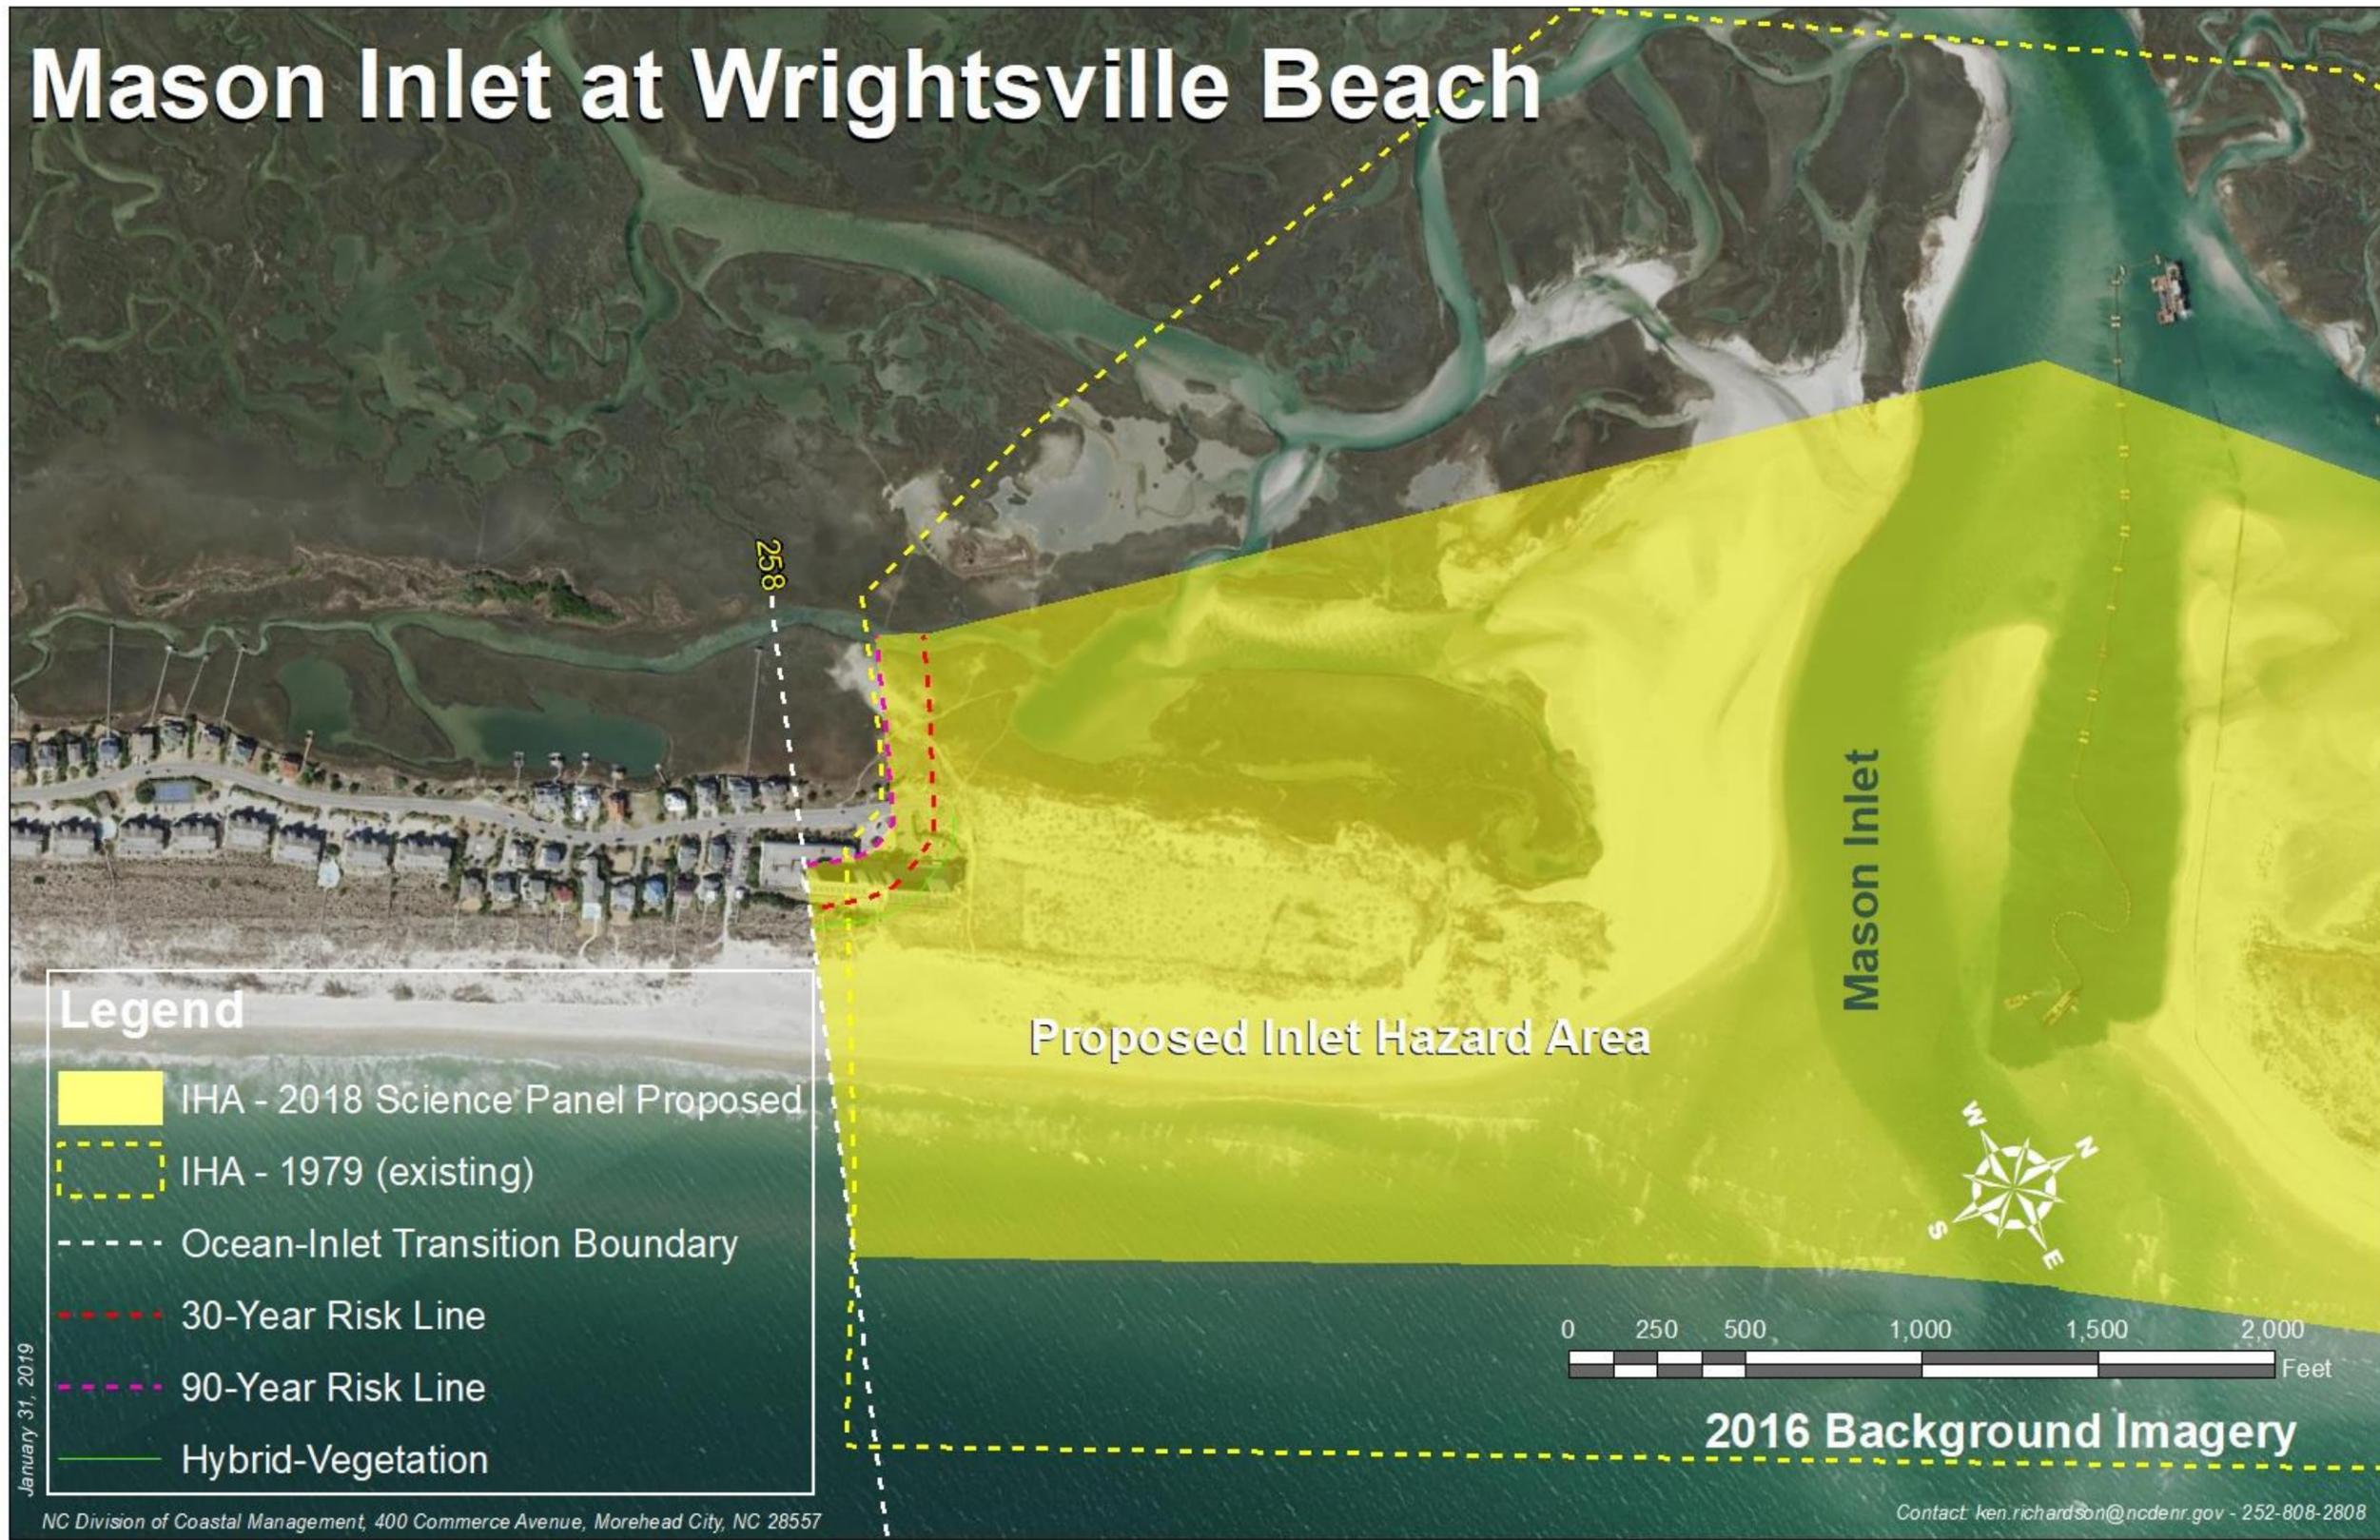
Figure C10. Proposed Inlet Hazard Area at Mason Inlet (Wrightsville Beach).
