Inlet Hazard Area Boundary, 2019 Update:

Science Panel Recommendations to the
North Carolina Coastal Resources Commission

February 12, 2019

NC Coastal Resources Commission's Science Panel on Coastal Hazards
& NC Division of Coastal Management

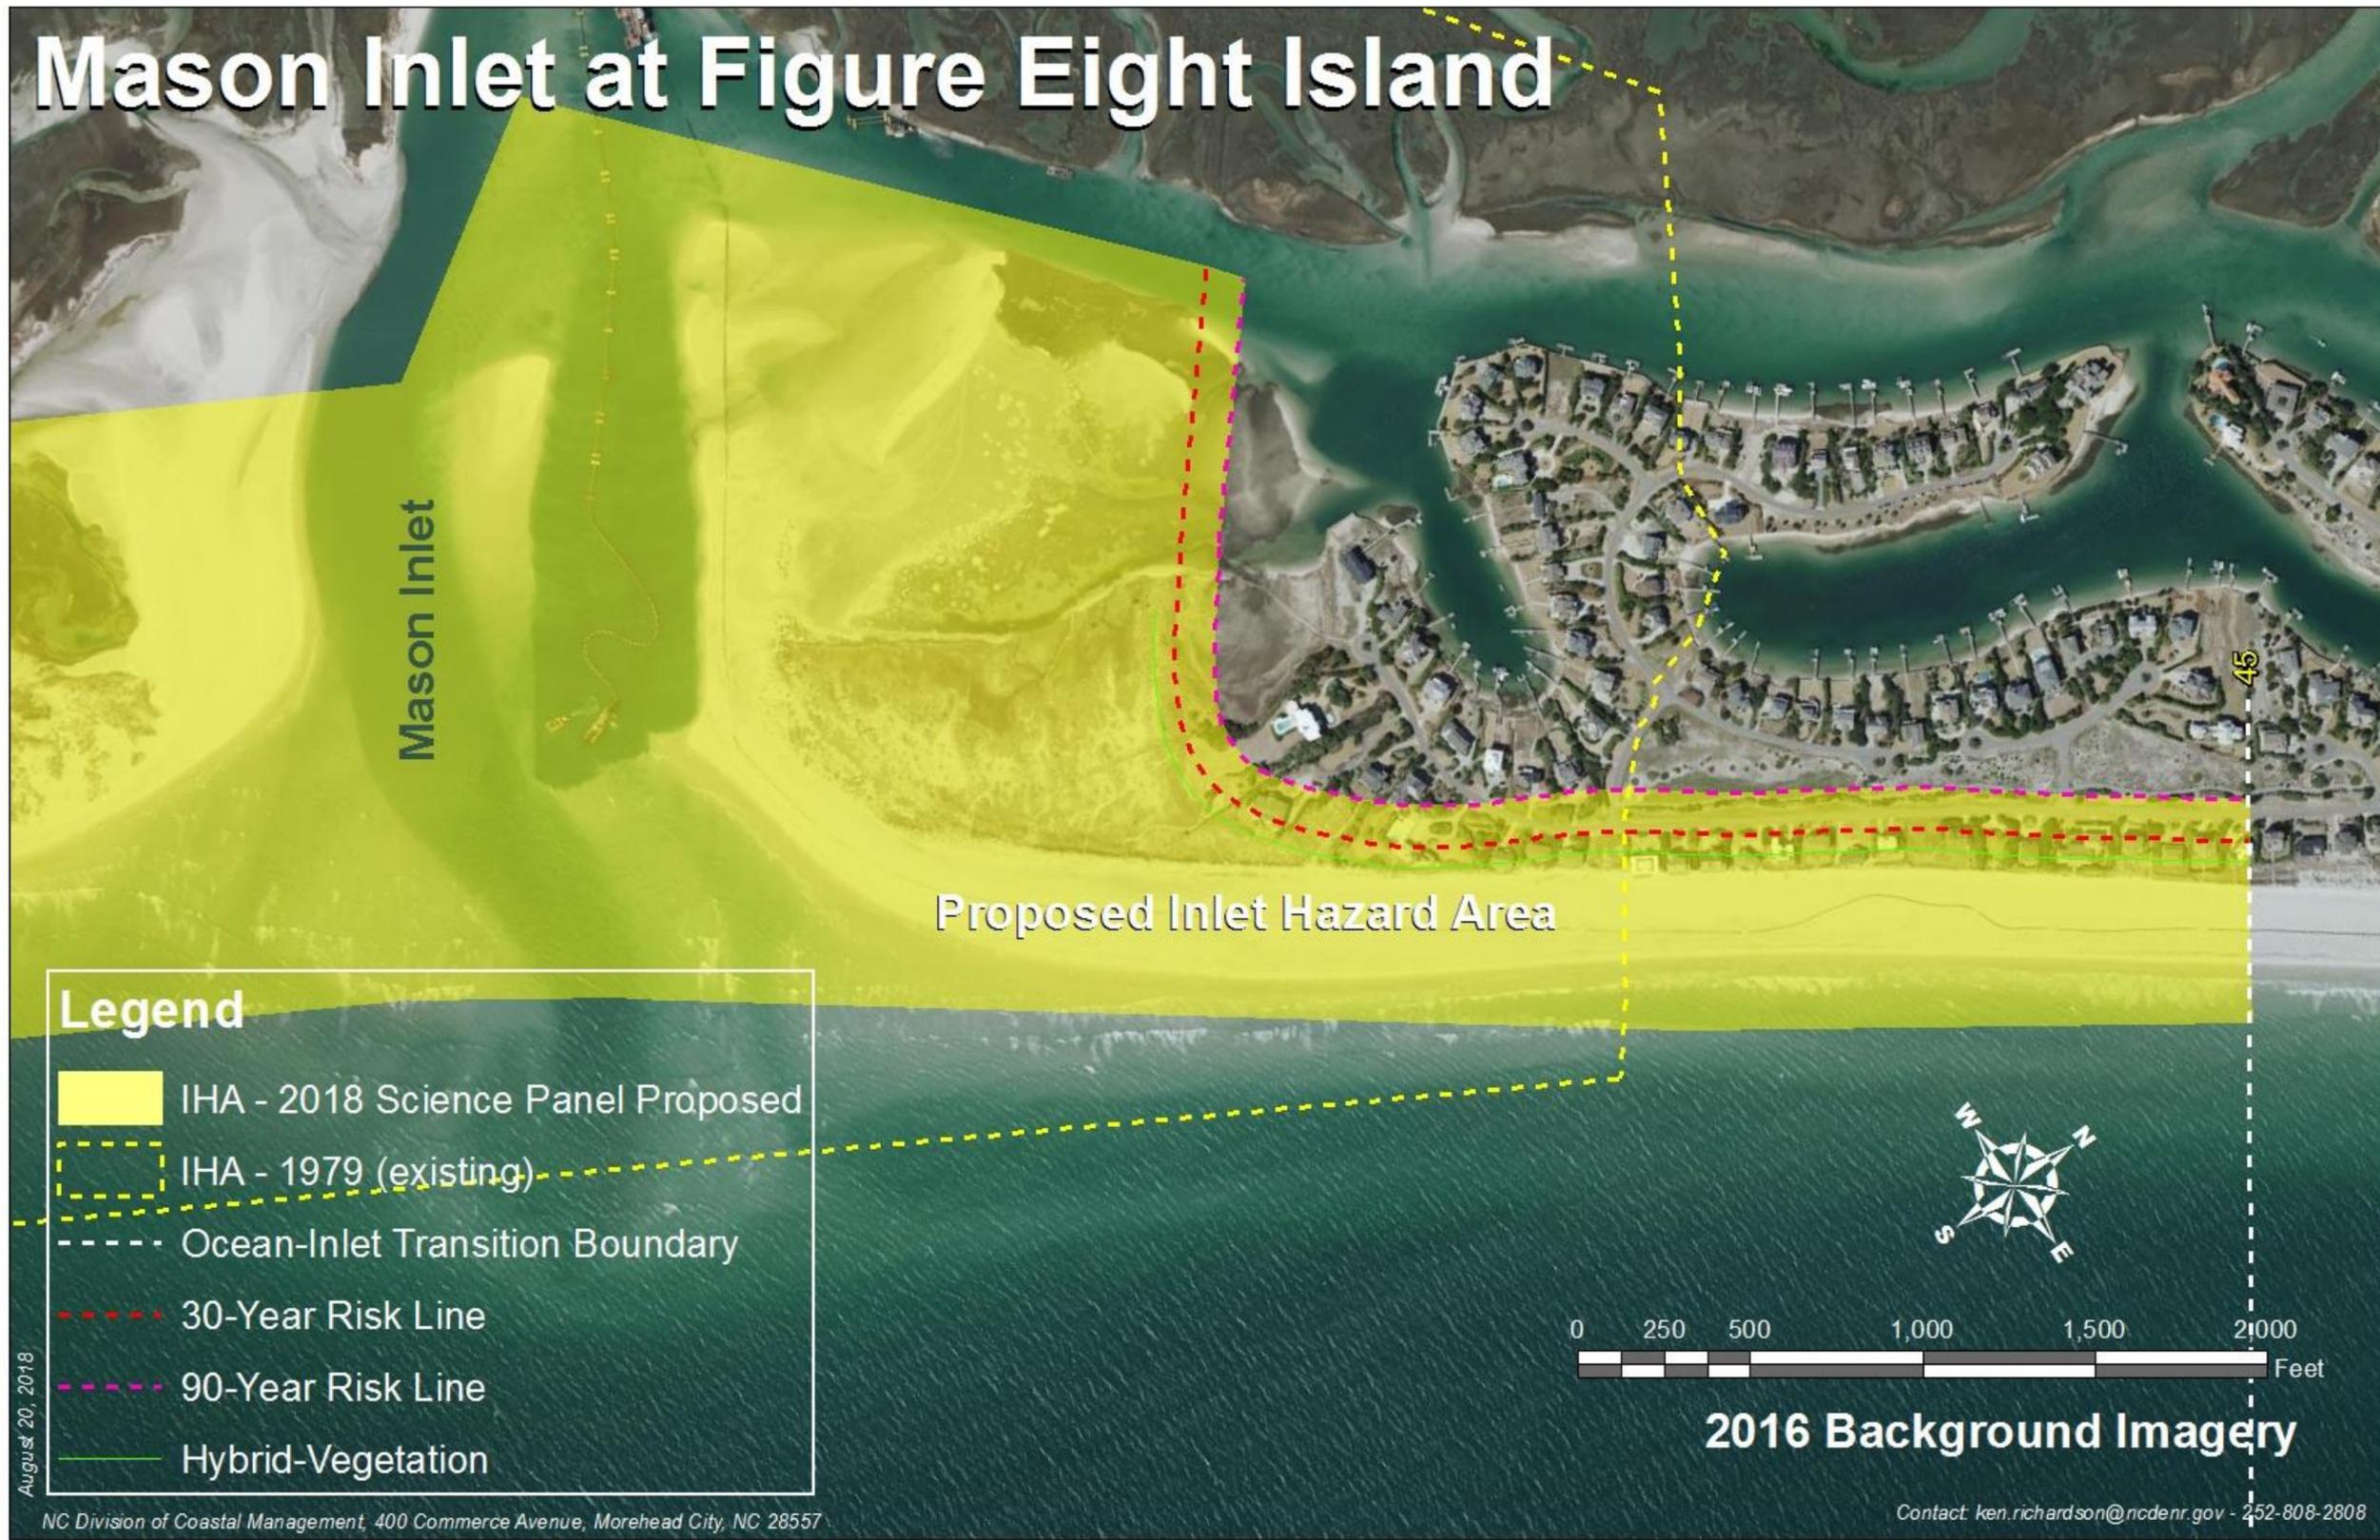
Figure C11. Proposed Inlet Hazard Area at Mason Inlet (Figure Eight Island).

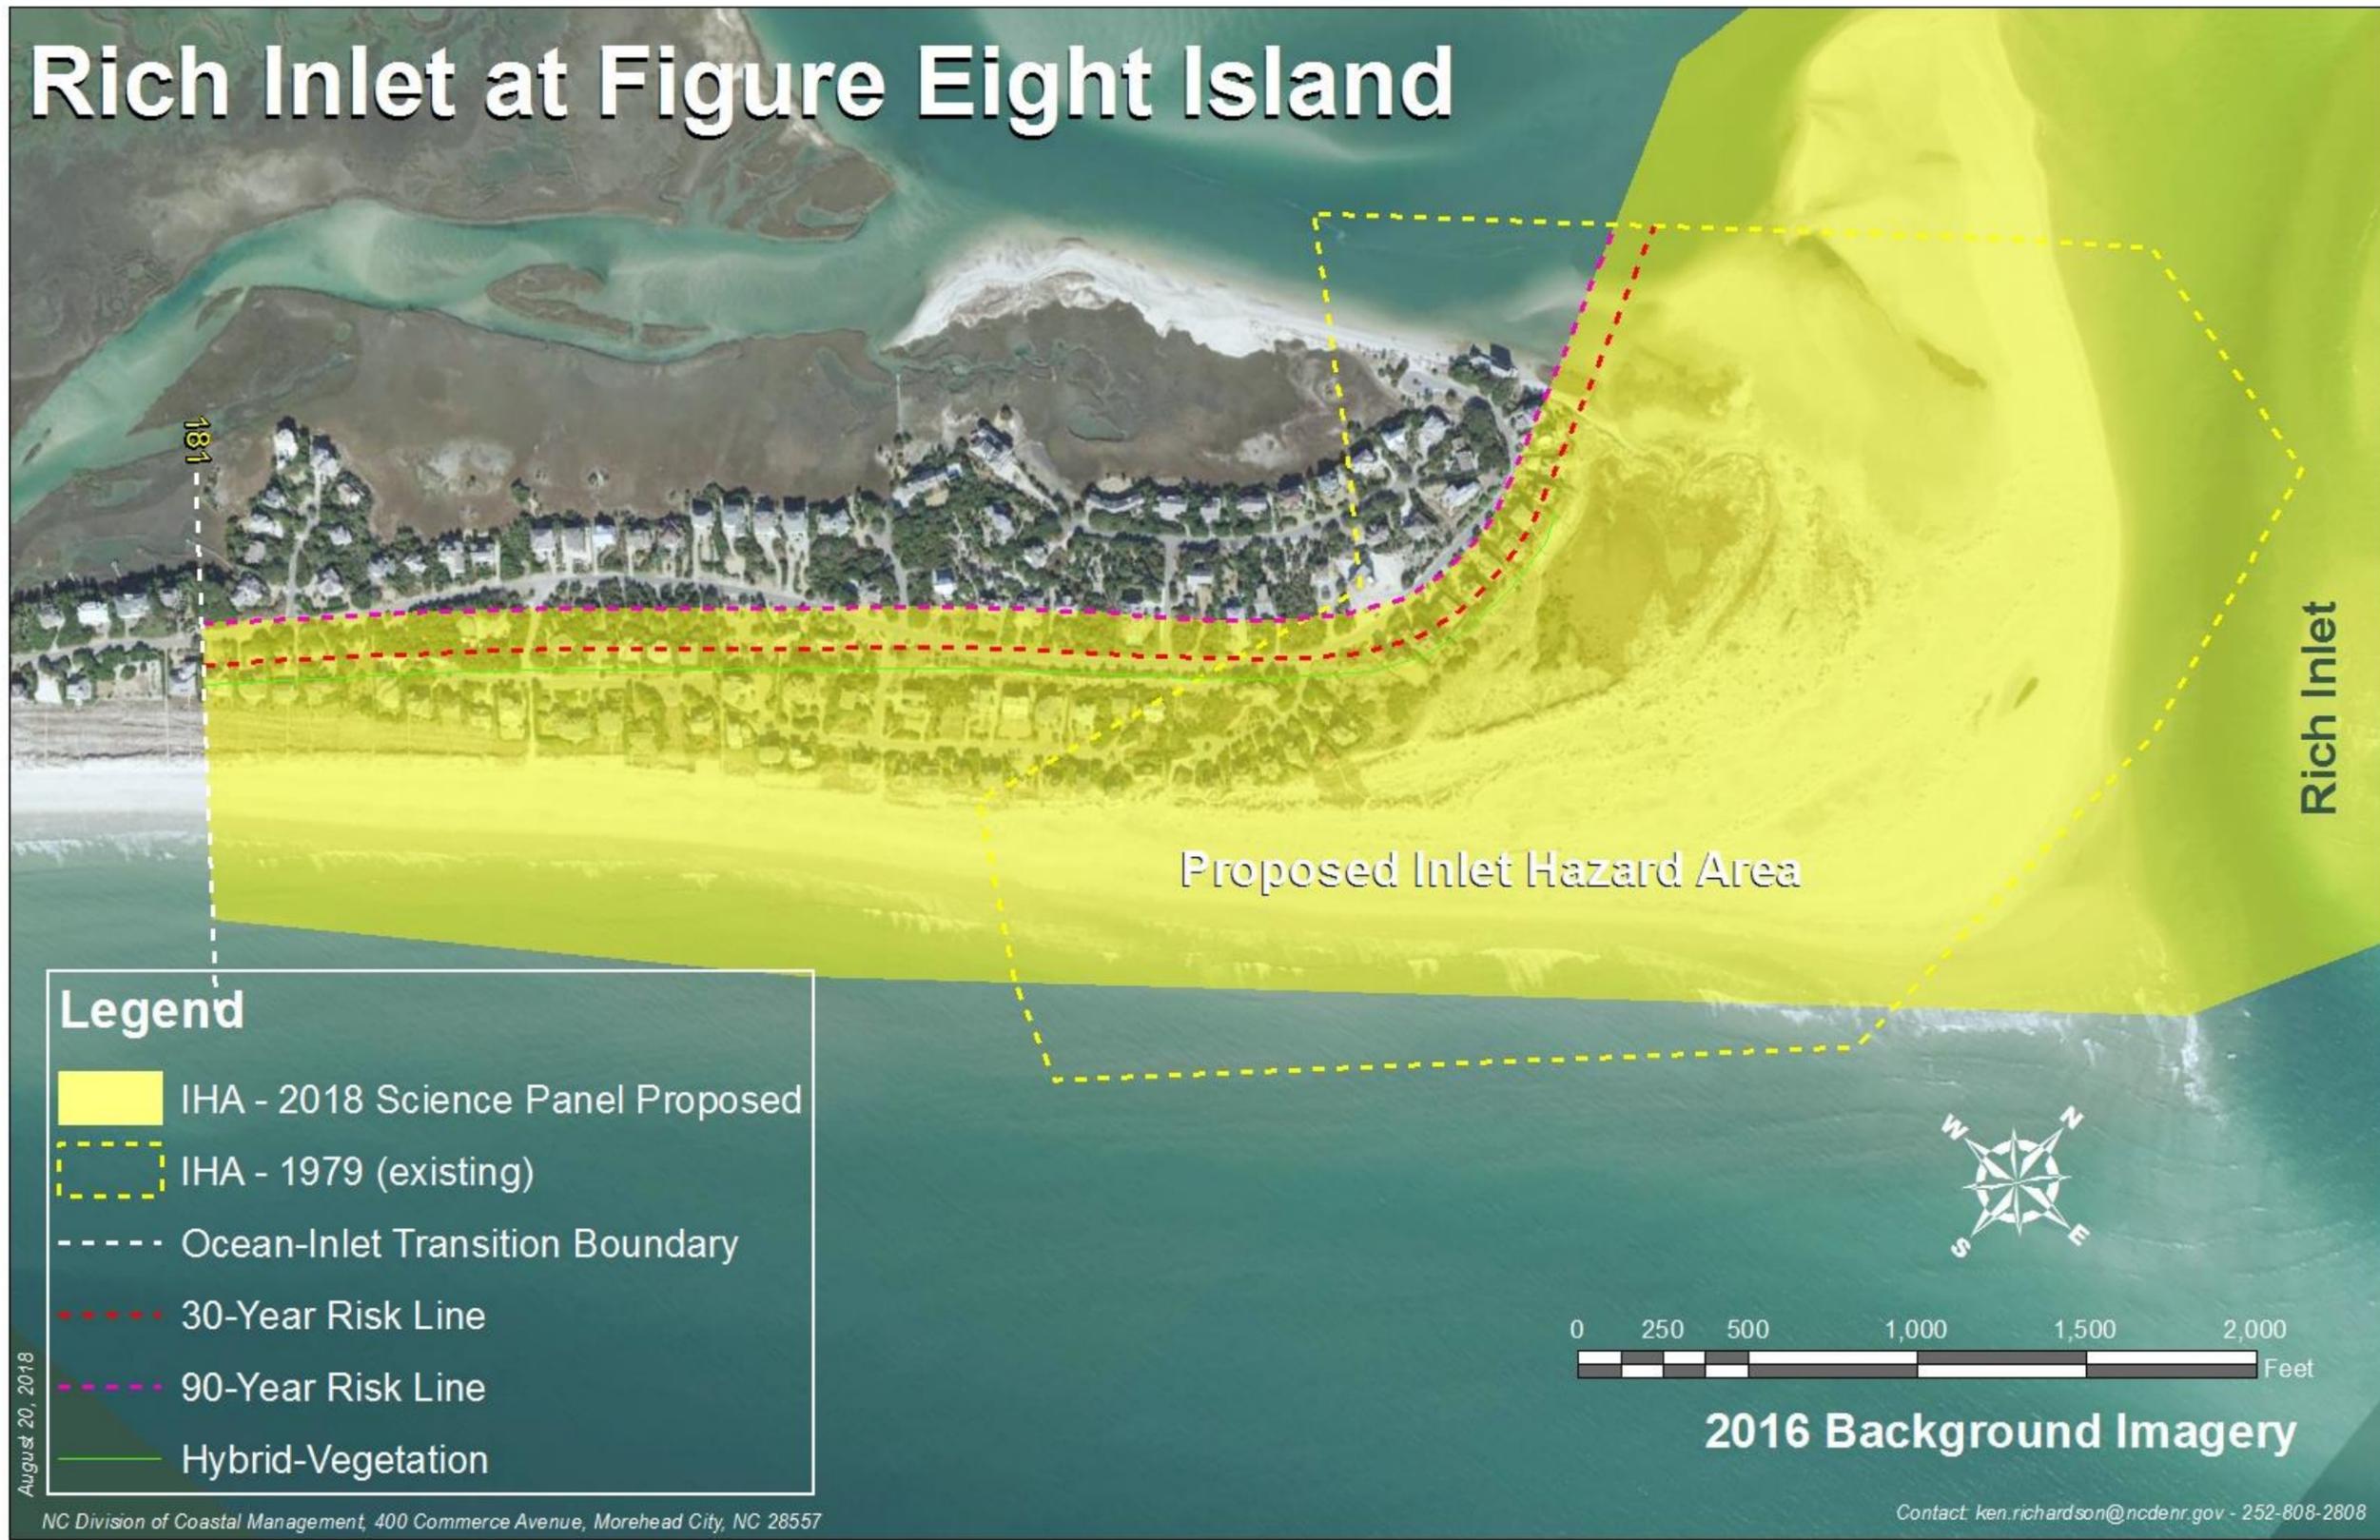
Figure C12. Proposed Inlet Hazard Area at Rich Inlet (Figure Eight Island).

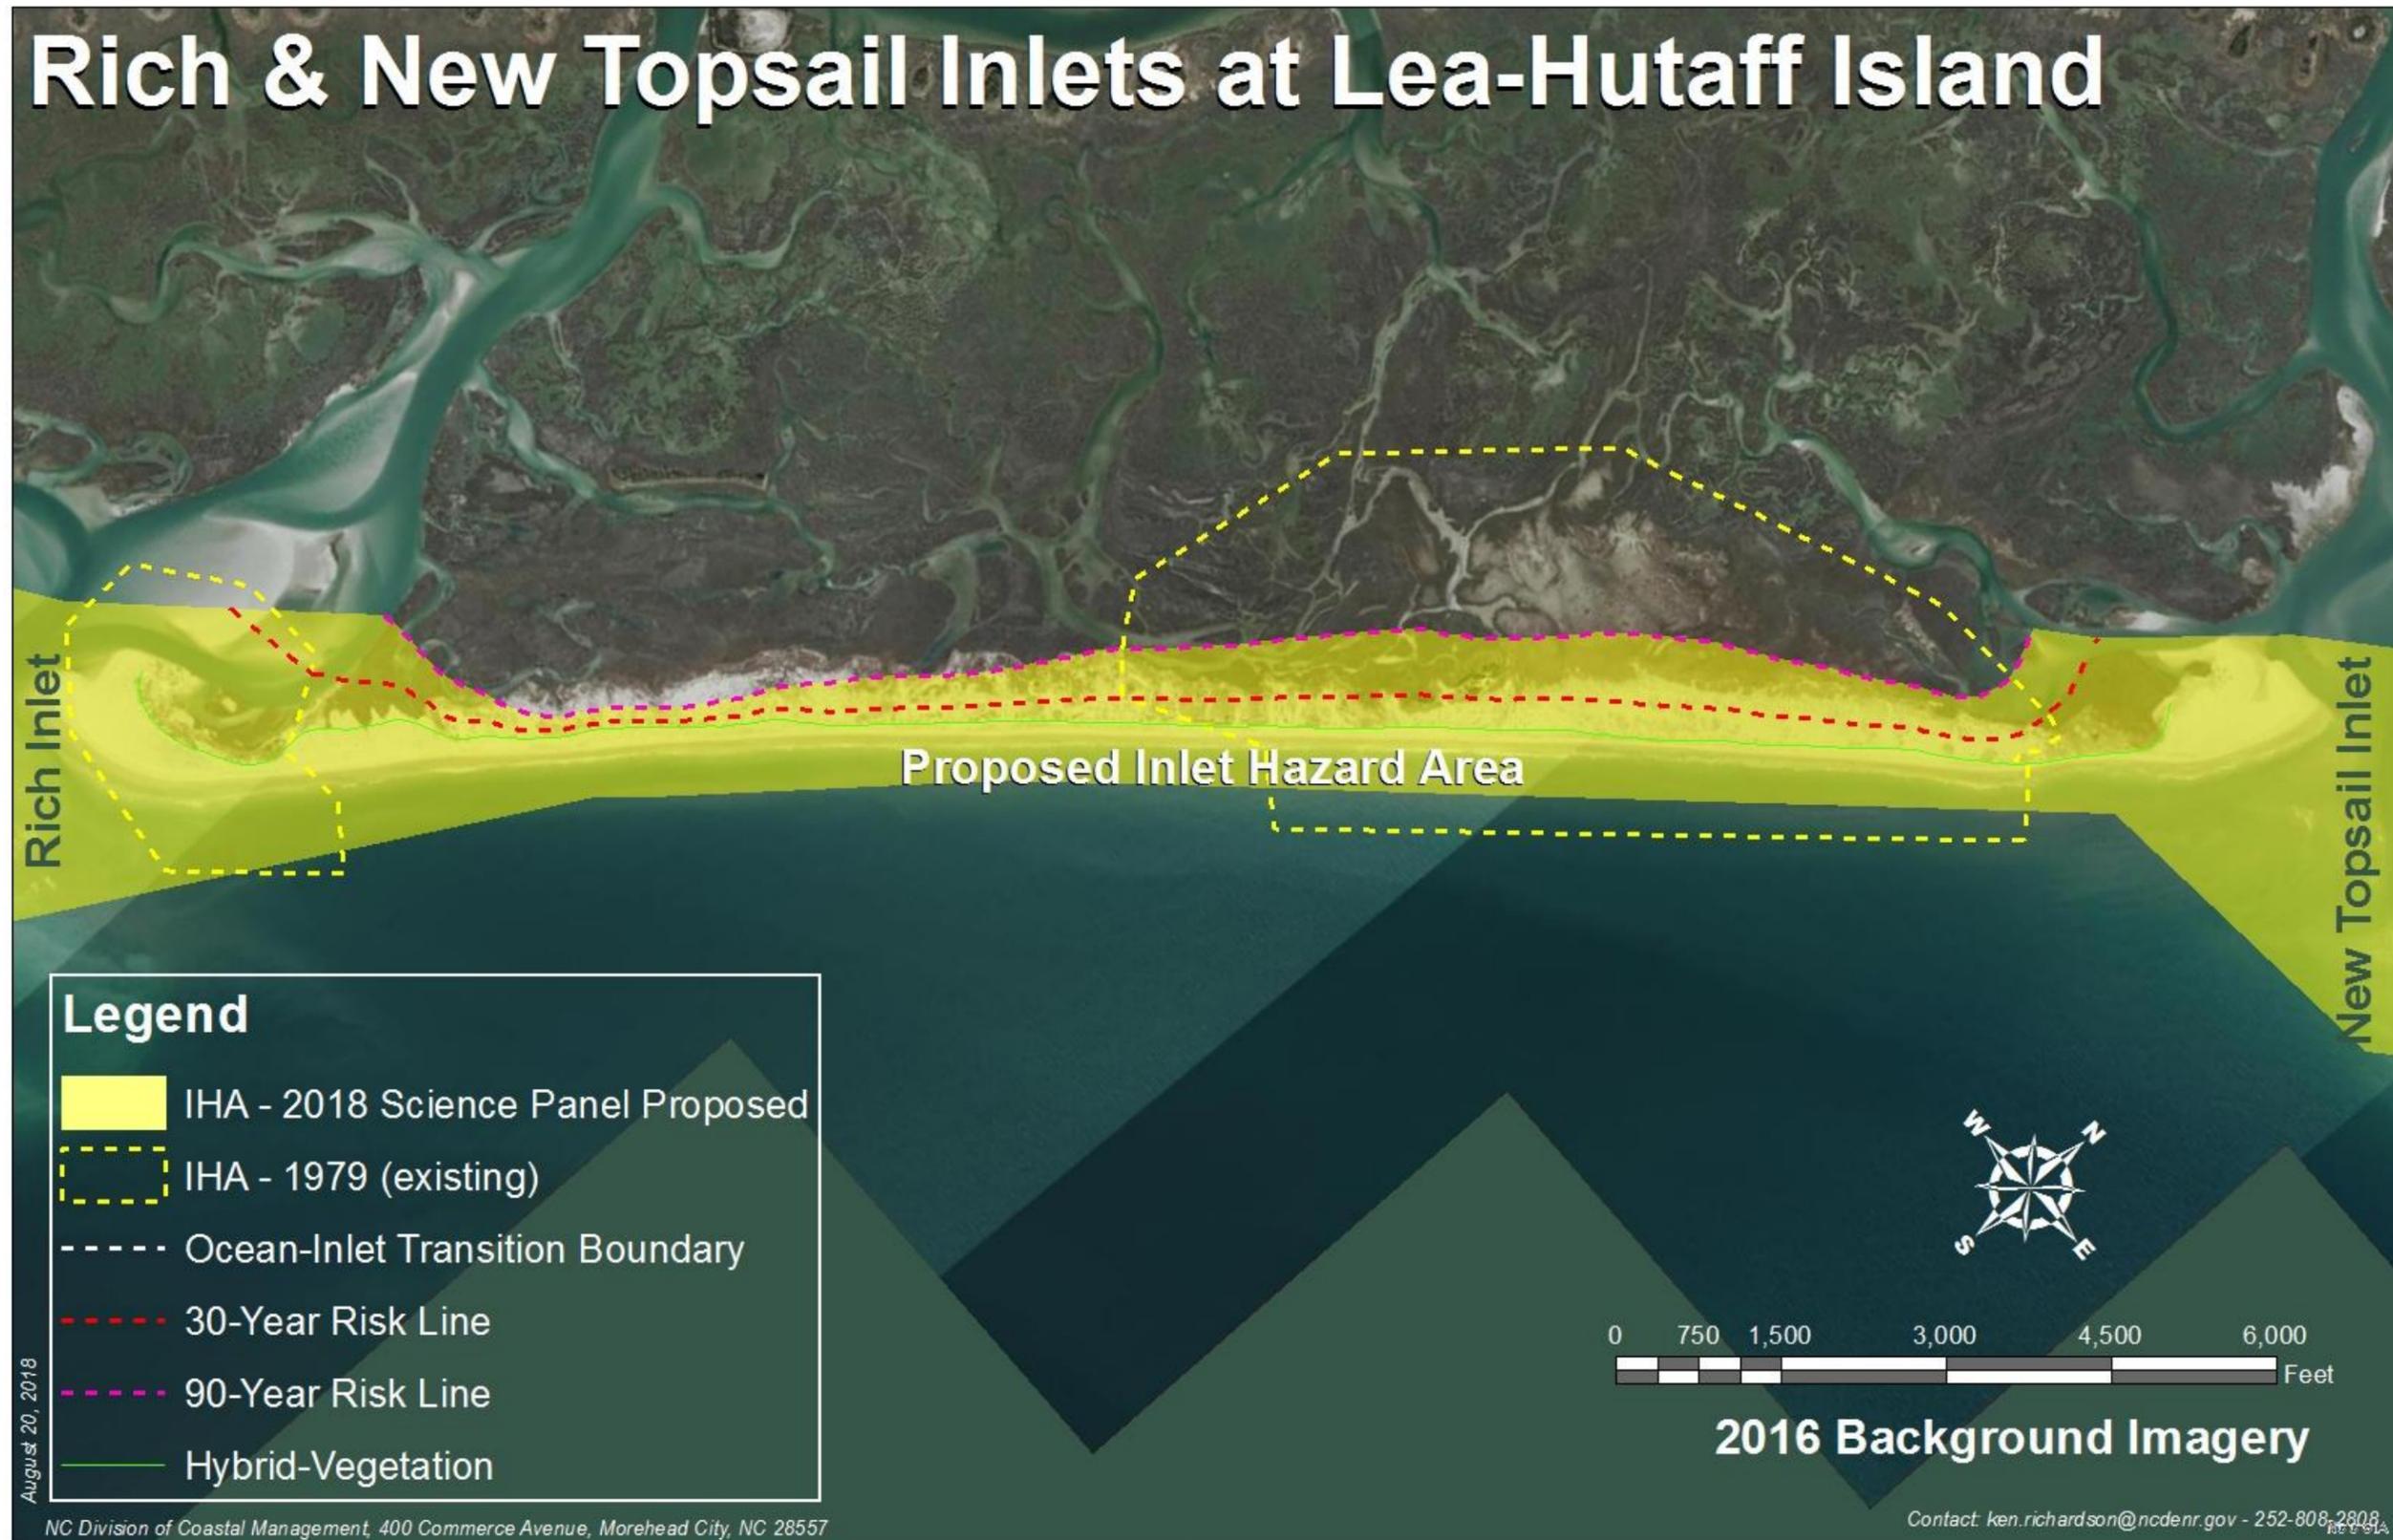
Figure C13. Proposed Inlet Hazard Area at Rich & New Topsail Inlets (Lea-Hutaff Island).

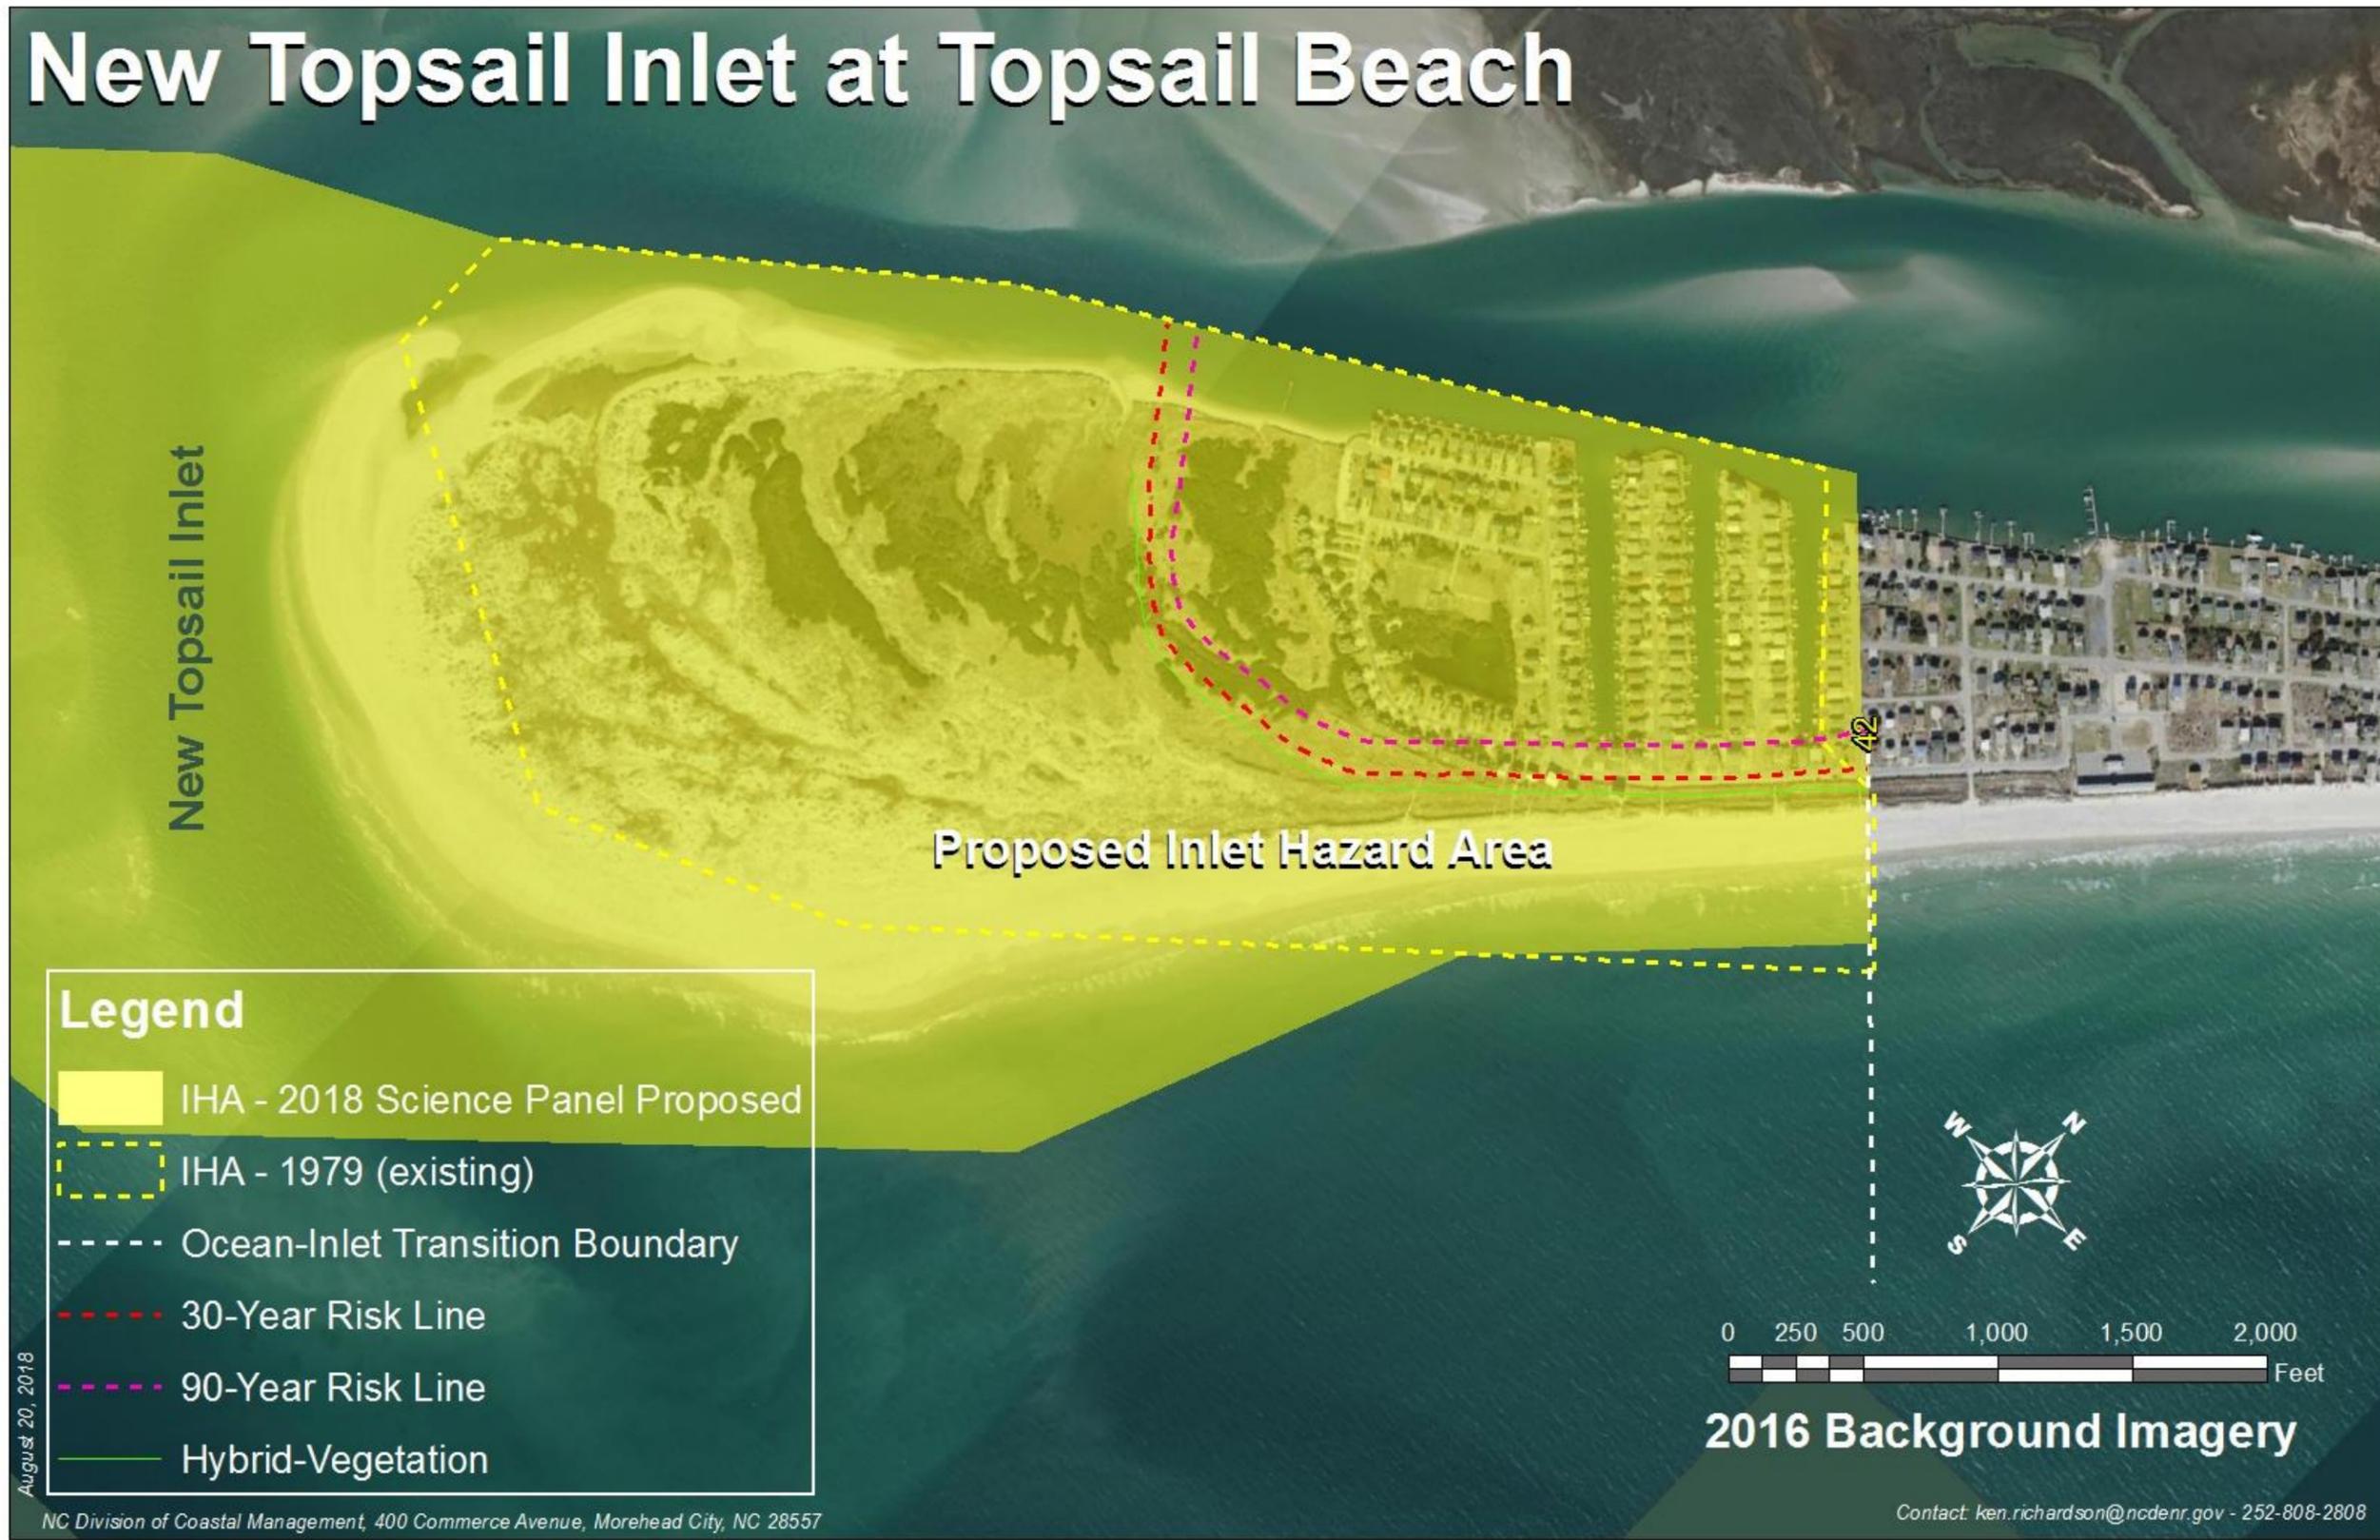
Figure C14. Proposed Inlet Hazard Area at New Topsail Inlet (Topsail Beach).

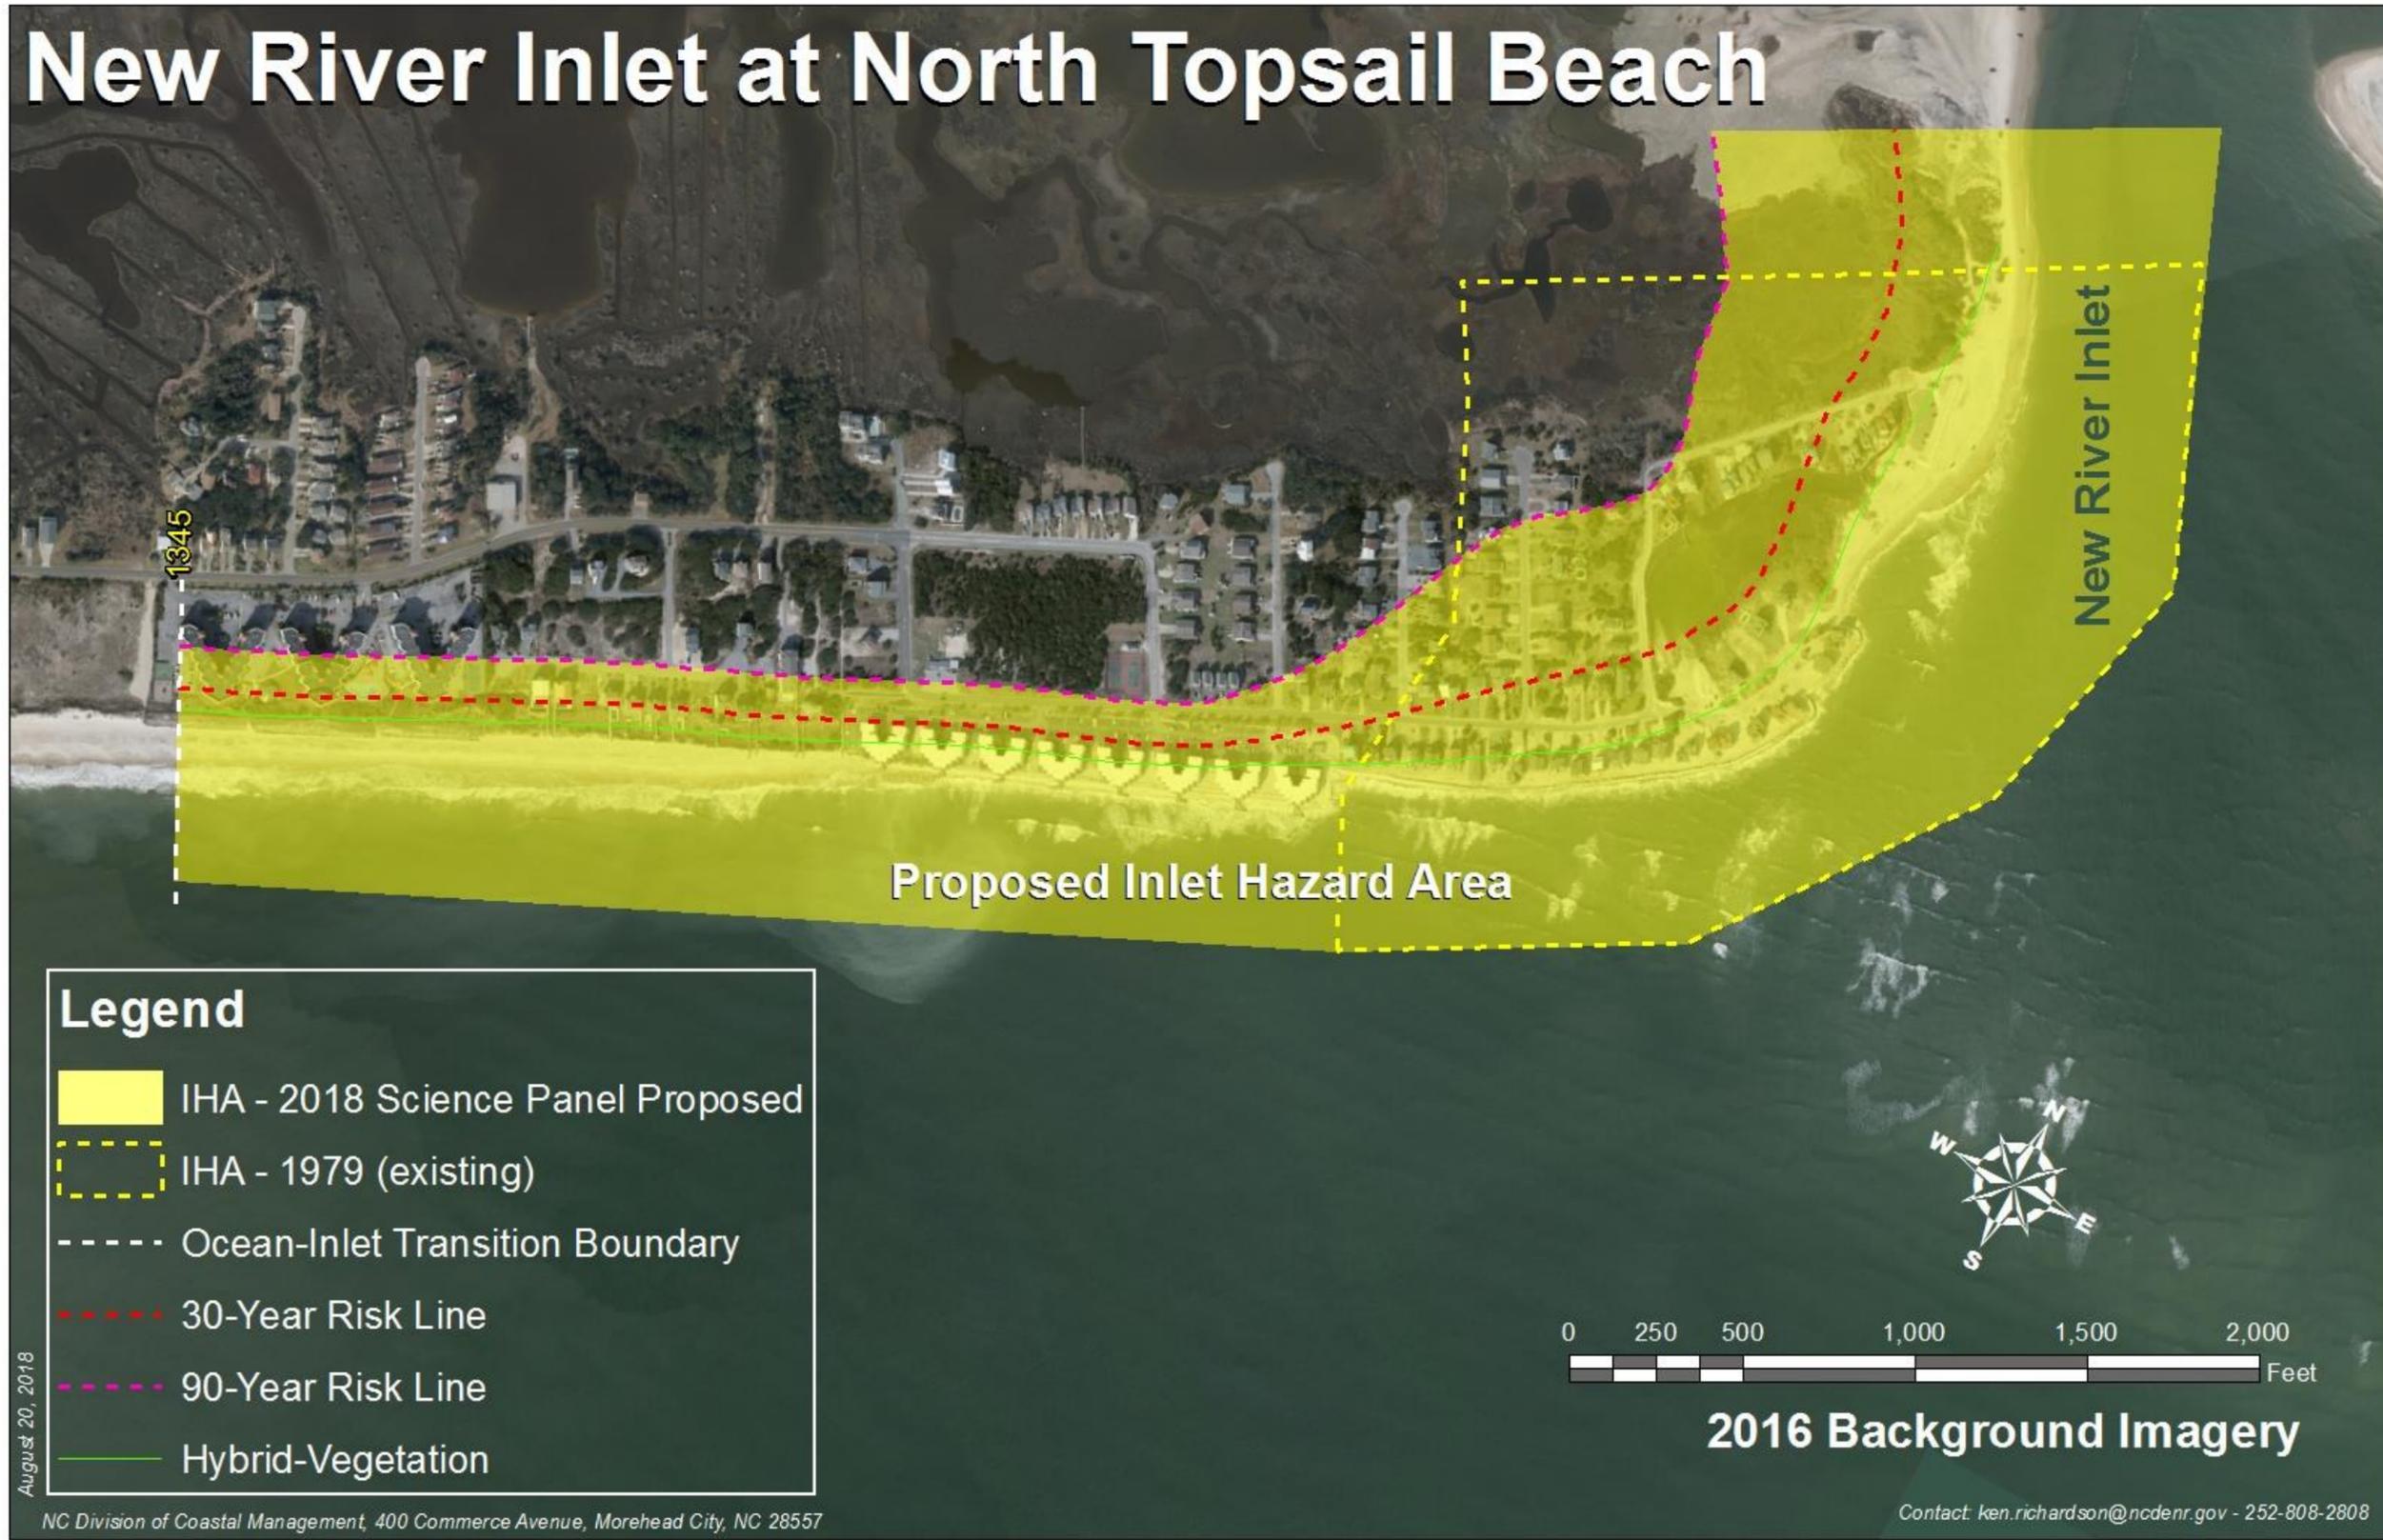
Figure C15. Proposed Inlet Hazard Area at New River Inlet (North Topsail Beach).

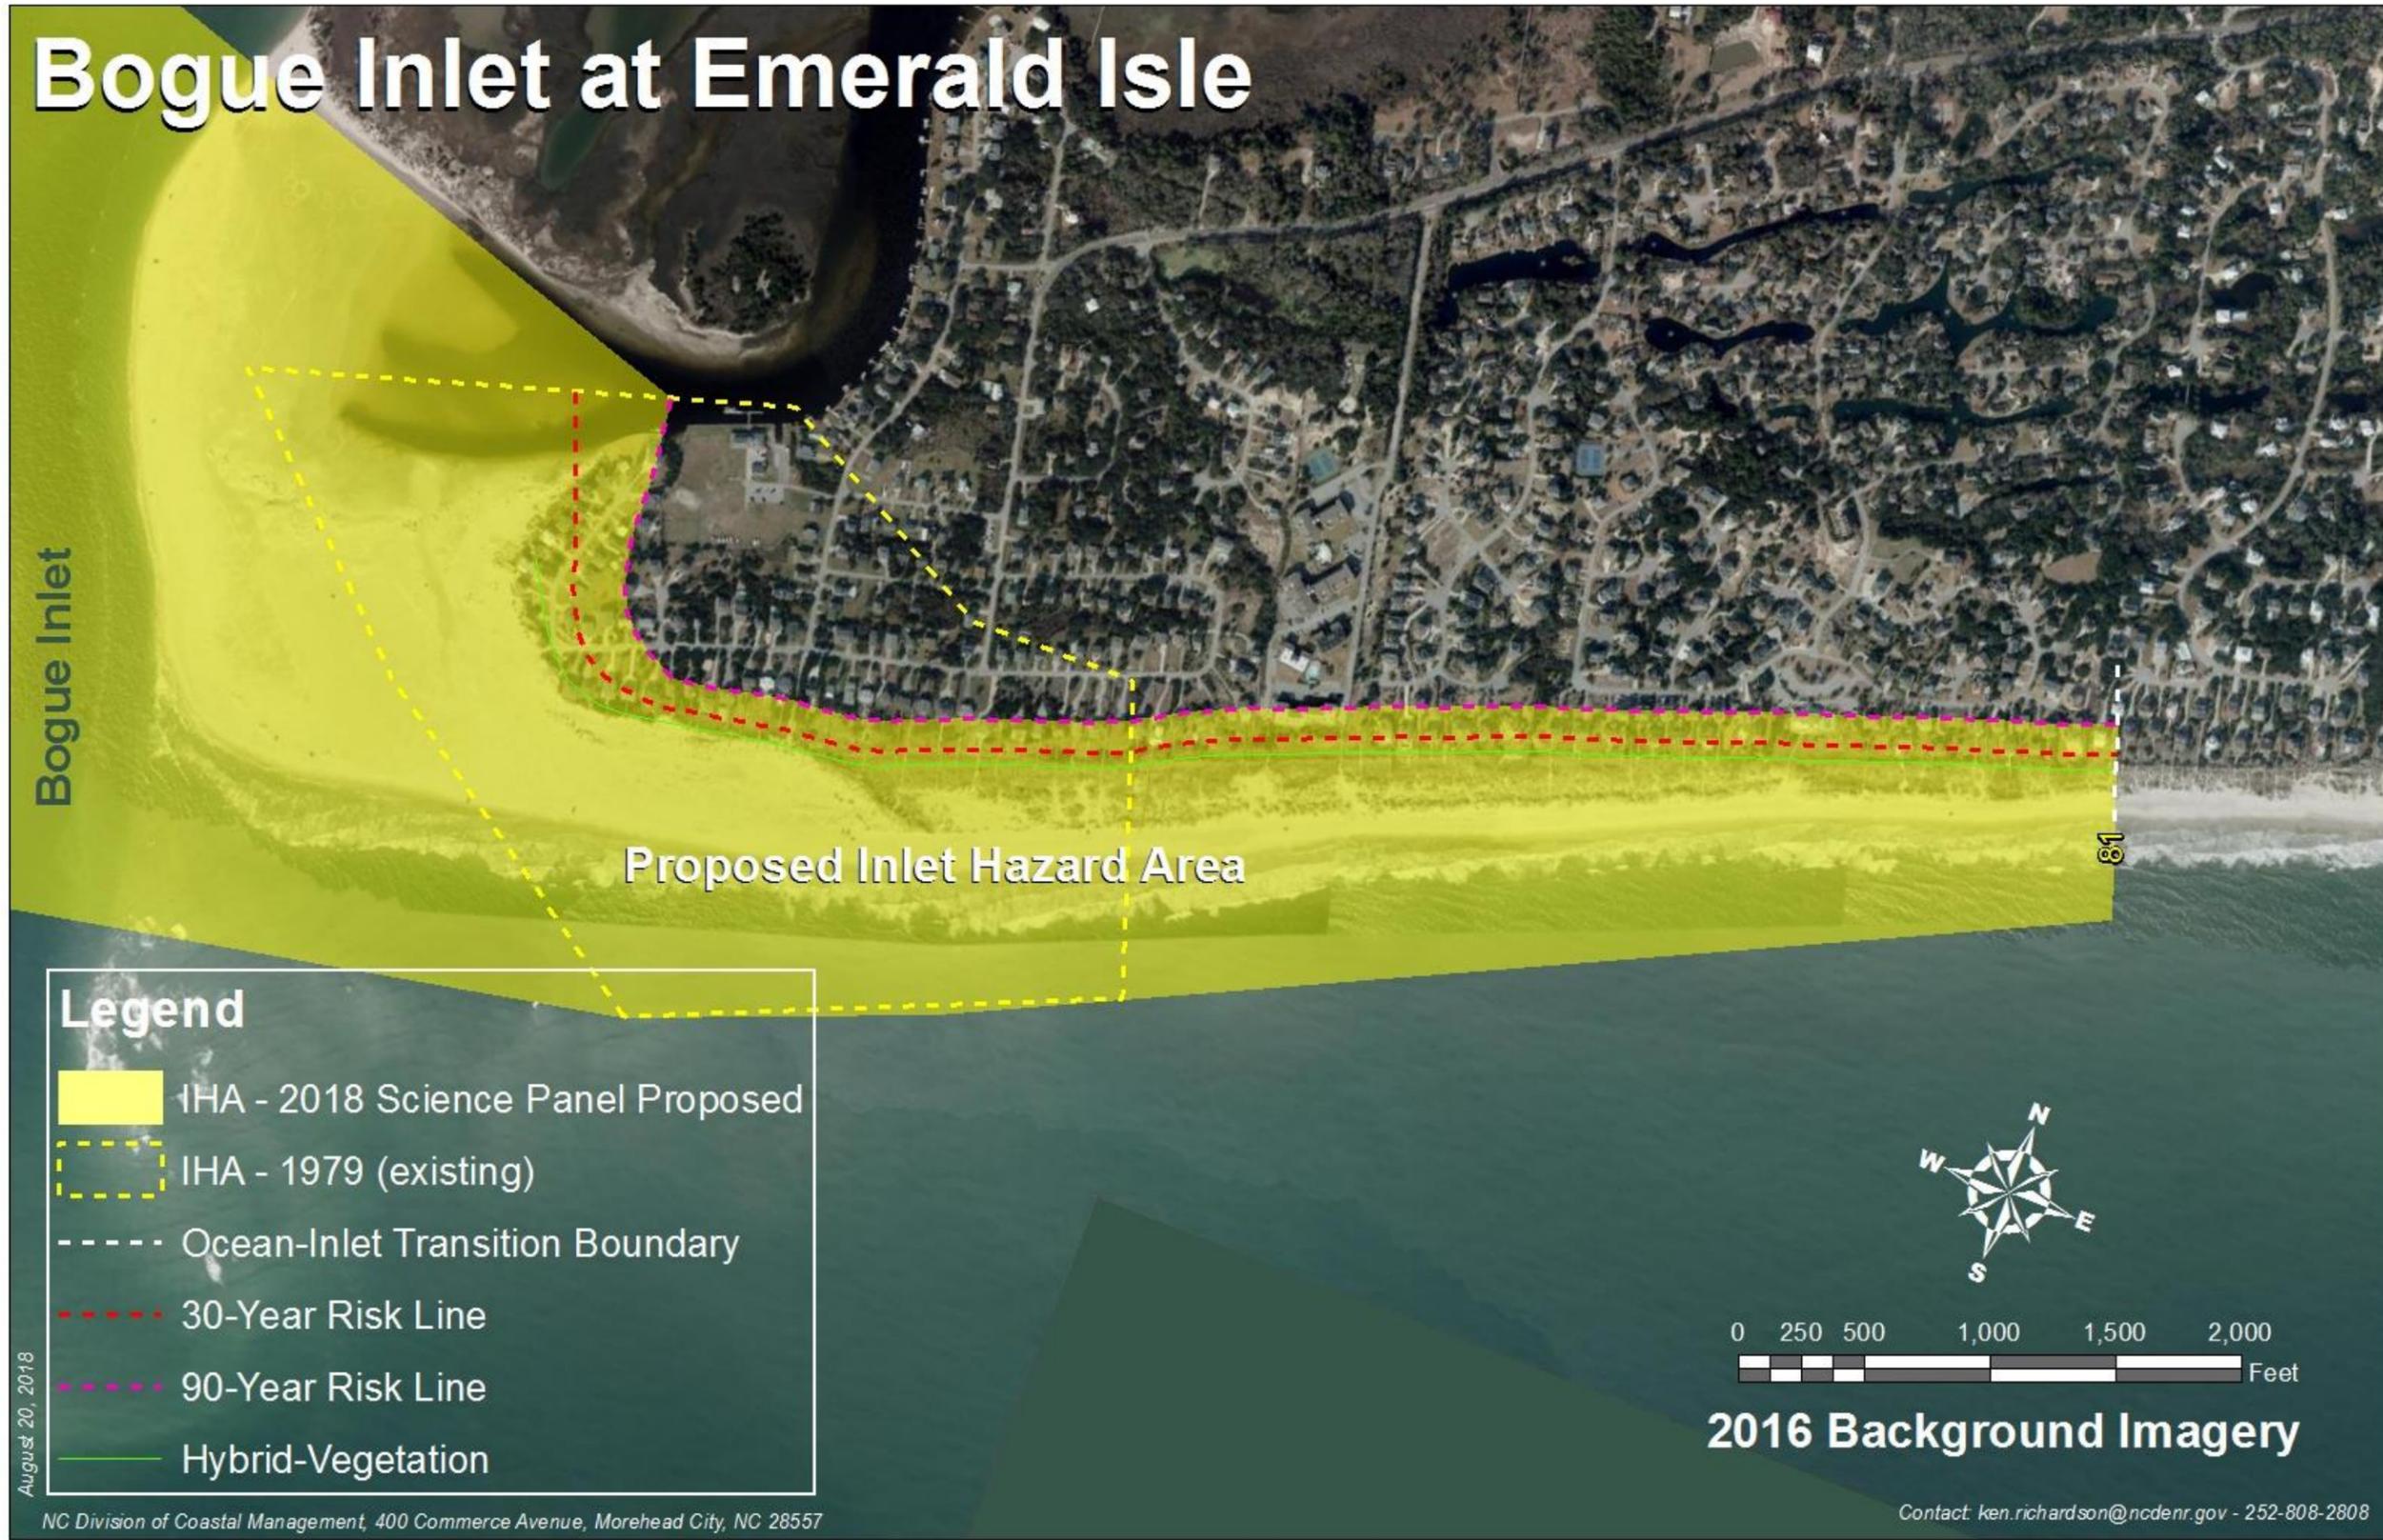
Figure C16. Proposed Inlet Hazard Area at Bogue Inlet (Emerald Isle).
