# Holden Beach Oceanfront Pier Due Diligence Inspection Holden Beach, North Carolina

October 15, 2021

Applied Technology & Management of NC

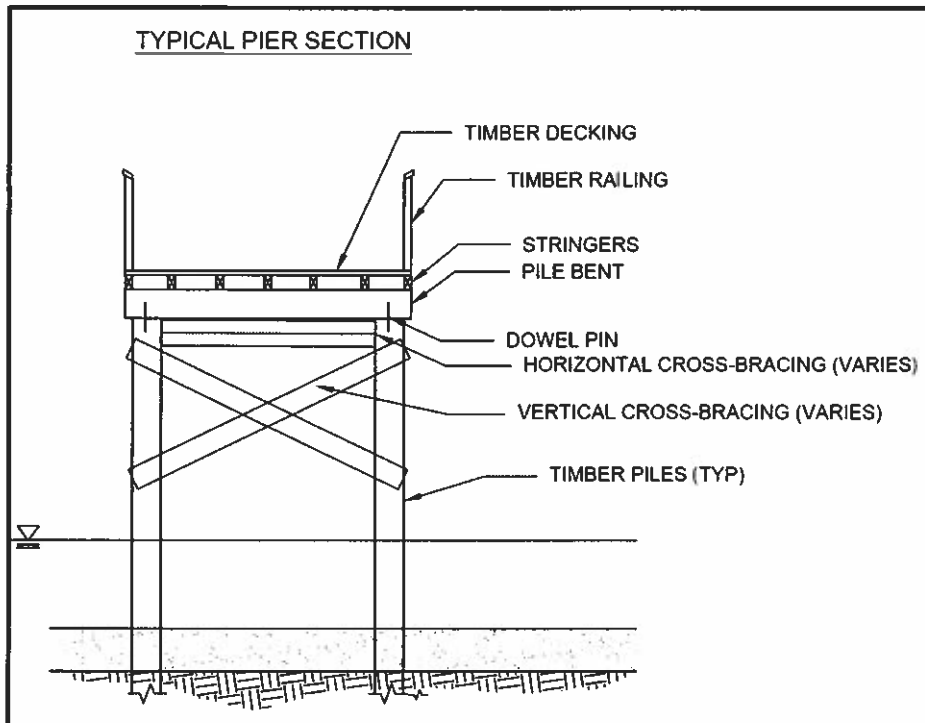
**Figure 3: General schematic of Holden Beach oceanfront pier and its elements.**

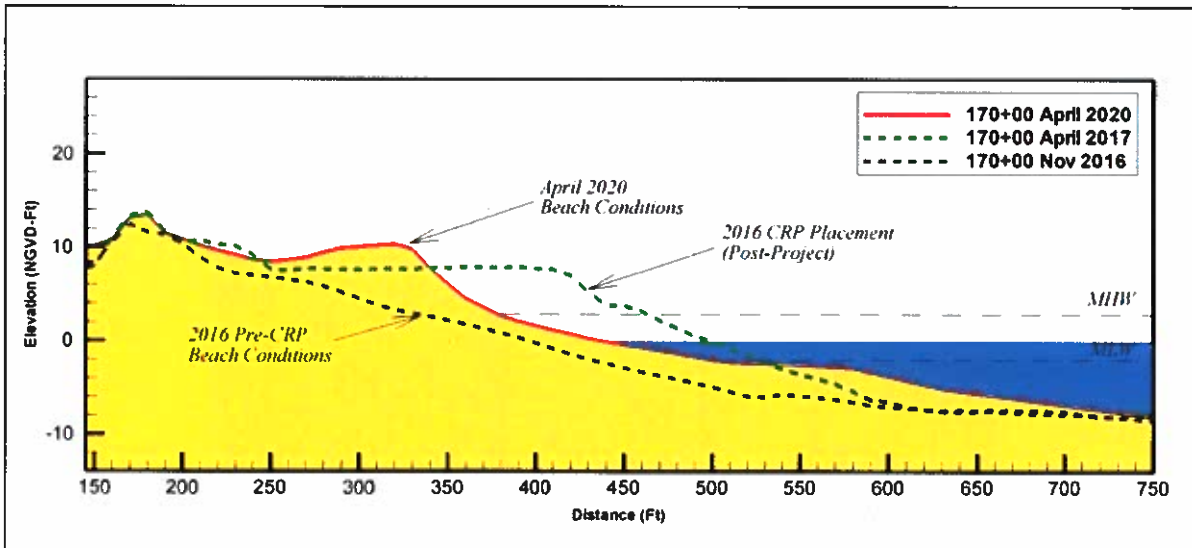
In absence of the piling as-built elevations and installation records, ATM could not ascertain the top elevation, overall length, or pile embedment. Pile embedment information is critical in determining the structural capacity of the piles. In reviewing recent beach profile survey data at Station 170+00 approximately 350 feet to the east of the pier, it is known that several more feet of sand exists when compared with 2016 (pre- Central Reach Project beach fill) survey data (see Figure 10). Pulling existing piles or even excavating around existing piles is not recommended. One possibility would be to pull a previously cut or non-load bearing piling to assess embedment depth. Timely replacement of the 3 cracked/broken piles identified in Table 2 could also provide valuable information on embedment depth.

Figure 10: Beach survey station closest to the pier compared with pre- and immediate post- Central Reach Project (CRP) conditions. Note that several more feet of sand currently exists.

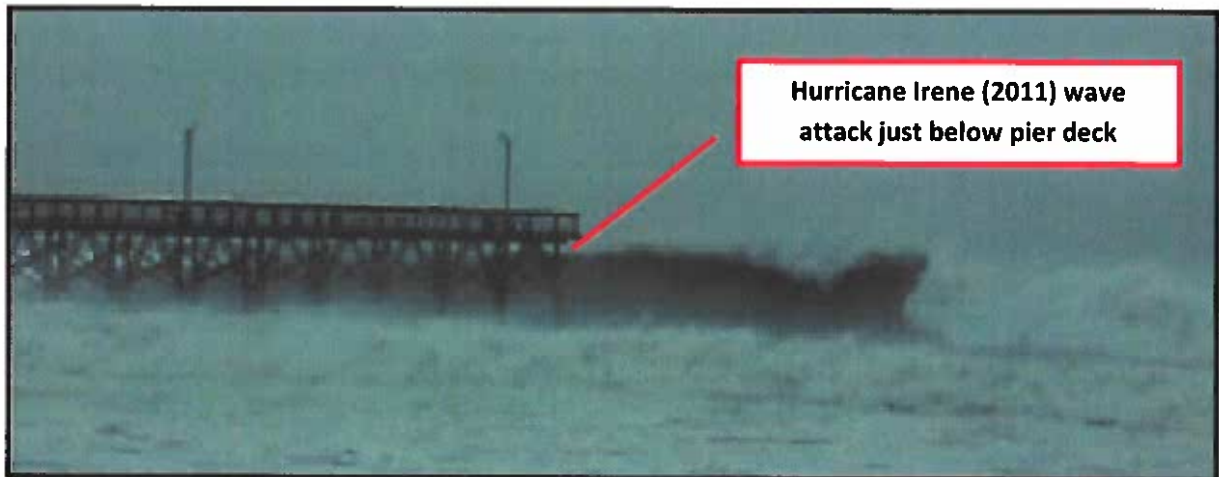
Deck elevation above wave attack is an important consideration and based on the deck survival from hurricanes over the last few decades (since Floyd), it appears the deck elevation is of adequate height. However this is no guarantee that the deck will survive under extreme storm conditions, especially with sea level rise and potentially more powerful storms. Figure 18 presents a screenshot of wave attack during Hurricane Irene (2011) where wave height is just below the pier deck. Not rebuilding the seaward portion of the original pier following Floyd was also a good decision as wave heights during storms are larger in deeper water.

**Figure 18: Wave heights just below pier deck during Hurricane Irene (2011).**
